Profile/Photo Observation Report

Date:	09/24/2018	Weather:		Coding:	PACP 6.0
Pipe Length (ft):	233.6	Owner:	NA	Pre Clean:	Not Known
P.O.#:		Surveyor:	Selasie Honu	PSR:	P-203-016-018
Customer:		Clean Date:	01/01/1900	Shape:	C

Street:	Maxwell St	Flow Control:	Not Controlled
City:	Hobart, IN	Year Renewed:	
Location:	Light Highway	Tape/Media #:	
Purpose:	Routine Assessment	Dia/Height:	10"
Use:	Sanitary	Material:	VCP
Drain Area:	NA	Lining:	
Category:	NA		
Comment:

Location Details:		Direction of Survey:	Upstream
US MH:	M-203-016	DS MH:	M-203-018
		Total Length Surveyed (ft):	101.1

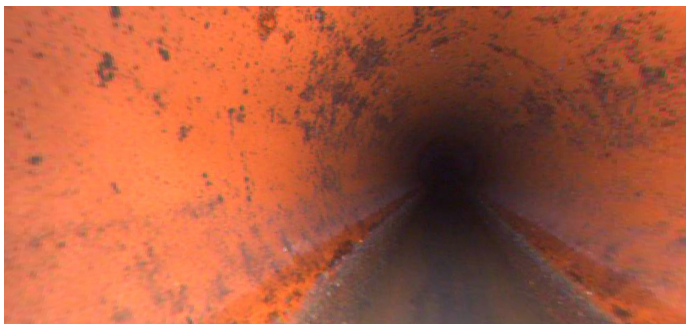
Code: **AMH**
Description: **Manhole**

Distance (ft): **.0**
Structural Grade: **0**
O&M Grade: **0**
Clock Start/From:
Clock To:
1st Value:
2nd Value:
Value Percent:
Continuous Index:
Within 8" of Joint: **NO**
Remarks: **M-203-018**

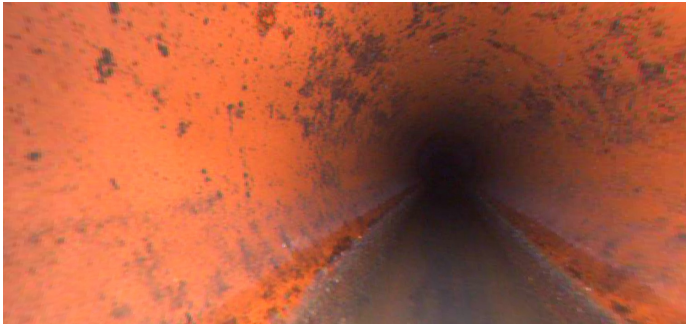
Code:	MWL
Description:	Water Level

Distance (ft):	.0
Structural Grade:	0
O&M Grade:	0
Clock Start/From:	
Clock To:	
1st Value:	
2nd Value:	
Value Percent:	5.000
Continuous Index:	
Within 8" of Joint:	NO
Remarks:

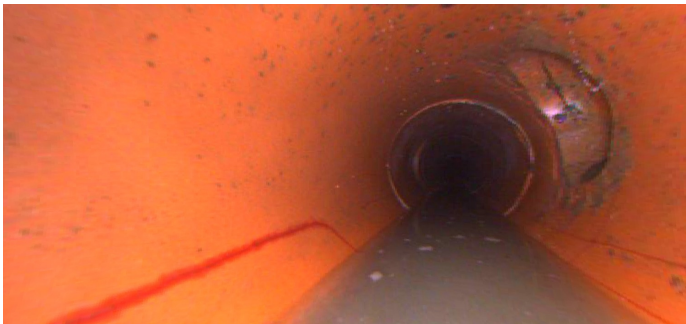
Code:	TF
Description:	Tap Factory

Distance (ft):	64.6
Structural Grade:	0
O&M Grade:	0
Clock Start/From:	2
Clock To:	
1st Value:	4.000
2nd Value:	
Value Percent:	
Continuous Index:	
Within 8" of Joint:	
Remarks:

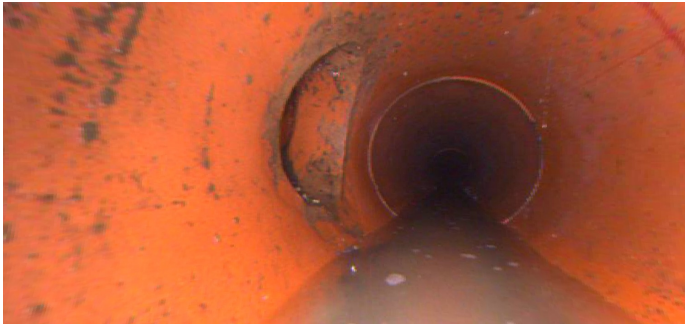
Code: **TF**
Description: **Tap Factory**

Distance (ft): **67.0**
Structural Grade: **0**
O&M Grade: **0**
Clock Start/From: **9**
Clock To:
1st Value: **4.000**
2nd Value:
Value Percent:
Continuous Index:
Within 8" of Joint:
Remarks:

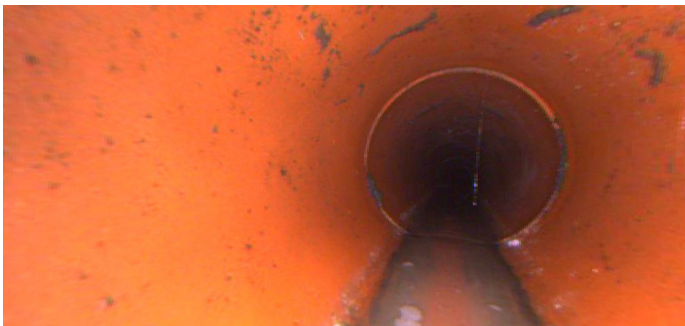
Code: **RFJ**
Description: **Roots Fine Joint**

Distance (ft): **82.1**
Structural Grade: **0**
O&M Grade: **1**
Clock Start/From: **8**
Clock To: **3**
1st Value:
2nd Value:
Value Percent:
Continuous Index:
Within 8" of Joint: **YES**
Remarks:

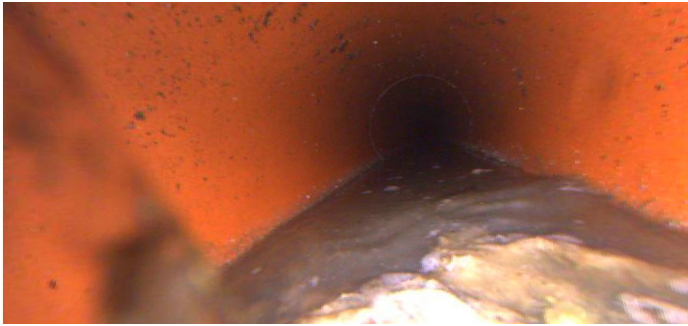
Code:	MSA
Description:	Abandoned Survey
Distance (ft):	101.1
Structural Grade:	0
O&M Grade:	0
Clock Start/From:	
Clock To:	
1st Value:	
2nd Value:	
Value Percent:	
Continuous Index:	
Within 8" of Joint:	NO
Remarks:	camera stopped
