Profile/Photo Observation Report

Street:	MAXWELL ST	Flow Control:	Not Controlled
City:	Hobart, IN	Year Renewed:	
Location:	Other	Tape/Media #:	
Purpose:	Not Known	Dia/Height:	10"
Use:	Sanitary	Material:	VCP
Drain Area:	NA	Lining:	
Category:	NA		
Comment:

Location Details:		Direction of Survey:	Upstream
US MH:	M-203-017	DS MH:	M-303-052
		Total Length Surveyed (ft):	151.6

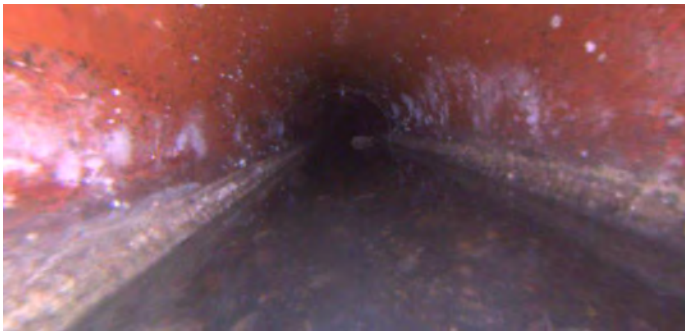
Code: **AMH**
Description: **Manhole**

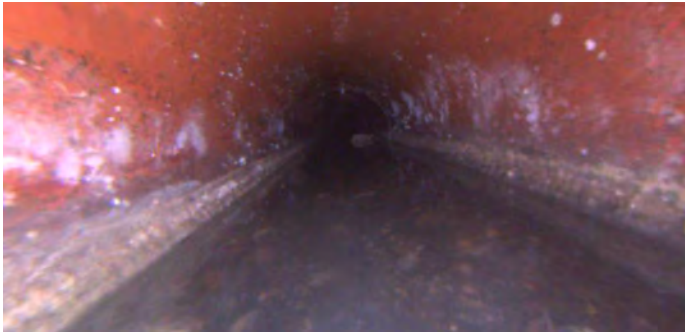
Code:	MWL
Description:	Water Level

Distance (ft):	.0
Structural Grade:	0
O&M Grade:	0
Clock Start/From:	
Clock To:	
1st Value:	
2nd Value:	
Value Percent:	30.000
Continuous Index:	
Within 8" of Joint:	NO
Remarks:

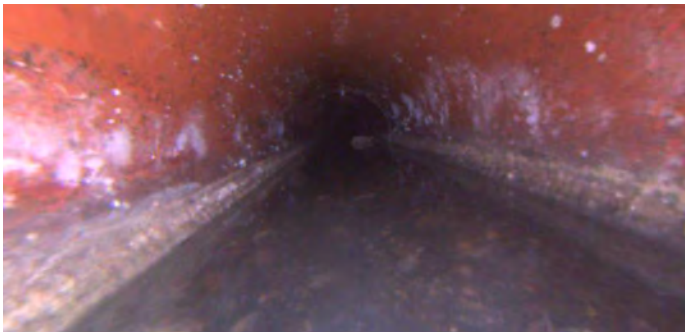
Code:	DAGS
Description:	Deposits Attached Grease

Distance (ft):	.0
Structural Grade:	0
O&M Grade:	2
Clock Start/From:	8
Clock To:	4
1st Value:	
2nd Value:	
Value Percent:	5.000
Continuous Index:	S01
Within 8" of Joint:	NO
Remarks:

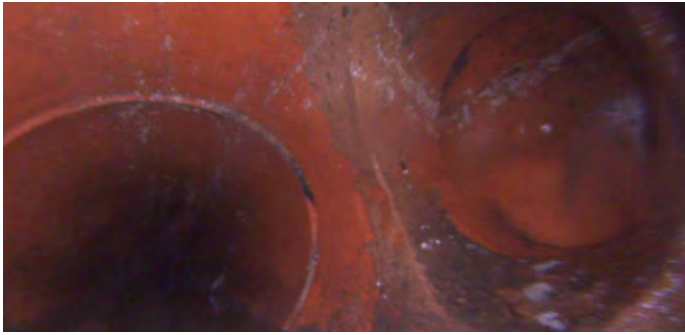
Code: **TFC**
Description: **Tap Factory Capped**

Distance (ft): **34.6**
Structural Grade: **0**
O&M Grade: **0**
Clock Start/From: **3**
Clock To:
1st Value: **4.000**
2nd Value:
Value Percent:
Continuous Index:
Within 8" of Joint:
Remarks:

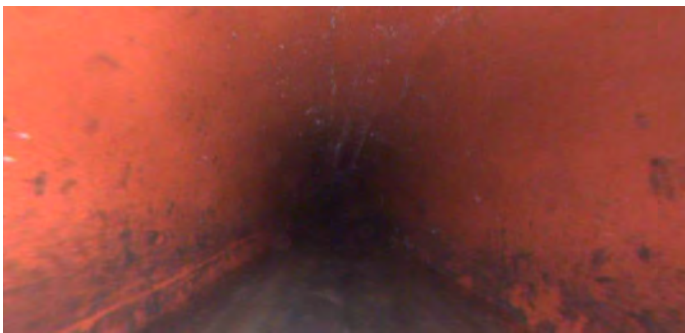
Code: **DAGS**
Description: **Deposits Attached Grease**

Distance (ft): **60.6**
Structural Grade: **0**
O&M Grade: **2**
Clock Start/From: **8**
Clock To: **4**
1st Value:
2nd Value:
Value Percent: **5.000**
Continuous Index: **F01**
Within 8" of Joint: **NO**
Remarks:

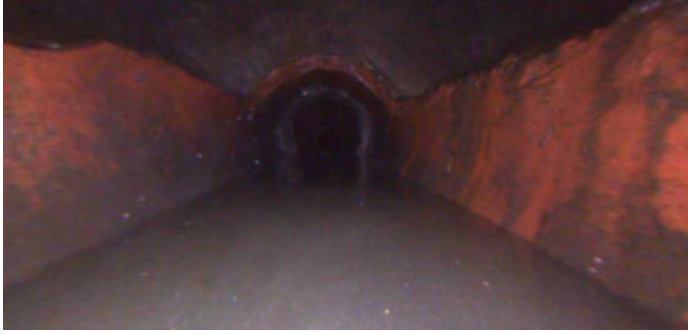
Code:	AMH
Description:	Manhole
Distance (ft):	151.6
Structural Grade:	0
O&M Grade:	0
Clock Start/From:	
Clock To:	
1st Value:	
2nd Value:	
Value Percent:	
Continuous Index:	
Within 8" of Joint:	NO
Remarks:	M-203-017
