Profile/Photo Observation Report

Street:	MAXWELL ST	Flow Control:	Not Controlled
City:	Hobart, IN	Year Renewed:	
Location:	Other	Tape/Media #:	
Purpose:	Not Known	Dia/Height:	10"
Use:	Sanitary	Material:	VCP
Drain Area:	NA	Lining:	
Category:	NA		
Comment:

Location Details:		Direction of Survey:	Upstream
US MH:	M-203-017	DS MH:	M-303-052
		Total Length Surveyed (ft):	151.6

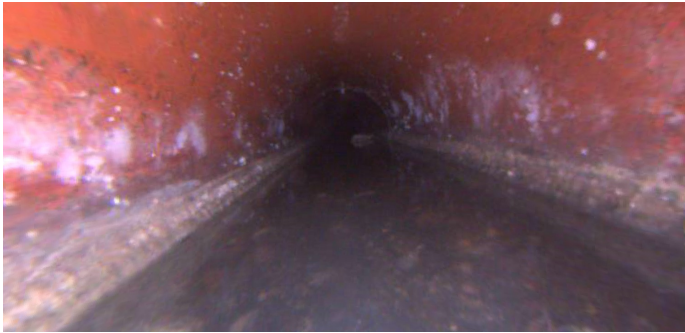
Code:	MWL
Description:	Water Level

Distance (ft):	.0
Structural Grade:	0
O&M Grade:	0
Clock Start/From:	
Clock To:	
1st Value:	
2nd Value:	
Value Percent:	30.000
Continuous Index:	
Within 8" of Joint:	NO
Remarks:

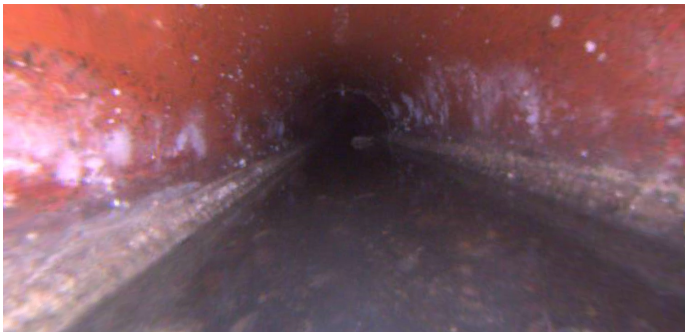
Code:	DAGS
Description:	Deposits Attached Grease

Distance (ft):	.0
Structural Grade:	0
O&M Grade:	2
Clock Start/From:	8
Clock To:	4
1st Value:	
2nd Value:	
Value Percent:	5.000
Continuous Index:	S01
Within 8" of Joint:	NO
Remarks:

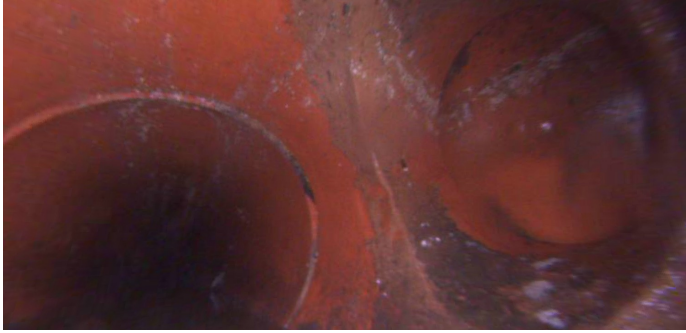
Code: **TFC**
Description: **Tap Factory Capped**

Distance (ft): **34.6**
Structural Grade: **0**
O&M Grade: **0**
Clock Start/From: **3**
Clock To:
1st Value: **4.000**
2nd Value:
Value Percent:
Continuous Index:
Within 8" of Joint:
Remarks:

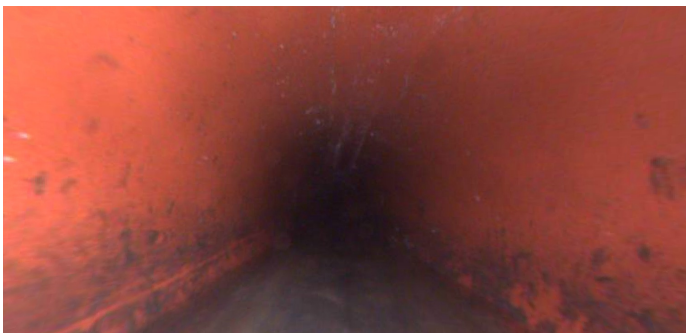
Code: **DAGS**
Description: **Deposits Attached Grease**

Distance (ft): **60.6**
Structural Grade: **0**
O&M Grade: **2**
Clock Start/From: **8**
Clock To: **4**
1st Value:
2nd Value:
Value Percent: **5.000**
Continuous Index: **F01**
Within 8" of Joint: **NO**
Remarks:

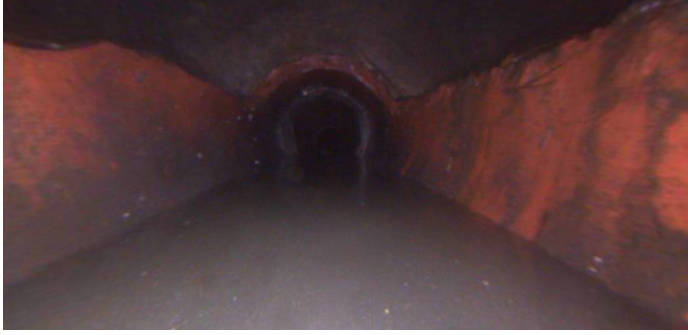
Code:	AMH
Description:	Manhole
Distance (ft):	151.6
Structural Grade:	0
O&M Grade:	0
Clock Start/From:	
Clock To:	
1st Value:	
2nd Value:	
Value Percent:	
Continuous Index:	
Within 8" of Joint:	NO
Remarks:	M-203-017
