Profile/Photo Observation Report

Location Details:		Direction of Survey:	Downstream
US MH:	M-203-018	DS MH:	M-203-017
		Total Length Surveyed (ft):	44.6

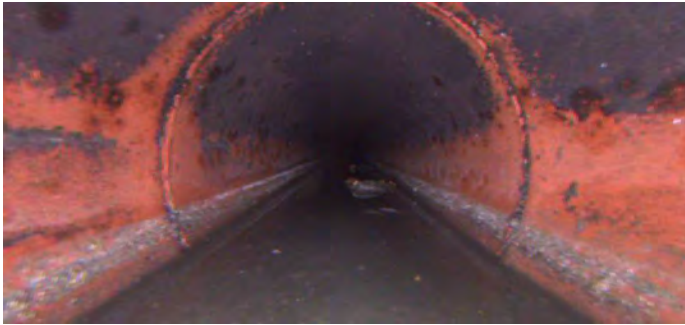
Code:	MWL
Description:	Water Level

Distance (ft):	.0
Structural Grade:	0
O&M Grade:	0
Clock Start/From:	
Clock To:	
1st Value:	
2nd Value:	
Value Percent:	5.000
Continuous Index:	
Within 8" of Joint:	NO
Remarks:

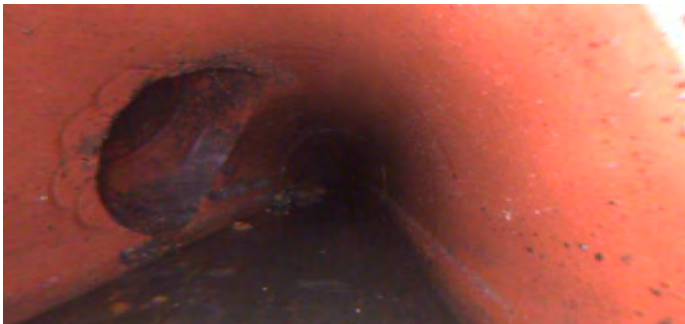
Code:	TF
Description:	Tap Factory

Distance (ft):	11.7
Structural Grade:	0
O&M Grade:	0
Clock Start/From:	9
Clock To:	
1st Value:	4.000
2nd Value:	
Value Percent:	
Continuous Index:	
Within 8" of Joint:	
Remarks:

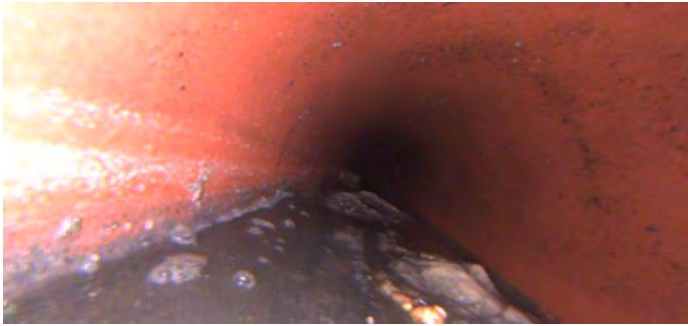
Code:	MSA
Description:	Abandoned Survey
Distance (ft):	44.6
Structural Grade:	0
O&M Grade:	0
Clock Start/From:	
Clock To:	
1st Value:	
2nd Value:	
Value Percent:	
Continuous Index:	
Within 8" of Joint:	NO
Remarks:	camera stopped
