## Profile/Photo Observation Report

Street:	<b>Maxwell St</b>	Flow Control:	<b>Not Controlled</b>
City:	<b>Hobart, IN</b>	Year Renewed:	
Location:	<b>Light Highway</b>	Tape/Media #:	
Purpose:	<b>Routine Assessment</b>	Dia/Height:	<b>10"</b>
Use:	<b>Sanitary</b>	Material:	<b>VCP</b>
Drain Area:	<b>NA</b>	Lining:	
Category:	<b>NA</b>		
Comment:

Location Details:		Direction of Survey:	<b>Downstream</b>
US MH:	<b>M-203-018</b>	DS MH:	<b>M-203-017</b>
		Total Length Surveyed (ft):	<b>44.6</b>

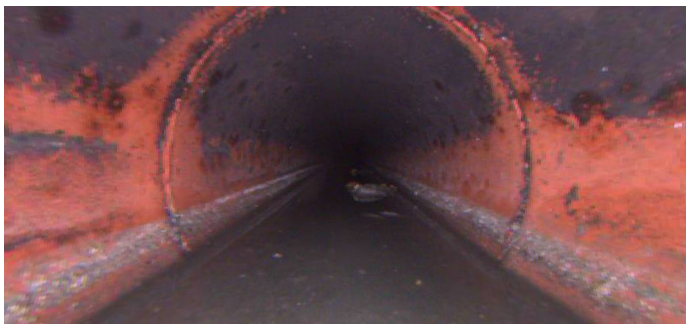
Code: **AMH**  
Description: **Manhole**

Distance (ft): **.0**  
Structural Grade: **0**  
O&M Grade: **0**  
Clock Start/From:  
Clock To:  
1st Value:  
2nd Value:  
Value Percent:  
Continuous Index:  
Within 8" of Joint: **NO**  
Remarks: **M-203-018**

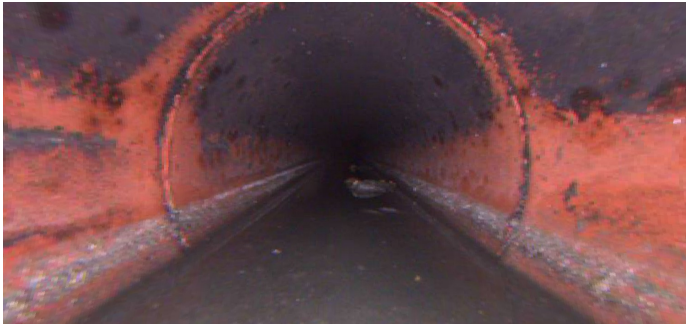
Code:	<b>MWL</b>
Description:	<b>Water Level</b>

Distance (ft):	<b>.0</b>
Structural Grade:	<b>0</b>
O&M Grade:	<b>0</b>
Clock Start/From:	
Clock To:	
1st Value:	
2nd Value:	
Value Percent:	<b>5.000</b>
Continuous Index:	
Within 8" of Joint:	<b>NO</b>
Remarks:

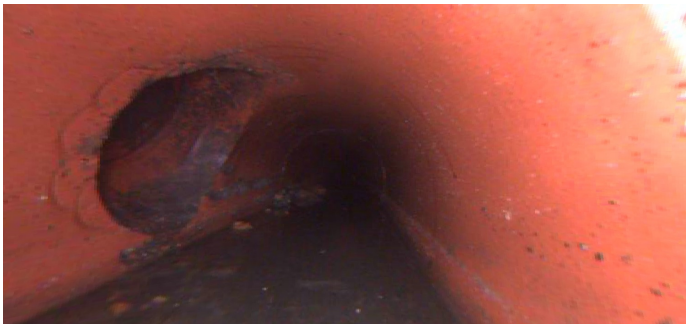
Code:	<b>TF</b>
Description:	<b>Tap Factory</b>

Distance (ft):	<b>11.7</b>
Structural Grade:	<b>0</b>
O&M Grade:	<b>0</b>
Clock Start/From:	<b>9</b>
Clock To:	
1st Value:	<b>4.000</b>
2nd Value:	
Value Percent:	
Continuous Index:	
Within 8" of Joint:	
Remarks:

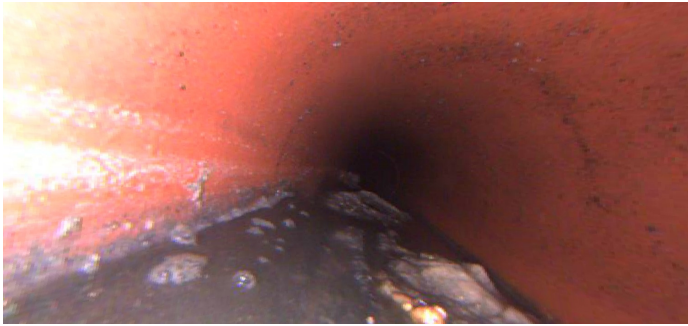
Code:	<b>MSA</b>
Description:	<b>Abandoned Survey</b>
Distance (ft):	<b>44.6</b>
Structural Grade:	<b>0</b>
O&M Grade:	<b>0</b>
Clock Start/From:	
Clock To:	
1st Value:	
2nd Value:	
Value Percent:	
Continuous Index:	
Within 8" of Joint:	<b>NO</b>
Remarks:	<b>camera stopped</b>
