## Profile/Photo Observation Report

Street:	<b>Off Parker Street</b>	Flow Control:	
City:	<b>Hobart, IN</b>	Year Renewed:	
Location:	<b>Yard</b>	Tape/Media #:	<b>873</b>
Purpose:	<b>Routine Assessment</b>	Dia/Height:	<b>10"</b>
Use:	<b>Sanitary</b>	Material:	<b>VCP</b>
Drain Area:		Lining:

US MH: **M-203-24** DS MH: **M-203-25** Total Length Surveyed (ft): **158.3**

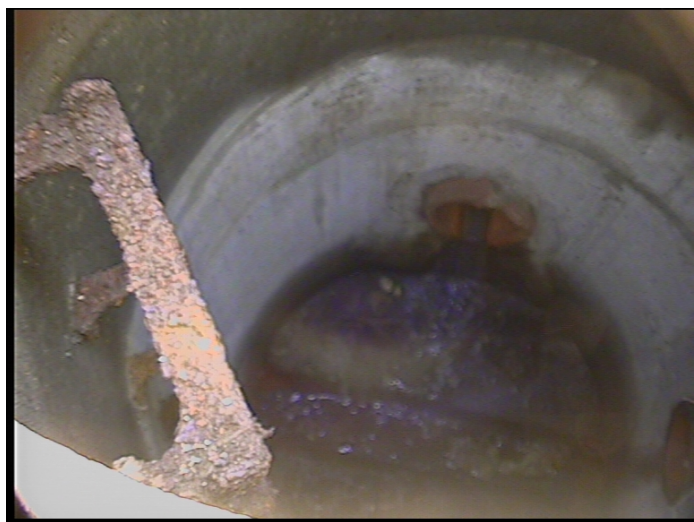
Code: **AMH**  
Description: **Manhole**

Distance (ft): **.0**  
Structural Grade: **0**  
O&M Grade: **0**  
Clock Start/From:  
Clock To:  
1st Value:  
2nd Value:  
Value Percent:  
Continuous Index:  
Within 8" of Joint: **NO**  
Remarks: **M-203-25**

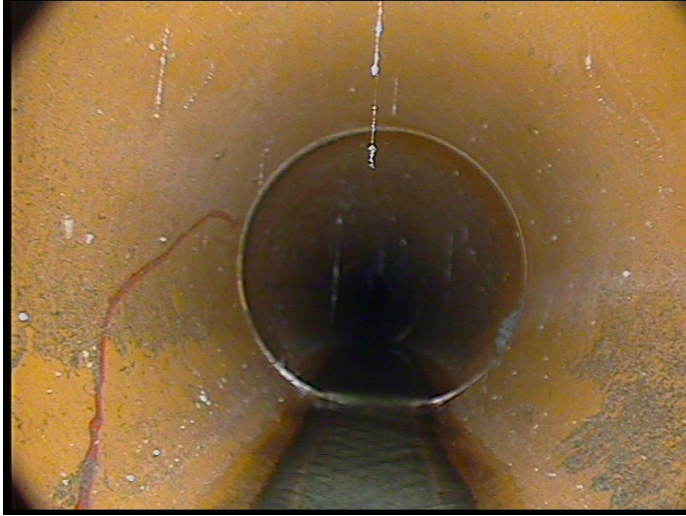
Code:	<b>MWL</b>
Description:	<b>Water Level</b>
Distance (ft):	<b>.0</b>
Structural Grade:	<b>0</b>
O&M Grade:	<b>0</b>
Clock Start/From:	
Clock To:	
1st Value:	
2nd Value:	
Value Percent:	<b>5.000</b>
Continuous Index:	
Within 8" of Joint:	<b>NO</b>
Remarks:

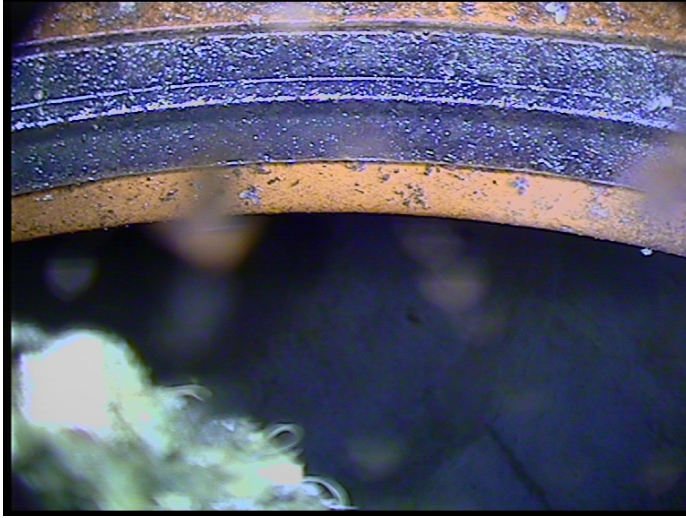
Code:	<b>AMH</b>
Description:	<b>Manhole</b>
Distance (ft):	<b>158.3</b>
Structural Grade:	<b>0</b>
O&M Grade:	<b>0</b>
Clock Start/From:	
Clock To:	
1st Value:	
2nd Value:	
Value Percent:	
Continuous Index:	
Within 8" of Joint:	<b>NO</b>
Remarks:	<b>M-203-24</b>
