Profile/Photo Observation Report

Street:	38th Avenue	Flow Control:	
City:	Hobart, IN	Year Renewed:	
Location:	Light Highway	Tape/Media #:	870
Purpose:	Routine Assessment	Dia/Height:	12"
Use:	Sanitary	Material:	VCP
Drain Area:		Lining:	
Category:	NA		
Comment:

Location Details:		Direction of Survey:	Upstream
US MH:	M-203-27	DS MH:	M-203-26
		Total Length Surveyed (ft):	330.2

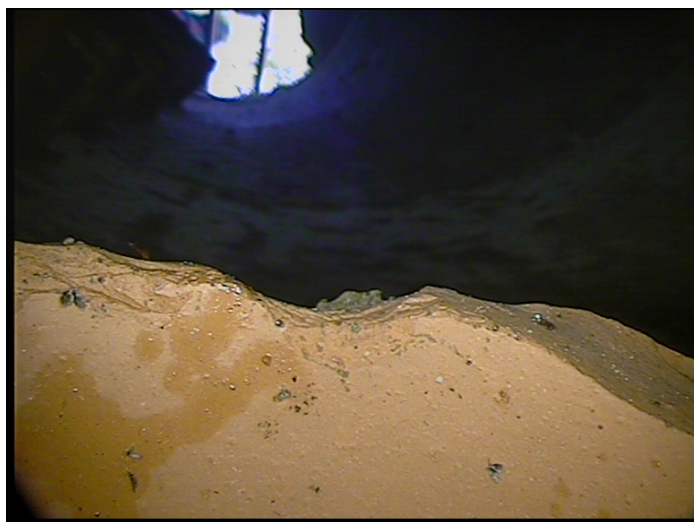
AMH

Manhole

.0

M-203-26

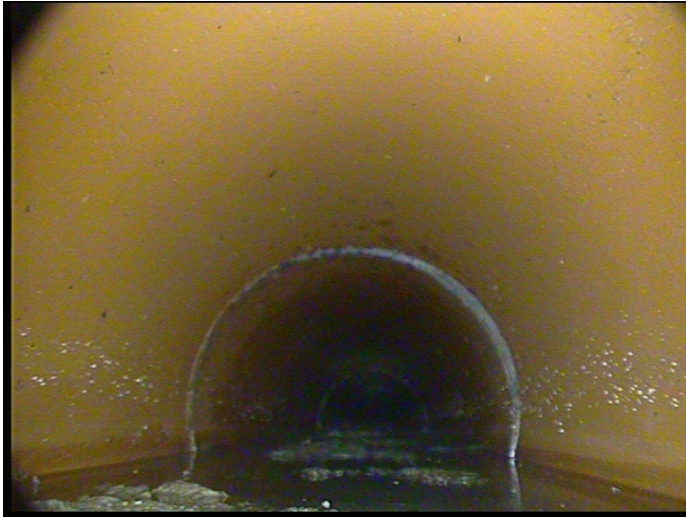
Code: **MWL**
Description: **Water Level**

Distance (ft): **.0**
Structural Grade: **0**
O&M Grade: **0**
Clock Start/From:
Clock To:
1st Value:
2nd Value:
Value Percent: **10.000**
Continuous Index:
Within 8" of Joint: **NO**
Remarks:

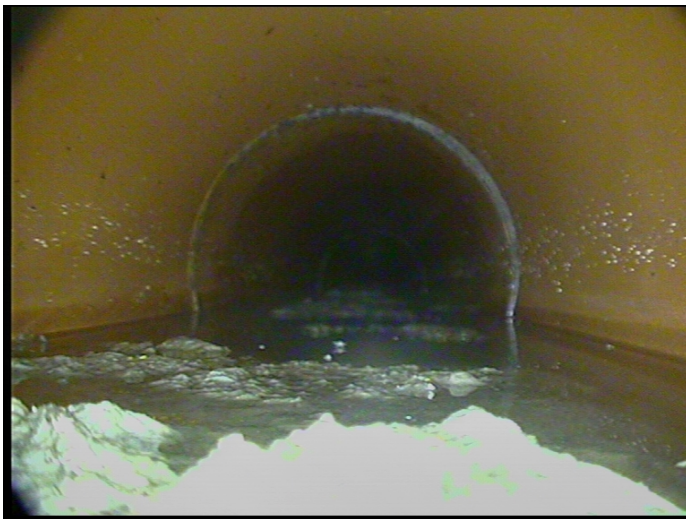
Code: **DSF**
Description: **Deposits Settled Fine**

Distance (ft): **.0**
Structural Grade: **0**
O&M Grade: **2**
Clock Start/From: **4**
Clock To: **8**
1st Value:
2nd Value:
Value Percent: **10.000**
Continuous Index: **S01**
Within 8" of Joint: **YES**
Remarks:

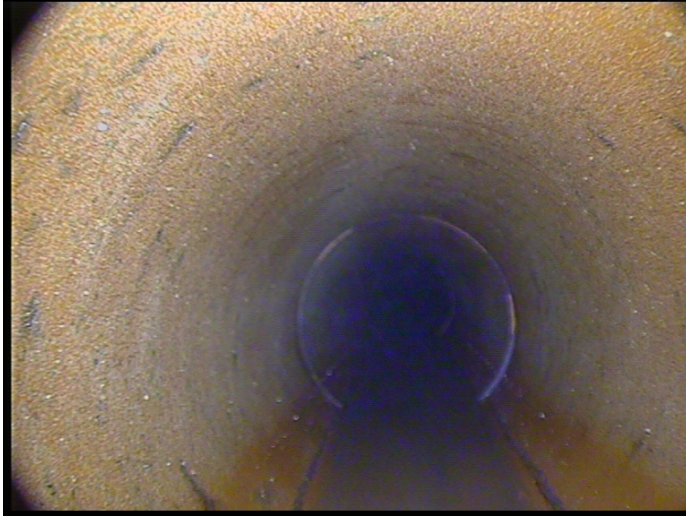
Code: **DSF**
Description: **Deposits Settled Fine**

Distance (ft): **285.8**
Structural Grade: **0**
O&M Grade: **2**
Clock Start/From: **4**
Clock To: **8**
1st Value:
2nd Value:
Value Percent: **10.000**
Continuous Index: **F01**
Within 8" of Joint: **NO**
Remarks:

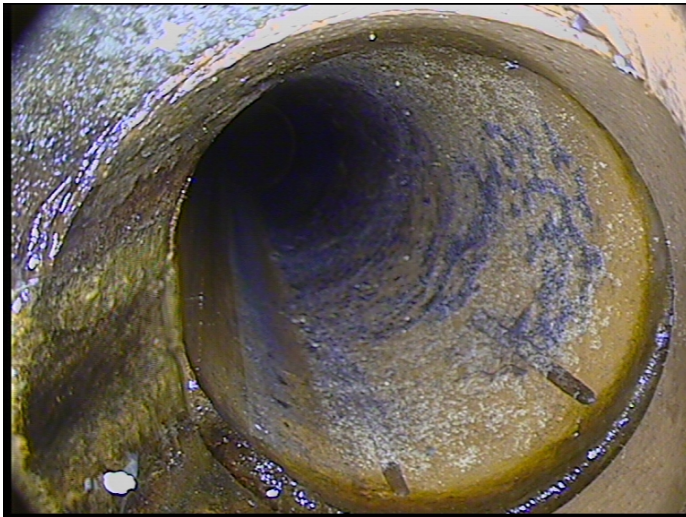
Code: **TFA**
Description: **Tap Factory Active**

Distance (ft): **315.5**
Structural Grade: **0**
O&M Grade: **0**
Clock Start/From: **9**
Clock To:
1st Value: **4.000**
2nd Value:
Value Percent:
Continuous Index:
Within 8" of Joint: **NO**
Remarks:

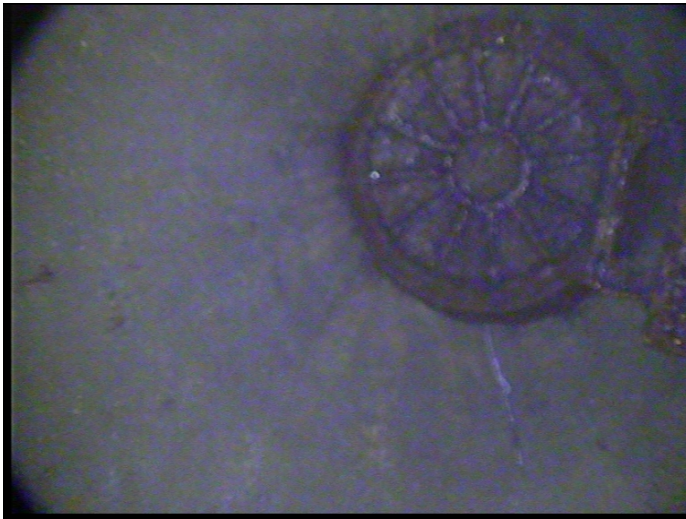
Code:	AMH
Description:	Manhole
Distance (ft):	330.2
Structural Grade:	0
O&M Grade:	0
Clock Start/From:	
Clock To:	
1st Value:	
2nd Value:	
Value Percent:	
Continuous Index:	
Within 8" of Joint:	NO
Remarks:	M-203-27
