Profile/Photo Observation Report

Date:	03/24/2018	Weather:		Coding:	PACP 6.0
Pipe Length (ft):	253.5	Owner:	NA	Pre Clean:	Not Known
P.O.#:		Surveyor:	Byrd Fitzgerald	PSR:	P-203-037-034
Customer:		Clean Date:	01/01/1900	Shape:	C

Street:	W 38TH AVE	Flow Control:	Not Controlled
City:	Hobart, IN	Year Renewed:	
Location:	Other	Tape/Media #:	
Purpose:	Not Known	Dia/Height:	10"
Use:	Sanitary	Material:	VCP
Drain Area:	NA	Lining:	
Category:	NA		
Comment:	pump

Location Details:		Direction of Survey:	Downstream
US MH:	M-203-034	DS MH:	M-203-037
		Total Length Surveyed (ft):	247.3

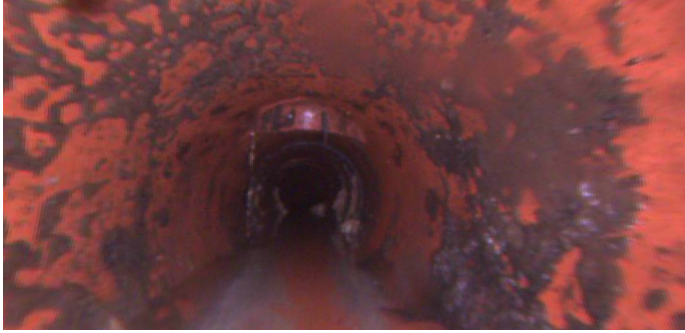
Code: **DAZ**
Description: **Deposits Attached Other**

Distance (ft): **33.9**
Structural Grade: **0**
O&M Grade: **2**
Clock Start/From: **7**
Clock To: **5**
1st Value:
2nd Value:
Value Percent: **5.000**
Continuous Index: **S01**
Within 8" of Joint: **NO**
Remarks:

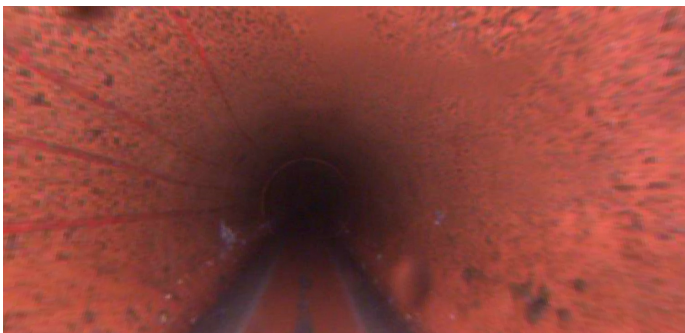
Code: **DAZ**
Description: **Deposits Attached Other**

Distance (ft): **40.5**
Structural Grade: **0**
O&M Grade: **2**
Clock Start/From: **7**
Clock To: **5**
1st Value:
2nd Value:
Value Percent: **5.000**
Continuous Index: **F01**
Within 8" of Joint: **NO**
Remarks:

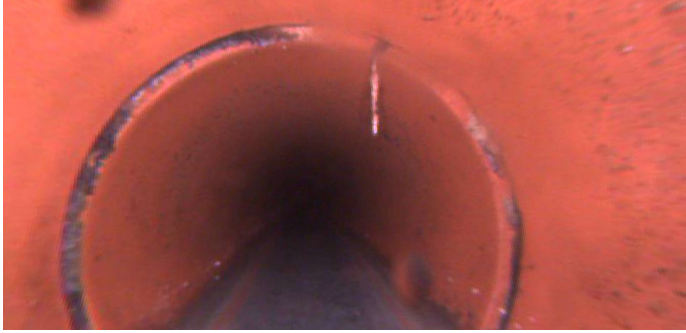
Code: **RFJ**
Description: **Roots Fine Joint**

Distance (ft): **47.6**
Structural Grade: **0**
O&M Grade: **1**
Clock Start/From: **1**
Clock To:
1st Value:
2nd Value:
Value Percent:
Continuous Index:
Within 8" of Joint: **YES**
Remarks:

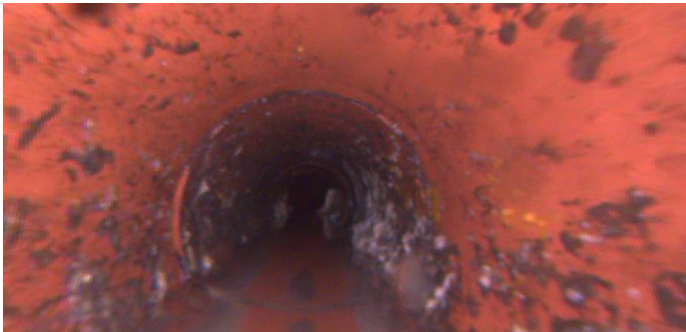
Code: **DAZ**
Description: **Deposits Attached Other**

Distance (ft): **82.4**
Structural Grade: **0**
O&M Grade: **2**
Clock Start/From: **7**
Clock To: **5**
1st Value:
2nd Value:
Value Percent: **5.000**
Continuous Index: **S02**
Within 8" of Joint: **NO**
Remarks:

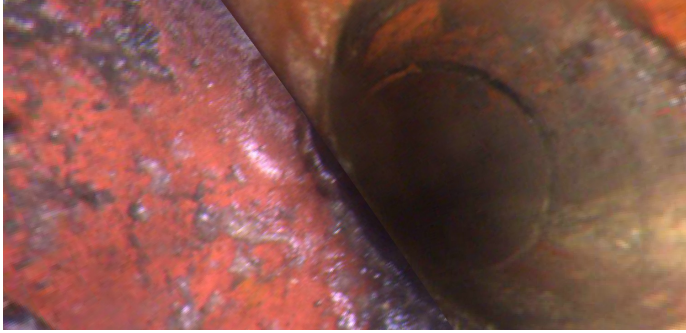
Code: **TF**
Description: **Tap Factory**

Distance (ft): **85.0**
Structural Grade: **0**
O&M Grade: **0**
Clock Start/From: **1**
Clock To:
1st Value: **4.000**
2nd Value:
Value Percent:
Continuous Index:
Within 8" of Joint: **YES**
Remarks:

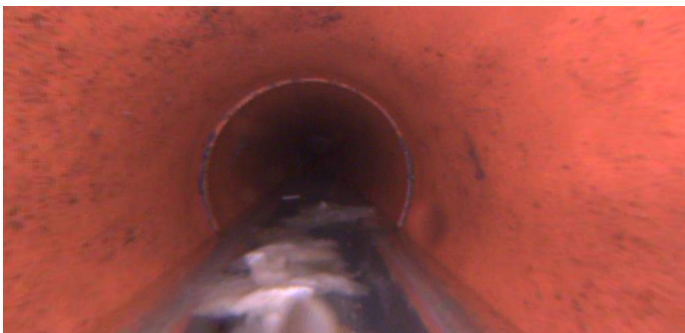
Code: **DSZ**
Description: **Deposits Settled Other**

Distance (ft): **106.4**
Structural Grade: **0**
O&M Grade: **2**
Clock Start/From: **6**
Clock To:
1st Value:
2nd Value:
Value Percent: **5.000**
Continuous Index:
Within 8" of Joint: **NO**
Remarks: **tissue**

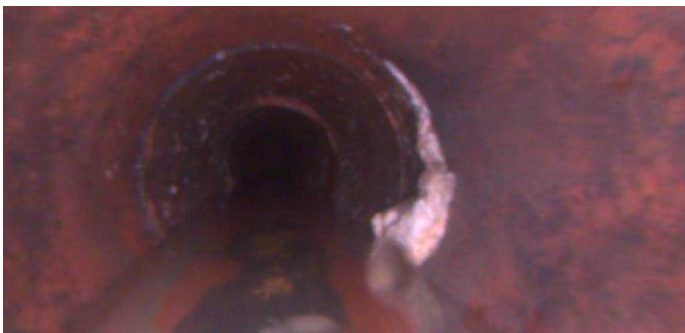
Code: **DAGS**
Description: **Deposits Attached Grease**

Distance (ft): **163.4**
Structural Grade: **0**
O&M Grade: **2**
Clock Start/From: **1**
Clock To: **5**
1st Value:
2nd Value:
Value Percent: **5.000**
Continuous Index:
Within 8" of Joint: **NO**
Remarks:

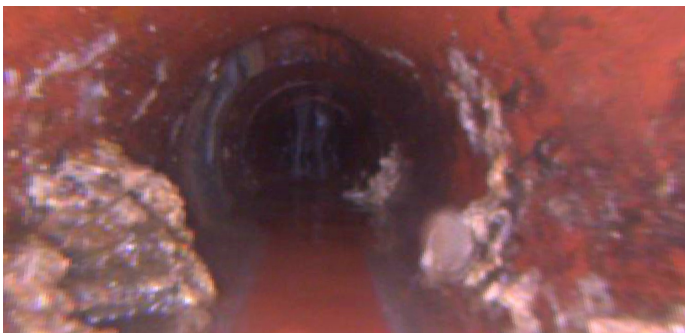
Code: **DAGS**
Description: **Deposits Attached Grease**

Distance (ft): **201.6**
Structural Grade: **0**
O&M Grade: **2**
Clock Start/From: **7**
Clock To: **5**
1st Value:
2nd Value:
Value Percent: **5.000**
Continuous Index: **S03**
Within 8" of Joint: **NO**
Remarks:

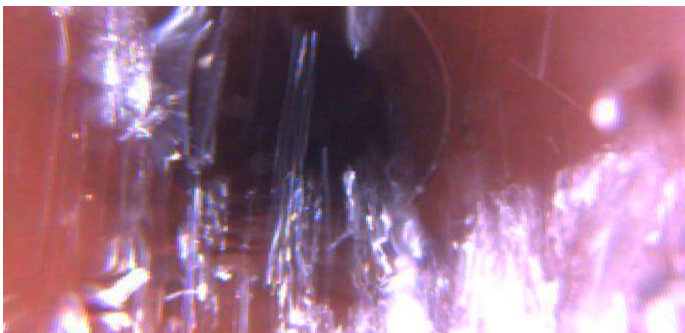
Code: **DAGS**
Description: **Deposits Attached Grease**

Distance (ft): **204.6**
Structural Grade: **0**
O&M Grade: **2**
Clock Start/From: **7**
Clock To: **5**
1st Value:
2nd Value:
Value Percent: **5.000**
Continuous Index: **F03**
Within 8" of Joint: **NO**
Remarks:

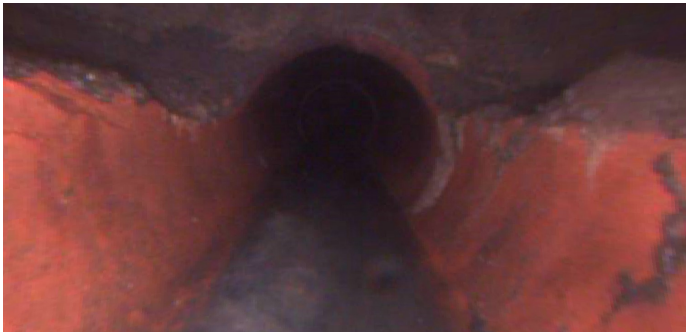
Code: **AMH**
Description: **Manhole**

Distance (ft): **247.3**
Structural Grade: **0**
O&M Grade: **0**
Clock Start/From:
Clock To:
1st Value:
2nd Value:
Value Percent:
Continuous Index:
Within 8" of Joint: **NO**
Remarks: **M-203-037**
