## Profile/Photo Observation Report

Street:	<b>E 38th Ave</b>	Flow Control:	<b>Not Controlled</b>
City:	<b>Hobart, IN</b>	Year Renewed:	
Location:	<b>Other</b>	Tape/Media #:	
Purpose:	<b>Not Known</b>	Dia/Height:	<b>10"</b>
Use:	<b>Sanitary</b>	Material:	<b>VCP</b>
Drain Area:	<b>NA</b>	Lining:	
Category:	<b>NA</b>		
Comment:	<b>pump</b>

Location Details:		Direction of Survey:	<b>Downstream</b>
US MH:	<b>M-203-034</b>	DS MH:	<b>M-203-037</b>
		Total Length Surveyed (ft):	<b>247.3</b>

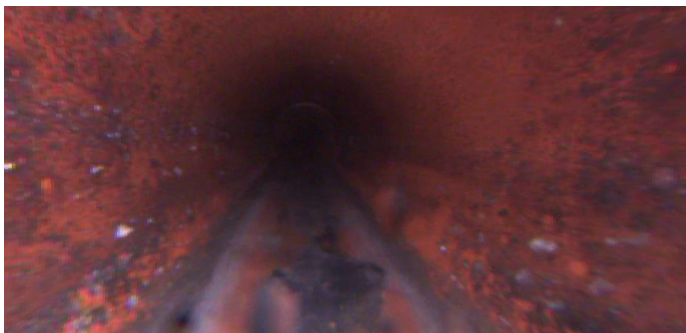
Code: **AMH**  
Description: **Manhole**

Distance (ft): **.0**  
Structural Grade: **0**  
O&M Grade: **0**  
Clock Start/From:  
Clock To:  
1st Value:  
2nd Value:  
Value Percent:  
Continuous Index:  
Within 8" of Joint: **NO**  
Remarks: **M-203-034**

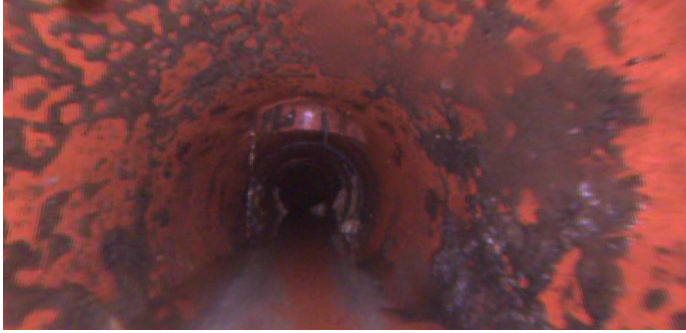
Code: **DAZ**  
Description: **Deposits Attached Other**

Distance (ft): **33.9**  
Structural Grade: **0**  
O&M Grade: **2**  
Clock Start/From: **7**  
Clock To: **5**  
1st Value:  
2nd Value:  
Value Percent: **5.000**  
Continuous Index: **S01**  
Within 8" of Joint: **NO**  
Remarks:

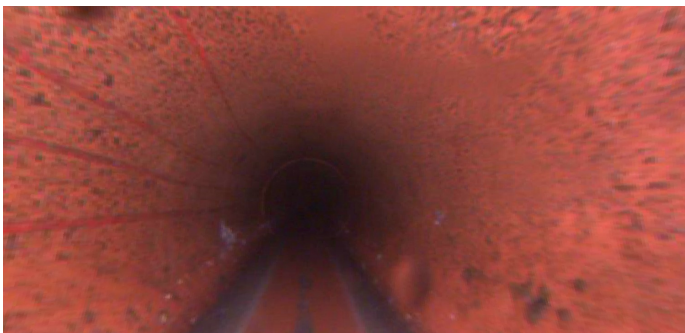
Code: **DAZ**  
Description: **Deposits Attached Other**

Distance (ft): **40.5**  
Structural Grade: **0**  
O&M Grade: **2**  
Clock Start/From: **7**  
Clock To: **5**  
1st Value:  
2nd Value:  
Value Percent: **5.000**  
Continuous Index: **F01**  
Within 8" of Joint: **NO**  
Remarks:

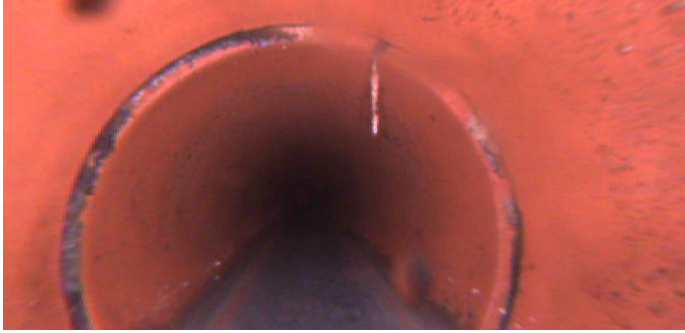
Code: **RFJ**  
Description: **Roots Fine Joint**

Distance (ft): **47.6**  
Structural Grade: **0**  
O&M Grade: **1**  
Clock Start/From: **1**  
Clock To:  
1st Value:  
2nd Value:  
Value Percent:  
Continuous Index:  
Within 8" of Joint: **YES**  
Remarks:

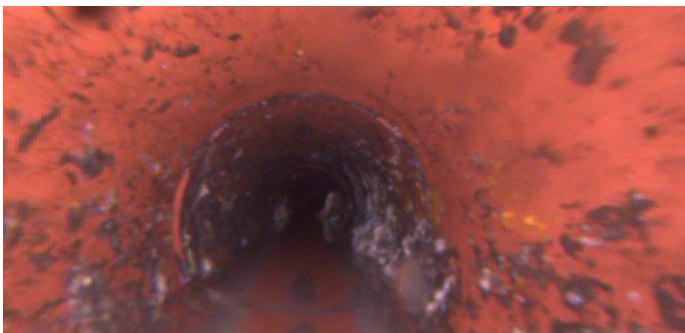
Code: **DAZ**  
Description: **Deposits Attached Other**

Distance (ft): **82.4**  
Structural Grade: **0**  
O&M Grade: **2**  
Clock Start/From: **7**  
Clock To: **5**  
1st Value:  
2nd Value:  
Value Percent: **5.000**  
Continuous Index: **S02**  
Within 8" of Joint: **NO**  
Remarks:

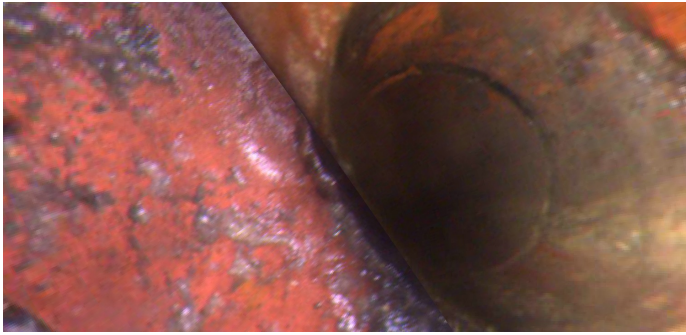
Code: **TF**  
Description: **Tap Factory**

Distance (ft): **85.0**  
Structural Grade: **0**  
O&M Grade: **0**  
Clock Start/From: **1**  
Clock To:  
1st Value: **4.000**  
2nd Value:  
Value Percent:  
Continuous Index:  
Within 8" of Joint: **YES**  
Remarks:

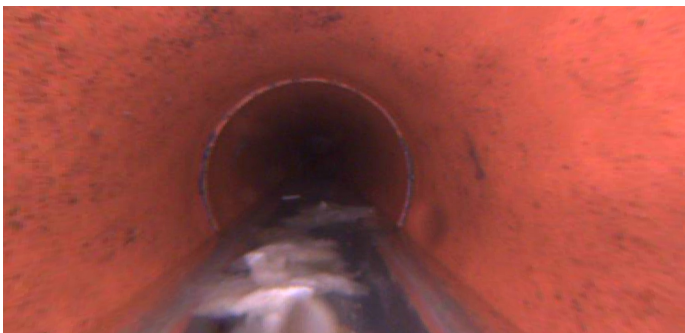
Code: **DSZ**  
Description: **Deposits Settled Other**

Distance (ft): **106.4**  
Structural Grade: **0**  
O&M Grade: **2**  
Clock Start/From: **6**  
Clock To:  
1st Value:  
2nd Value:  
Value Percent: **5.000**  
Continuous Index:  
Within 8" of Joint: **NO**  
Remarks: **tissue**

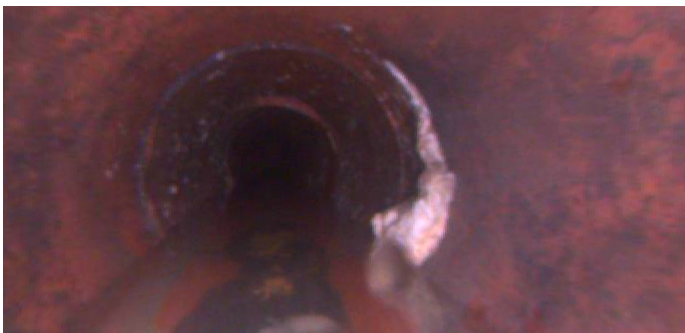
Code: **DAGS**  
Description: **Deposits Attached Grease**

Distance (ft): **163.4**  
Structural Grade: **0**  
O&M Grade: **2**  
Clock Start/From: **1**  
Clock To: **5**  
1st Value:  
2nd Value:  
Value Percent: **5.000**  
Continuous Index:  
Within 8" of Joint: **NO**  
Remarks:

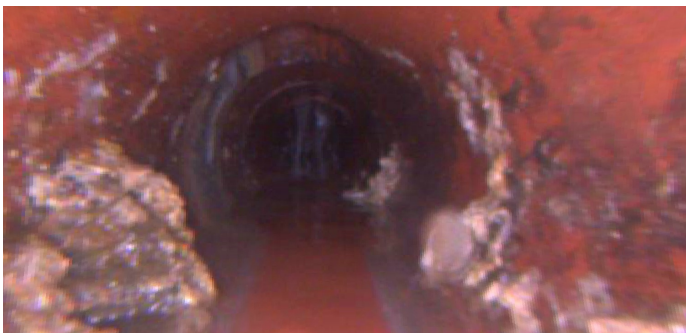
Code: **DAGS**  
Description: **Deposits Attached Grease**

Distance (ft): **201.6**  
Structural Grade: **0**  
O&M Grade: **2**  
Clock Start/From: **7**  
Clock To: **5**  
1st Value:  
2nd Value:  
Value Percent: **5.000**  
Continuous Index: **S03**  
Within 8" of Joint: **NO**  
Remarks:

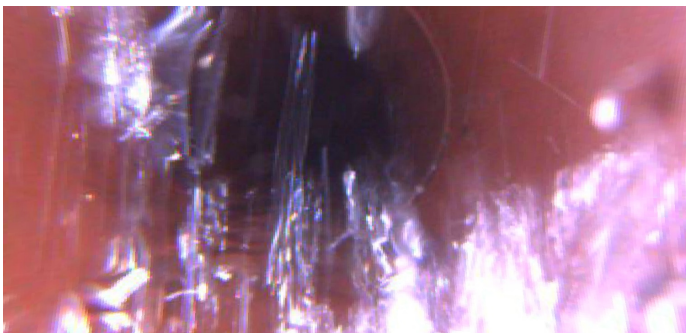
Code: **DAGS**  
Description: **Deposits Attached Grease**

Distance (ft): **204.6**  
Structural Grade: **0**  
O&M Grade: **2**  
Clock Start/From: **7**  
Clock To: **5**  
1st Value:  
2nd Value:  
Value Percent: **5.000**  
Continuous Index: **F03**  
Within 8" of Joint: **NO**  
Remarks:
