Profile/Photo Observation Report

Date:	03/25/2018	Weather:		Coding:	PACP 6.0
Pipe Length (ft):	96.1	Owner:	NA	Pre Clean:	Not Known
P.O.#:		Surveyor:	Byrd Fitzgerald	PSR:	P-203-038-039
Customer:		Clean Date:	01/01/1900	Shape:	C

Location Details:		Direction of Survey:	Downstream
US MH:	M-203-039	DS MH:	M-203-038
		Total Length Surveyed (ft):	62.7

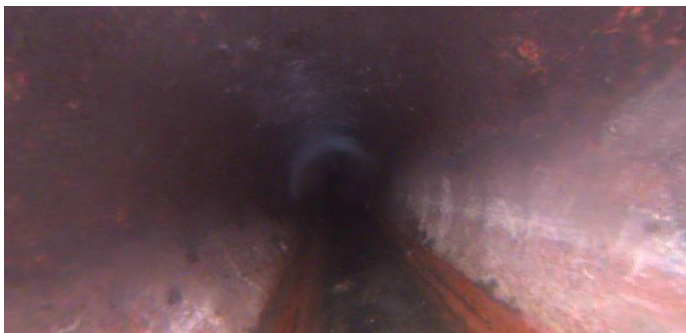
Code: **AMH**
Description: **Manhole**

Distance (ft): **.0**
Structural Grade: **0**
O&M Grade: **0**
Clock Start/From:
Clock To:
1st Value:
2nd Value:
Value Percent:
Continuous Index:
Within 8" of Joint: **NO**
Remarks: **M-203-039**

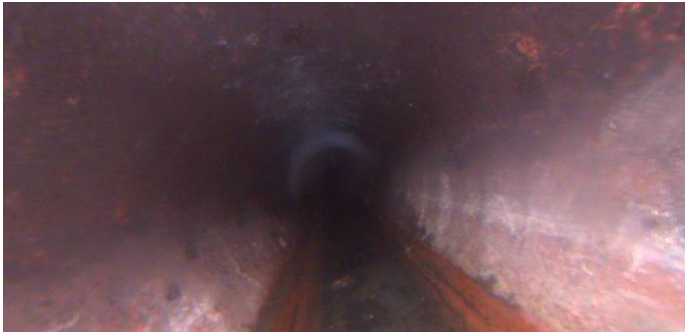
Code:	MWL
Description:	Water Level

Distance (ft):	.0
Structural Grade:	0
O&M Grade:	0
Clock Start/From:	
Clock To:	
1st Value:	
2nd Value:	
Value Percent:	5.000
Continuous Index:	
Within 8" of Joint:	NO
Remarks:

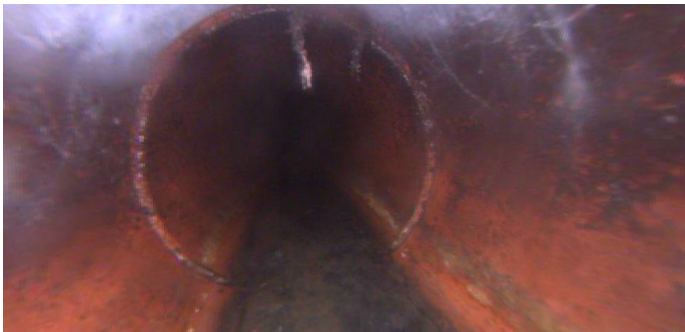
Code:	RFJ
Description:	Roots Fine Joint

Distance (ft):	3.3
Structural Grade:	0
O&M Grade:	1
Clock Start/From:	12
Clock To:	
1st Value:	
2nd Value:	
Value Percent:	
Continuous Index:	S01
Within 8" of Joint:	YES
Remarks:	wandering

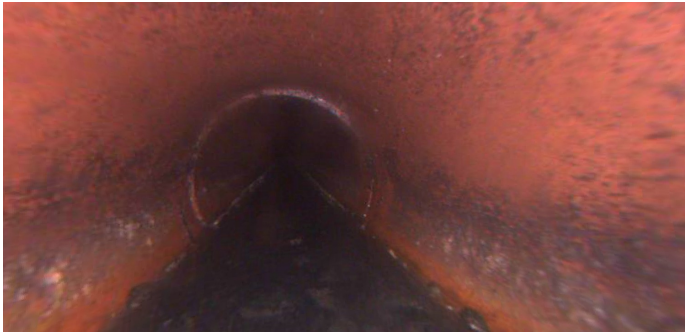
Code: **DAGS**
Description: **Deposits Attached Grease**

Distance (ft): **21.0**
Structural Grade: **0**
O&M Grade: **2**
Clock Start/From: **8**
Clock To: **4**
1st Value:
2nd Value:
Value Percent: **5.000**
Continuous Index: **S02**
Within 8" of Joint: **NO**
Remarks:

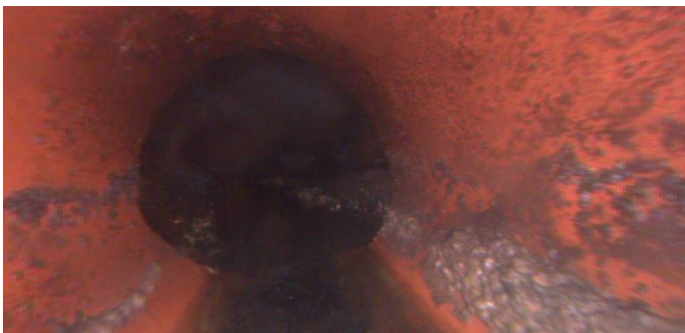
Code: **RFJ**
Description: **Roots Fine Joint**

Distance (ft): **61.3**
Structural Grade: **0**
O&M Grade: **1**
Clock Start/From: **12**
Clock To:
1st Value:
2nd Value:
Value Percent:
Continuous Index: **F01**
Within 8" of Joint: **YES**
Remarks: **wandering**

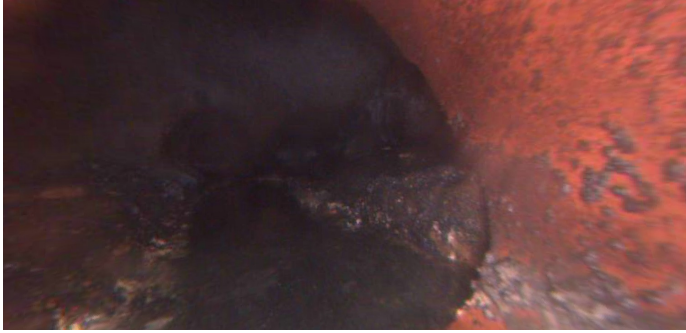
Code: **DAGS**
Description: **Deposits Attached Grease**

Distance (ft): **61.7**
Structural Grade: **0**
O&M Grade: **2**
Clock Start/From: **8**
Clock To: **4**
1st Value:
2nd Value:
Value Percent: **5.000**
Continuous Index: **F02**
Within 8" of Joint: **NO**
Remarks:

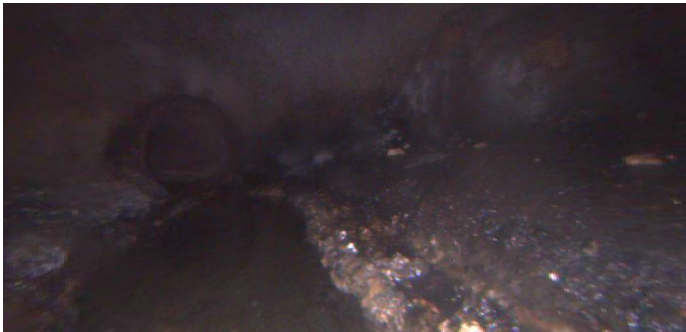
Code: **AMH**
Description: **Manhole**

Distance (ft): **62.7**
Structural Grade: **0**
O&M Grade: **0**
Clock Start/From:
Clock To:
1st Value:
2nd Value:
Value Percent:
Continuous Index:
Within 8" of Joint: **NO**
Remarks: **M-203-038**
