## Profile/Photo Observation Report

Street:	<b>E 38th Ave</b>	Flow Control:	<b>Not Controlled</b>
City:	<b>Hobart, IN</b>	Year Renewed:	
Location:	<b>Other</b>	Tape/Media #:	
Purpose:	<b>Not Known</b>	Dia/Height:	<b>8"</b>
Use:	<b>Sanitary</b>	Material:	<b>VCP</b>
Drain Area:	<b>NA</b>	Lining:	
Category:	<b>NA</b>		
Comment:

Location Details:		Direction of Survey:	<b>Downstream</b>
US MH:	<b>M-203-039</b>	DS MH:	<b>M-203-040</b>
		Total Length Surveyed (ft):	<b>103.8</b>

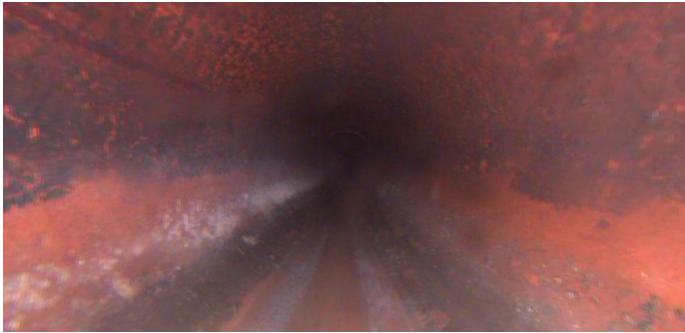
Code:	<b>MWL</b>
Description:	<b>Water Level</b>

Distance (ft):	<b>.0</b>
Structural Grade:	<b>0</b>
O&M Grade:	<b>0</b>
Clock Start/From:	
Clock To:	
1st Value:	
2nd Value:	
Value Percent:	<b>5.000</b>
Continuous Index:	
Within 8" of Joint:	<b>NO</b>
Remarks:

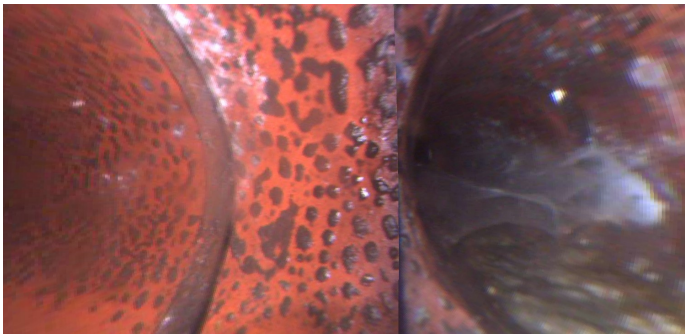
Code:	<b>TFD</b>
Description:	<b>Tap Factory Defective</b>

Distance (ft):	<b>56.0</b>
Structural Grade:	<b>0</b>
O&M Grade:	<b>2</b>
Clock Start/From:	<b>3</b>
Clock To:	
1st Value:	<b>4.000</b>
2nd Value:	
Value Percent:	
Continuous Index:	
Within 8" of Joint:	<b>YES</b>
Remarks:	<b>partially blocked</b>

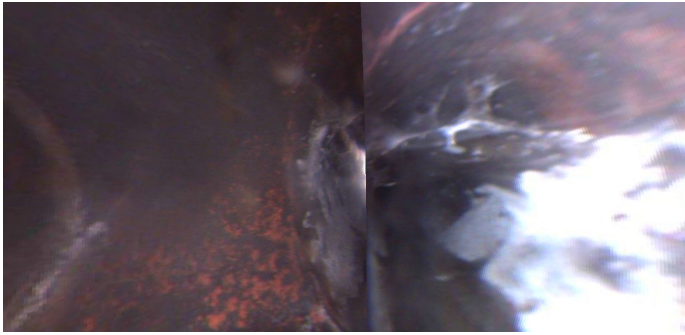
Code: **TF**  
Description: **Tap Factory**

Distance (ft): **87.7**  
Structural Grade: **0**  
O&M Grade: **0**  
Clock Start/From: **3**  
Clock To:  
1st Value: **4.000**  
2nd Value:  
Value Percent:  
Continuous Index:  
Within 8" of Joint: **YES**  
Remarks:

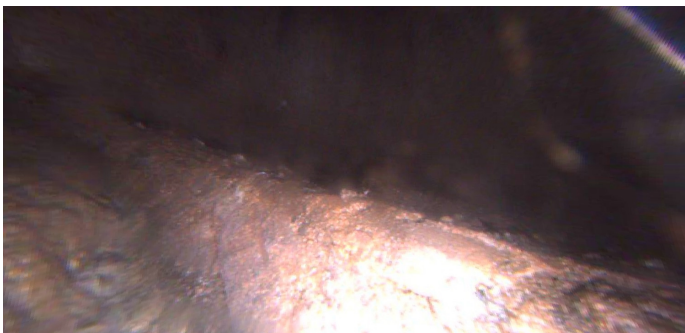
Code: **AMH**  
Description: **Manhole**

Distance (ft): **103.8**  
Structural Grade: **0**  
O&M Grade: **0**  
Clock Start/From:  
Clock To:  
1st Value:  
2nd Value:  
Value Percent:  
Continuous Index:  
Within 8" of Joint: **NO**  
Remarks: **M-203-040**
