## Profile/Photo Observation Report

Street:	<b>W 38TH AVE</b>	Flow Control:	<b>Not Controlled</b>
City:	<b>Hobart, IN</b>	Year Renewed:	
Location:	<b>Other</b>	Tape/Media #:	
Purpose:	<b>Not Known</b>	Dia/Height:	<b>10"</b>
Use:	<b>Sanitary</b>	Material:	<b>VCP</b>
Drain Area:	<b>NA</b>	Lining:	
Category:	<b>NA</b>		
Comment:	<b>Graveled over</b>

Location Details:		Direction of Survey:	<b>Downstream</b>
US MH:	<b>M-203-041</b>	DS MH:	<b>M-203-047</b>
		Total Length Surveyed (ft):	<b>226.4</b>

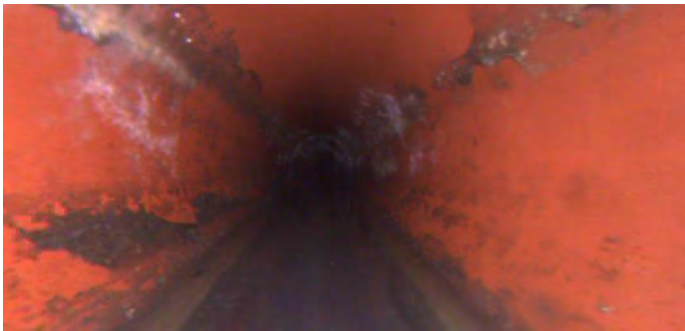
Code: **AMH**  
Description: **Manhole**

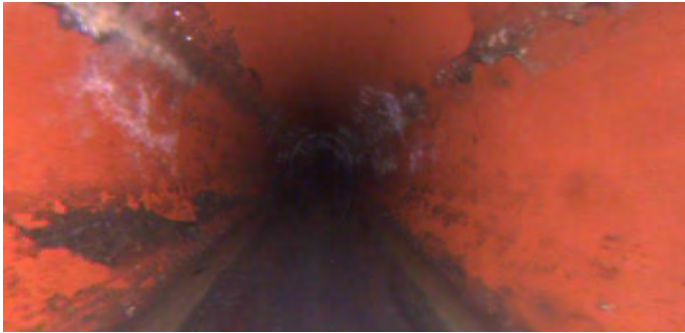
Code:	<b>MWL</b>
Description:	<b>Water Level</b>

Distance (ft):	<b>.0</b>
Structural Grade:	<b>0</b>
O&M Grade:	<b>0</b>
Clock Start/From:	
Clock To:	
1st Value:	
2nd Value:	
Value Percent:	<b>5.000</b>
Continuous Index:	
Within 8" of Joint:	<b>NO</b>
Remarks:

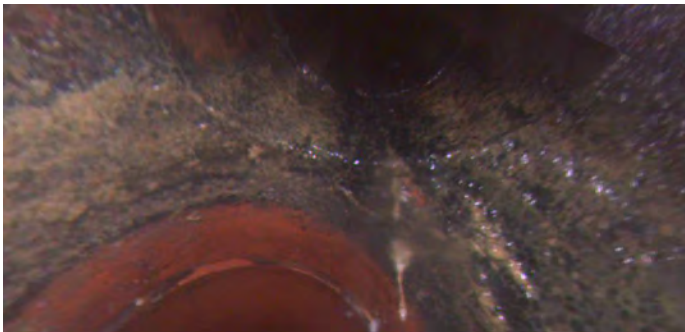
Code:	<b>TF</b>
Description:	<b>Tap Factory</b>

Distance (ft):	<b>41.4</b>
Structural Grade:	<b>0</b>
O&M Grade:	<b>0</b>
Clock Start/From:	<b>12</b>
Clock To:	
1st Value:	<b>4.000</b>
2nd Value:	
Value Percent:	
Continuous Index:	
Within 8" of Joint:	<b>YES</b>
Remarks:

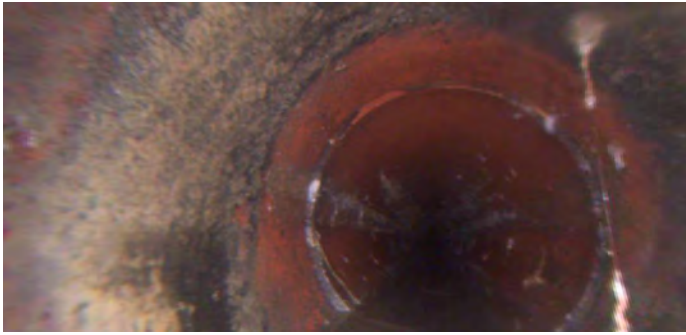
Code: **DAGS**  
Description: **Deposits Attached Grease**

Distance (ft): **41.4**  
Structural Grade: **0**  
O&M Grade: **2**  
Clock Start/From: **7**  
Clock To: **5**  
1st Value:  
2nd Value:  
Value Percent: **5.000**  
Continuous Index:  
Within 8" of Joint: **NO**  
Remarks:

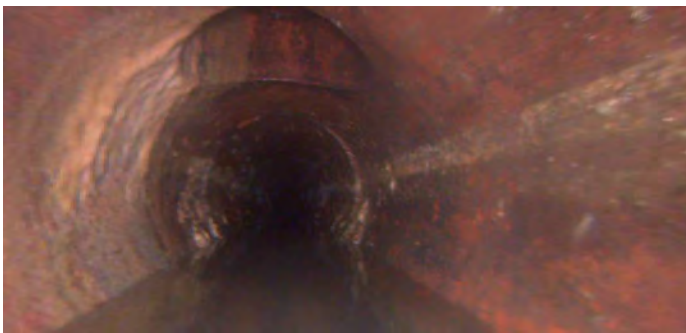
Code: **TF**  
Description: **Tap Factory**

Distance (ft): **57.6**  
Structural Grade: **0**  
O&M Grade: **0**  
Clock Start/From: **12**  
Clock To:  
1st Value: **4.000**  
2nd Value:  
Value Percent:  
Continuous Index:  
Within 8" of Joint: **YES**  
Remarks:

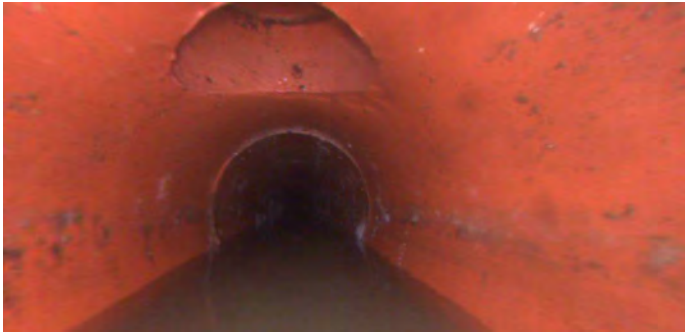
Code: **TF**  
Description: **Tap Factory**

Distance (ft): **99.9**  
Structural Grade: **0**  
O&M Grade: **0**  
Clock Start/From: **12**  
Clock To:  
1st Value: **4.000**  
2nd Value:  
Value Percent:  
Continuous Index:  
Within 8" of Joint: **YES**  
Remarks:

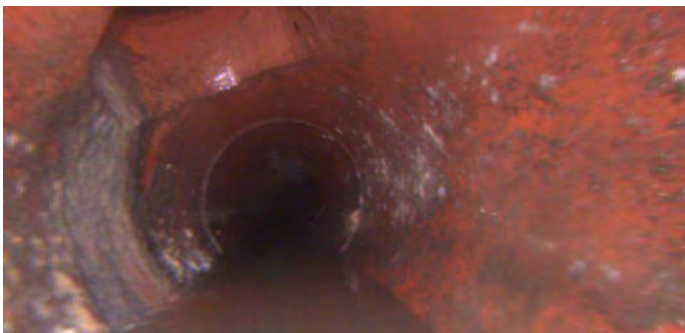
Code: **TF**  
Description: **Tap Factory**

Distance (ft): **112.2**  
Structural Grade: **0**  
O&M Grade: **0**  
Clock Start/From: **11**  
Clock To:  
1st Value: **4.000**  
2nd Value:  
Value Percent:  
Continuous Index:  
Within 8" of Joint: **YES**  
Remarks:

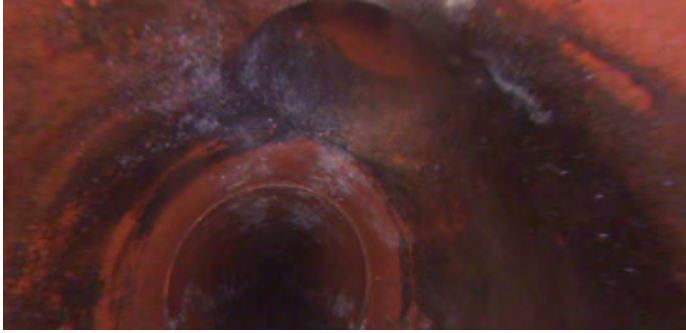
Code: **TF**  
Description: **Tap Factory**

Distance (ft): **134.7**  
Structural Grade: **0**  
O&M Grade: **0**  
Clock Start/From: **1**  
Clock To:  
1st Value: **4.000**  
2nd Value:  
Value Percent:  
Continuous Index:  
Within 8" of Joint: **YES**  
Remarks:

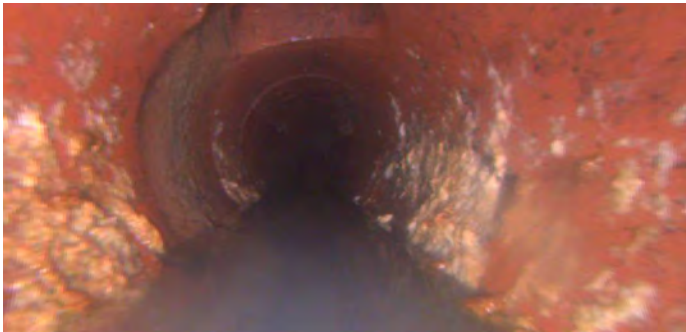
Code: **DAGS**  
Description: **Deposits Attached Grease**

Distance (ft): **172.0**  
Structural Grade: **0**  
O&M Grade: **2**  
Clock Start/From: **7**  
Clock To: **5**  
1st Value:  
2nd Value:  
Value Percent: **5.000**  
Continuous Index:  
Within 8" of Joint: **NO**  
Remarks:

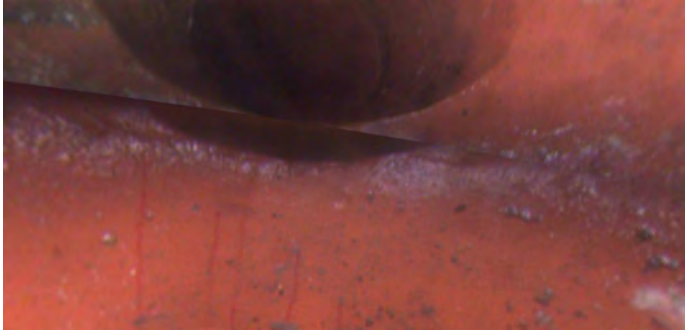
Code: **TF**  
Description: **Tap Factory**

Distance (ft): **173.0**  
Structural Grade: **0**  
O&M Grade: **0**  
Clock Start/From: **12**  
Clock To:  
1st Value: **4.000**  
2nd Value:  
Value Percent:  
Continuous Index:  
Within 8" of Joint: **YES**  
Remarks:

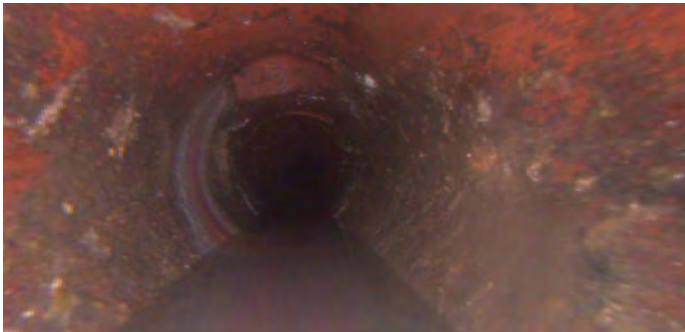
Code: **DAGS**  
Description: **Deposits Attached Grease**

Distance (ft): **209.3**  
Structural Grade: **0**  
O&M Grade: **2**  
Clock Start/From: **7**  
Clock To: **5**  
1st Value:  
2nd Value:  
Value Percent: **5.000**  
Continuous Index:  
Within 8" of Joint: **NO**  
Remarks:

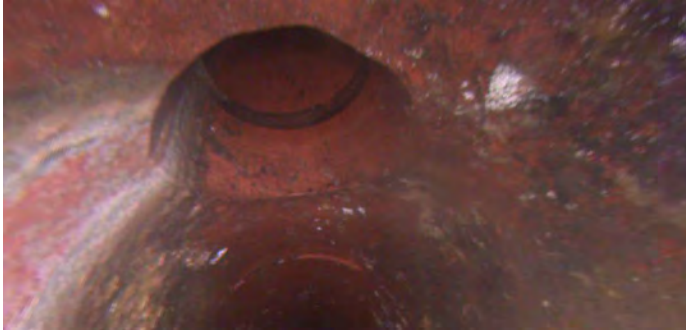
Code: **TF**  
Description: **Tap Factory**

Distance (ft): **210.0**  
Structural Grade: **0**  
O&M Grade: **0**  
Clock Start/From: **12**  
Clock To:  
1st Value: **4.000**  
2nd Value:  
Value Percent:  
Continuous Index:  
Within 8" of Joint:  
Remarks:

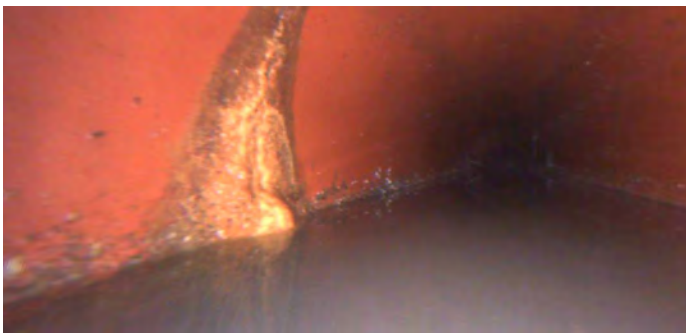
Code: **DAE**  
Description: **Deposits Attached Encrustation**

Distance (ft): **220.9**  
Structural Grade: **0**  
O&M Grade: **2**  
Clock Start/From: **8**  
Clock To: **10**  
1st Value:  
2nd Value:  
Value Percent: **5.000**  
Continuous Index:  
Within 8" of Joint: **YES**  
Remarks:

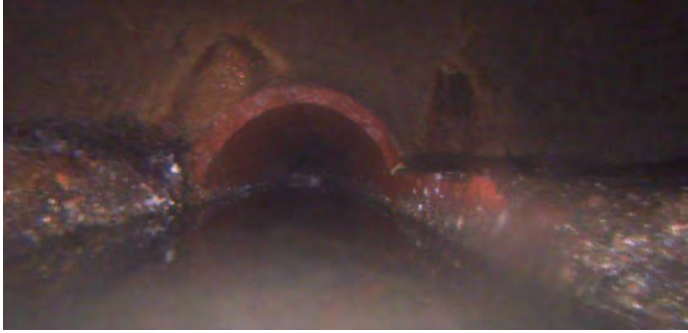
Code:	<b>AMH</b>
Description:	<b>Manhole</b>
Distance (ft):	<b>226.4</b>
Structural Grade:	<b>0</b>
O&M Grade:	<b>0</b>
Clock Start/From:	
Clock To:	
1st Value:	
2nd Value:	
Value Percent:	
Continuous Index:	
Within 8" of Joint:	<b>NO</b>
Remarks:	<b>M-203-047</b>
