Profile/Photo Observation Report

Street:	E 38th Ave	Flow Control:	Not Controlled
City:	Hobart, IN	Year Renewed:	
Location:	Other	Tape/Media #:	
Purpose:	Not Known	Dia/Height:	10"
Use:	Sanitary	Material:	VCP
Drain Area:	NA	Lining:	
Category:	NA		
Comment:	Graveled over

Location Details:		Direction of Survey:	Downstream
US MH:	M-203-041	DS MH:	M-203-047
		Total Length Surveyed (ft):	226.4

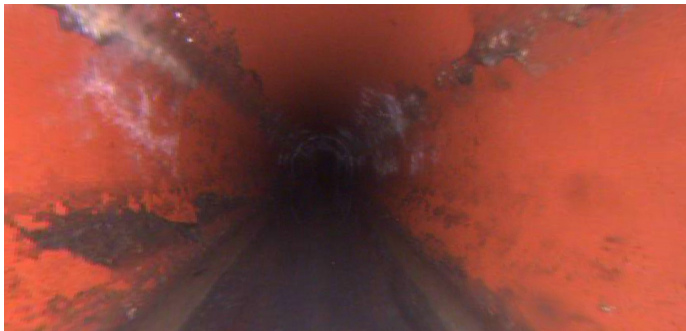
Code: **AMH**
Description: **Manhole**

Distance (ft): **.0**
Structural Grade: **0**
O&M Grade: **0**
Clock Start/From:
Clock To:
1st Value:
2nd Value:
Value Percent:
Continuous Index:
Within 8" of Joint: **NO**
Remarks: **M-203-041**

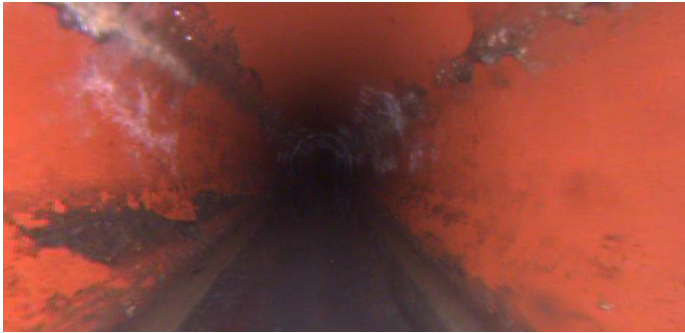
Code:	MWL
Description:	Water Level

Distance (ft):	.0
Structural Grade:	0
O&M Grade:	0
Clock Start/From:	
Clock To:	
1st Value:	
2nd Value:	
Value Percent:	5.000
Continuous Index:	
Within 8" of Joint:	NO
Remarks:

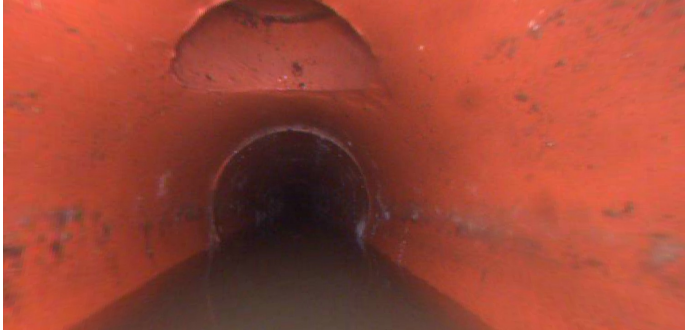
Code: **TF**
Description: **Tap Factory**

Distance (ft): **99.9**
Structural Grade: **0**
O&M Grade: **0**
Clock Start/From: **12**
Clock To:
1st Value: **4.000**
2nd Value:
Value Percent:
Continuous Index:
Within 8" of Joint: **YES**
Remarks:

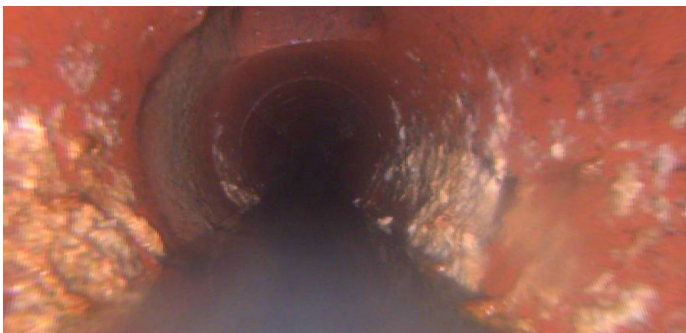
Code: **DAGS**
Description: **Deposits Attached Grease**

Distance (ft): **172.0**
Structural Grade: **0**
O&M Grade: **2**
Clock Start/From: **7**
Clock To: **5**
1st Value:
2nd Value:
Value Percent: **5.000**
Continuous Index:
Within 8" of Joint: **NO**
Remarks:

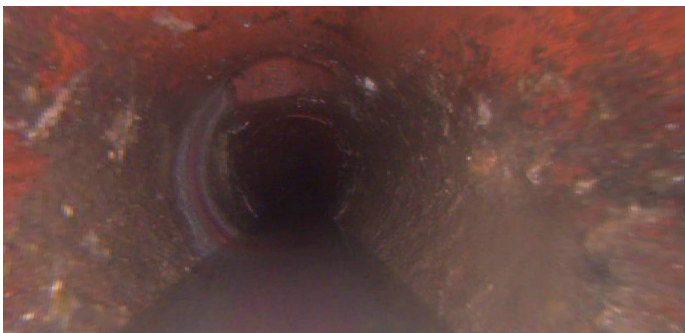
Code: **DAGS**
Description: **Deposits Attached Grease**

Distance (ft): **209.3**
Structural Grade: **0**
O&M Grade: **2**
Clock Start/From: **7**
Clock To: **5**
1st Value:
2nd Value:
Value Percent: **5.000**
Continuous Index:
Within 8" of Joint: **NO**
Remarks:

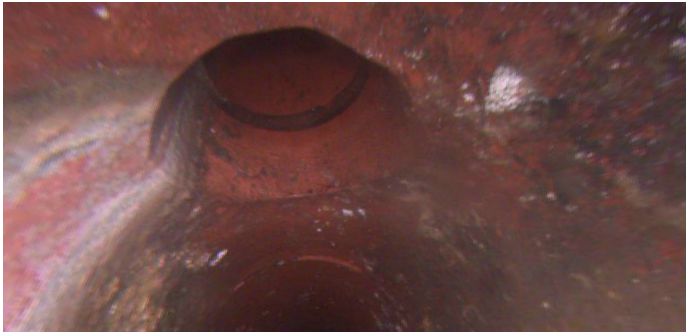
Code: **TF**
Description: **Tap Factory**

Distance (ft): **210.0**
Structural Grade: **0**
O&M Grade: **0**
Clock Start/From: **12**
Clock To:
1st Value: **4.000**
2nd Value:
Value Percent:
Continuous Index:
Within 8" of Joint:
Remarks:

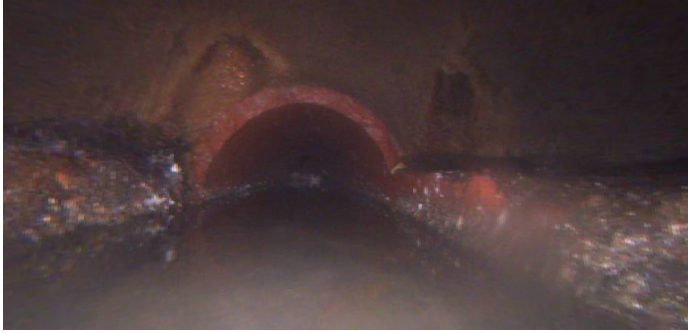
Code:	AMH
Description:	Manhole
Distance (ft):	226.4
Structural Grade:	0
O&M Grade:	0
Clock Start/From:	
Clock To:	
1st Value:	
2nd Value:	
Value Percent:	
Continuous Index:	
Within 8" of Joint:	NO
Remarks:	M-203-047
