## Profile/Photo Observation Report

Street:	<b>OFF E 37TH AVE</b>	Flow Control:	<b>Not Controlled</b>
City:	<b>Hobart, IN</b>	Year Renewed:	
Location:	<b>Other</b>	Tape/Media #:	
Purpose:	<b>Not Known</b>	Dia/Height:	<b>10"</b>
Use:	<b>Sanitary</b>	Material:	<b>PVC</b>
Drain Area:	<b>NA</b>	Lining:	
Category:	<b>NA</b>		
Comment:

Location Details:		Direction of Survey:	<b>Upstream</b>
US MH:	<b>M-802-002</b>	DS MH:	<b>M-802-003</b>
		Total Length Surveyed (ft):	<b>22.6</b>

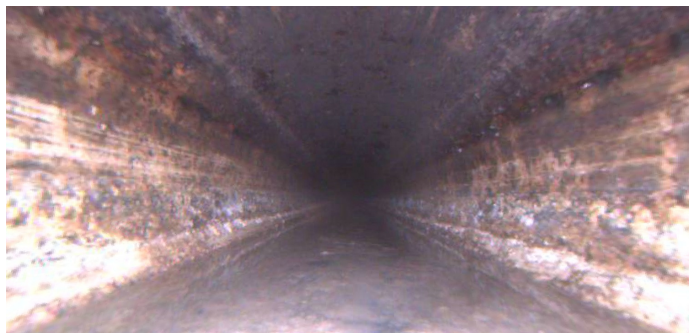
Code: **DAGS**  
Description: **Deposits Attached Grease**

Distance (ft): **.0**  
Structural Grade: **0**  
O&M Grade: **2**  
Clock Start/From: **8**  
Clock To: **4**  
1st Value:  
2nd Value:  
Value Percent: **5.000**  
Continuous Index: **S01**  
Within 8" of Joint: **NO**  
Remarks:

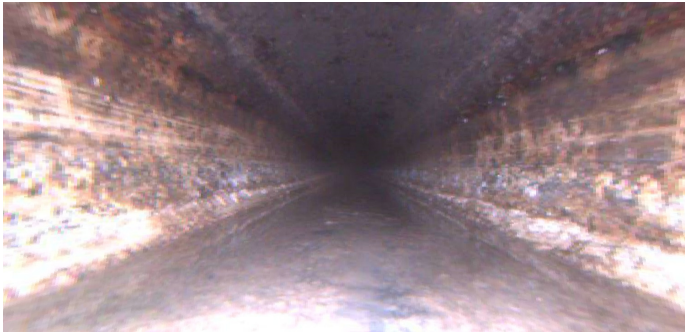
Code:	<b>AMH</b>
Description:	<b>Manhole</b>

Distance (ft):	<b>.0</b>
Structural Grade:	<b>0</b>
O&M Grade:	<b>0</b>
Clock Start/From:	
Clock To:	
1st Value:	
2nd Value:	
Value Percent:	
Continuous Index:	
Within 8" of Joint:	<b>NO</b>
Remarks:	<b>M-802-003</b>

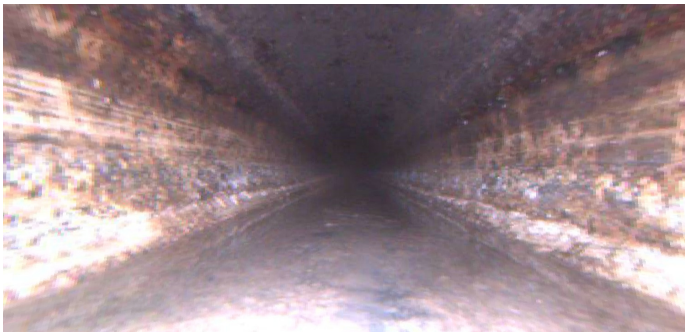
Code:	<b>MWL</b>
Description:	<b>Water Level</b>

Distance (ft):	<b>.0</b>
Structural Grade:	<b>0</b>
O&M Grade:	<b>0</b>
Clock Start/From:	
Clock To:	
1st Value:	
2nd Value:	
Value Percent:	<b>5.000</b>
Continuous Index:	
Within 8" of Joint:	<b>NO</b>
Remarks:

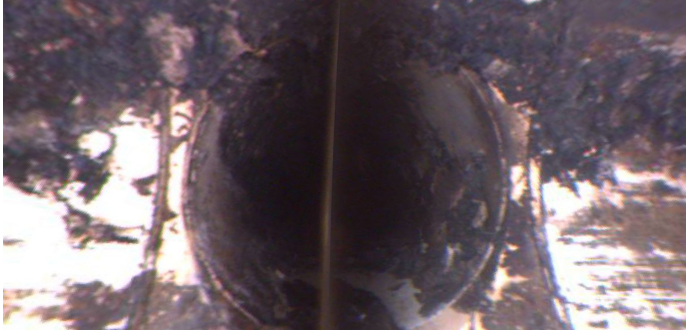
Code: **TF**  
Description: **Tap Factory**

Distance (ft): **9.5**  
Structural Grade: **0**  
O&M Grade: **0**  
Clock Start/From: **9**  
Clock To:  
1st Value: **4.000**  
2nd Value:  
Value Percent:  
Continuous Index:  
Within 8" of Joint:  
Remarks:

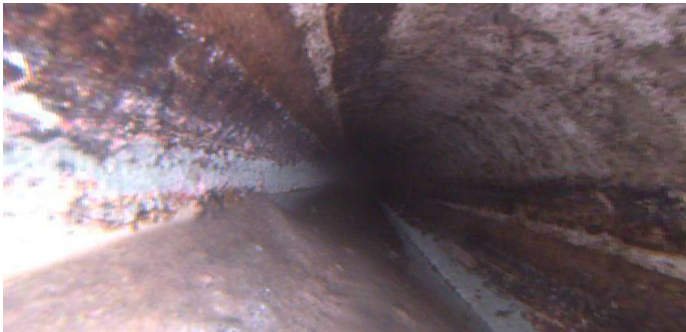
Code: **MSA**  
Description: **Abandoned Survey**

Distance (ft): **22.6**  
Structural Grade: **0**  
O&M Grade: **0**  
Clock Start/From:  
Clock To:  
1st Value:  
2nd Value:  
Value Percent:  
Continuous Index:  
Within 8" of Joint: **NO**  
Remarks: **camera stopped**

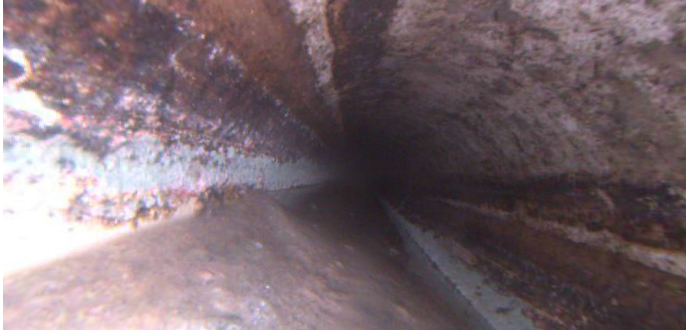
Code:	<b>DAGS</b>
Description:	<b>Deposits Attached Grease</b>
Distance (ft):	<b>22.6</b>
Structural Grade:	<b>0</b>
O&M Grade:	<b>2</b>
Clock Start/From:	<b>8</b>
Clock To:	<b>4</b>
1st Value:	
2nd Value:	
Value Percent:	<b>5.000</b>
Continuous Index:	<b>F01</b>
Within 8" of Joint:	<b>NO</b>
Remarks:
