Profile/Photo Observation Report

Date:	03/25/2018	Weather:		Coding:	PACP 6.0
Pipe Length (ft):	188.8	Owner:	NA	Pre Clean:	Not Known
P.O.#:		Surveyor:	Byrd Fitzgerald	PSR:	P-203-044-045
Customer:		Clean Date:	01/01/1900	Shape:	C

Street:	ALLEY BETWEEN MAITLAND ST & EV	Flow Control:	Not Controlled
City:	Hobart, IN	Year Renewed:	
Location:	Other	Tape/Media #:	
Purpose:	Not Known	Dia/Height:	8"
Use:	Sanitary	Material:	VCP
Drain Area:	NA	Lining:	
Category:	NA		
Comment:

Location Details:		Direction of Survey:	Downstream
US MH:	M-203-045	DS MH:	M-203-044
		Total Length Surveyed (ft):	25.2

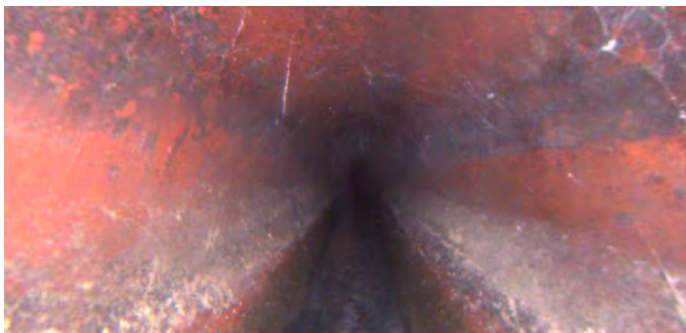
Code: **DAZ**
Description: **Deposits Attached Other**

Distance (ft): **.0**
Structural Grade: **0**
O&M Grade: **2**
Clock Start/From: **7**
Clock To: **5**
1st Value:
2nd Value:
Value Percent: **5.000**
Continuous Index: **S01**
Within 8" of Joint: **NO**
Remarks:

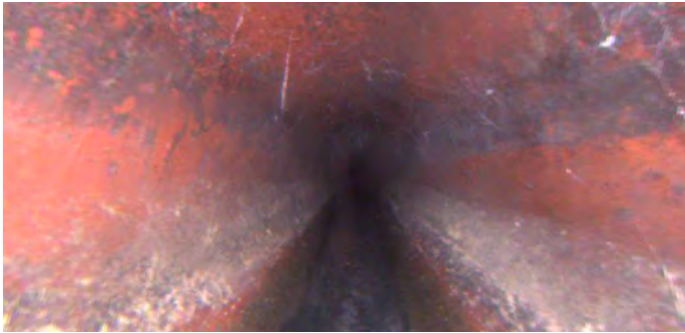
Code:	AMH
Description:	Manhole

Distance (ft):	.0
Structural Grade:	0
O&M Grade:	0
Clock Start/From:	
Clock To:	
1st Value:	
2nd Value:	
Value Percent:	
Continuous Index:	
Within 8" of Joint:	NO
Remarks:	M-203-045

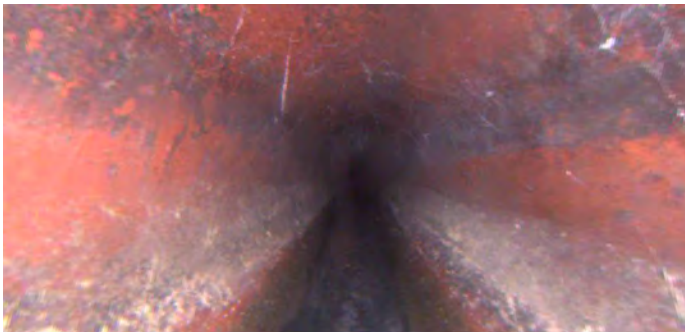
Code:	MWL
Description:	Water Level

Distance (ft):	.0
Structural Grade:	0
O&M Grade:	0
Clock Start/From:	
Clock To:	
1st Value:	
2nd Value:	
Value Percent:	5.000
Continuous Index:	
Within 8" of Joint:	NO
Remarks:

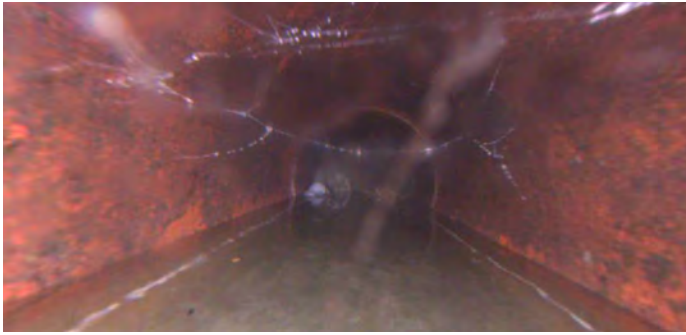
Code: **DAZ**
Description: **Deposits Attached Other**

Distance (ft): **23.1**
Structural Grade: **0**
O&M Grade: **2**
Clock Start/From: **7**
Clock To: **5**
1st Value:
2nd Value:
Value Percent: **5.000**
Continuous Index: **F01**
Within 8" of Joint: **NO**
Remarks:

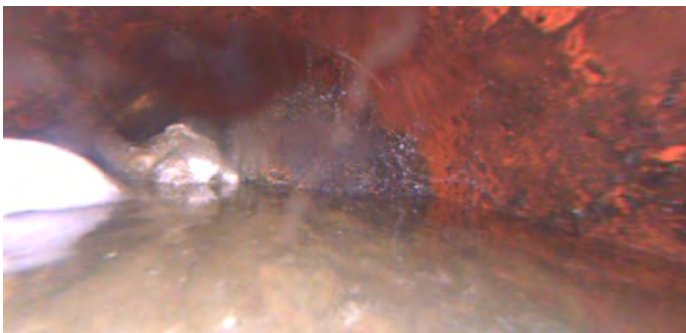
Code: **RBB**
Description: **Roots Ball Barrel**

Distance (ft): **24.4**
Structural Grade: **0**
O&M Grade: **5**
Clock Start/From: **1**
Clock To: **6**
1st Value:
2nd Value:
Value Percent: **55.000**
Continuous Index:
Within 8" of Joint: **NO**
Remarks:

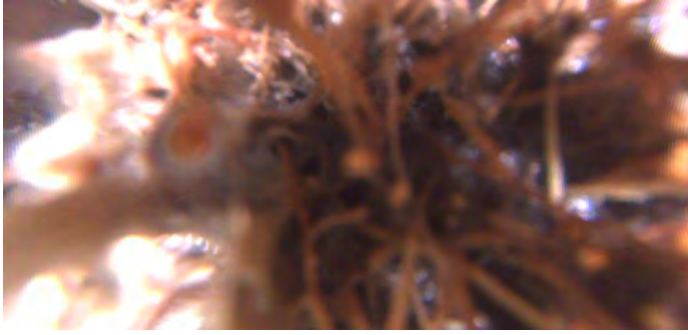
Code:	MSA
Description:	Abandoned Survey
Distance (ft):	25.2
Structural Grade:	0
O&M Grade:	0
Clock Start/From:	
Clock To:	
1st Value:	
2nd Value:	
Value Percent:	
Continuous Index:	
Within 8" of Joint:	NO
Remarks:	rbb
