Profile/Photo Observation Report

Street:	EVERGREEN ST	Flow Control:	Not Controlled
City:	Hobart, IN	Year Renewed:	
Location:	Other	Tape/Media #:	
Purpose:	Not Known	Dia/Height:	10"
Use:	Sanitary	Material:	VCP
Drain Area:	NA	Lining:	
Category:	NA		
Comment:

Location Details:		Direction of Survey:	Downstream
US MH:	M-203-045	DS MH:	M-203-046
		Total Length Surveyed (ft):	6.6

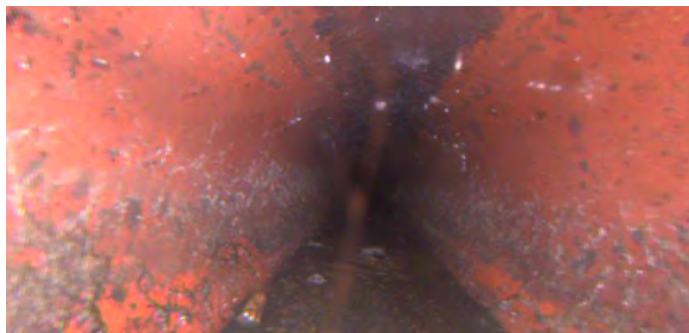
Code: **AMH**
Description: **Manhole**

Distance (ft): **.0**
Structural Grade: **0**
O&M Grade: **0**
Clock Start/From:
Clock To:
1st Value:
2nd Value:
Value Percent:
Continuous Index:
Within 8" of Joint: **NO**
Remarks: **M-203-045**

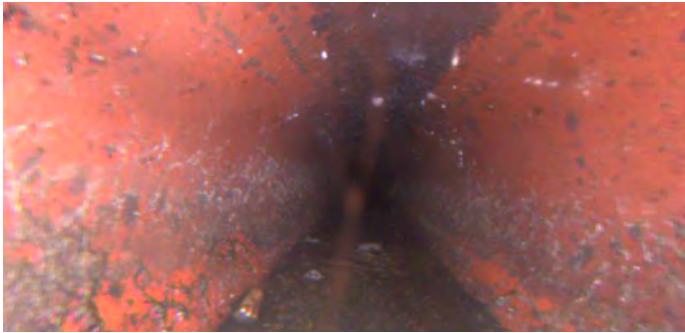
Code:	MWL
Description:	Water Level

Distance (ft):	.0
Structural Grade:	0
O&M Grade:	0
Clock Start/From:	
Clock To:	
1st Value:	
2nd Value:	
Value Percent:	5.000
Continuous Index:	
Within 8" of Joint:	NO
Remarks:

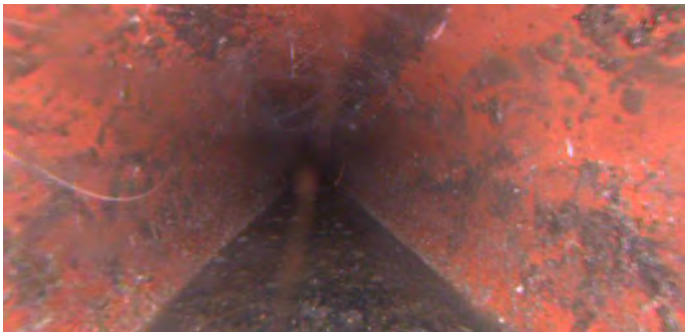
Code:	MSA
Description:	Abandoned Survey

Distance (ft):	6.6
Structural Grade:	0
O&M Grade:	0
Clock Start/From:	
Clock To:	
1st Value:	
2nd Value:	
Value Percent:	
Continuous Index:	
Within 8" of Joint:	NO
Remarks:	camera stopped/no blockage
