Profile/Photo Observation Report

Street:	EVERGREEN ST	Flow Control:	Not Controlled
City:	Hobart, IN	Year Renewed:	
Location:	Other	Tape/Media #:	
Purpose:	Not Known	Dia/Height:	8"
Use:	Sanitary	Material:	VCP
Drain Area:	NA	Lining:	
Category:	NA		
Comment:

Location Details:		Direction of Survey:	Downstream
US MH:	M-203-045	DS MH:	M-203-046
		Total Length Surveyed (ft):	6.6

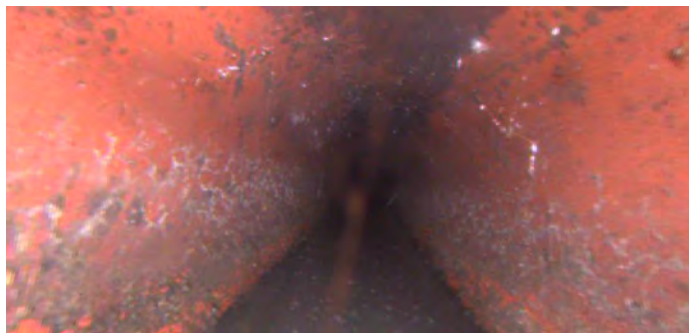
Code: **AMH**
Description: **Manhole**

Distance (ft): **.0**
Structural Grade: **0**
O&M Grade: **0**
Clock Start/From:
Clock To:
1st Value:
2nd Value:
Value Percent:
Continuous Index:
Within 8" of Joint: **NO**
Remarks: **M-203-045**

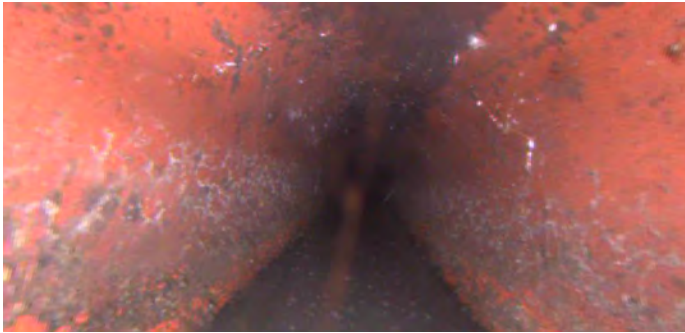
Code:	MWL
Description:	Water Level

Distance (ft):	.0
Structural Grade:	0
O&M Grade:	0
Clock Start/From:	
Clock To:	
1st Value:	
2nd Value:	
Value Percent:	5.000
Continuous Index:	
Within 8" of Joint:	NO
Remarks:
