Profile/Photo Observation Report

Street:	W 38TH AVE	Flow Control:	Not Controlled
City:	Hobart, IN	Year Renewed:	
Location:	Other	Tape/Media #:	
Purpose:	Not Known	Dia/Height:	12"
Use:	Sanitary	Material:	VCP
Drain Area:	NA	Lining:	
Category:	NA		
Comment:

Location Details:		Direction of Survey:	Downstream
US MH:	M-203-051	DS MH:	M-203-041
		Total Length Surveyed (ft):	4.2

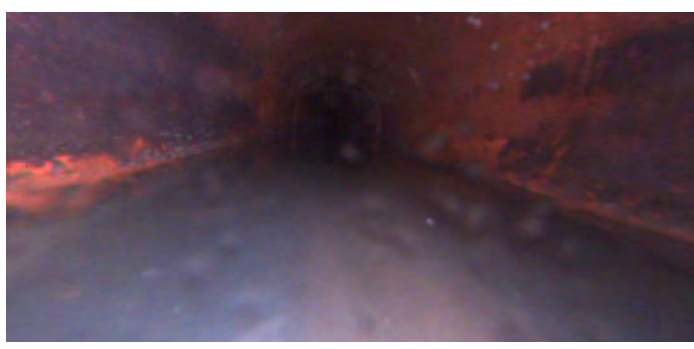
Code: **AMH**
Description: **Manhole**

Distance (ft): **.0**
Structural Grade: **0**
O&M Grade: **0**
Clock Start/From:
Clock To:
1st Value:
2nd Value:
Value Percent:
Continuous Index:
Within 8" of Joint: **NO**
Remarks: **M-203-051**

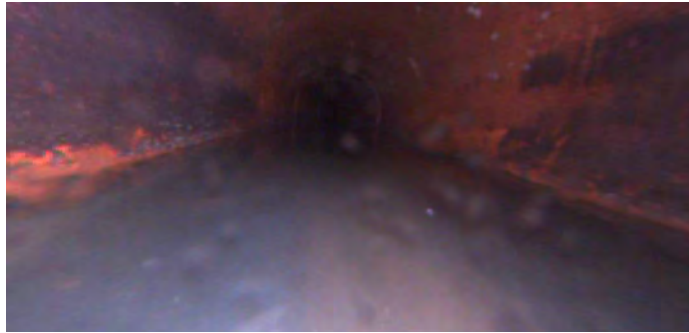
Code: **MWL**
Description: **Water Level**

Distance (ft): **.0**
Structural Grade: **0**
O&M Grade: **0**
Clock Start/From:
Clock To:
1st Value:
2nd Value:
Value Percent: **10.000**
Continuous Index:
Within 8" of Joint: **NO**
Remarks:
