Profile/Photo Observation Report

Date:	03/24/2018	Weather:		Coding:	PACP 6.0
Pipe Length (ft):	339.2	Owner:	NA	Pre Clean:	Not Known
P.O.#:		Surveyor:	Byrd Fitzgerald	PSR:	P-203-041-051
Customer:		Clean Date:	01/01/1900	Shape:	C

Street:	E 38th Ave	Flow Control:	Not Controlled
City:	Hobart, IN	Year Renewed:	
Location:	Other	Tape/Media #:	
Purpose:	Not Known	Dia/Height:	12"
Use:	Sanitary	Material:	VCP
Drain Area:	NA	Lining:	
Category:	NA		
Comment:	pump

Location Details:		Direction of Survey:	Upstream
US MH:	M-203-051	DS MH:	M-203-041
		Total Length Surveyed (ft):	49.6

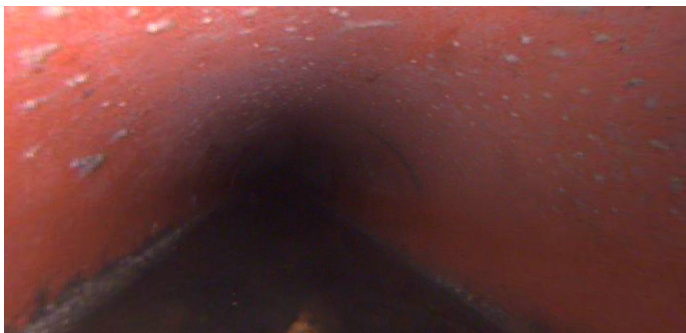
Code: **AMH**
Description: **Manhole**

Distance (ft): **.0**
Structural Grade: **0**
O&M Grade: **0**
Clock Start/From:
Clock To:
1st Value:
2nd Value:
Value Percent:
Continuous Index:
Within 8" of Joint: **NO**
Remarks: **M-203-041**

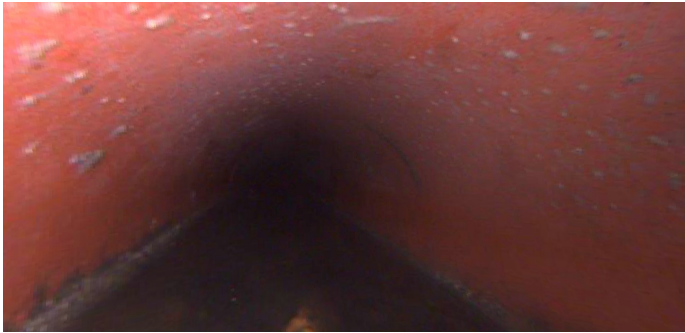
Code:	MWL
Description:	Water Level

Distance (ft):	.0
Structural Grade:	0
O&M Grade:	0
Clock Start/From:	
Clock To:	
1st Value:	
2nd Value:	
Value Percent:	10.000
Continuous Index:	
Within 8" of Joint:	NO
Remarks:

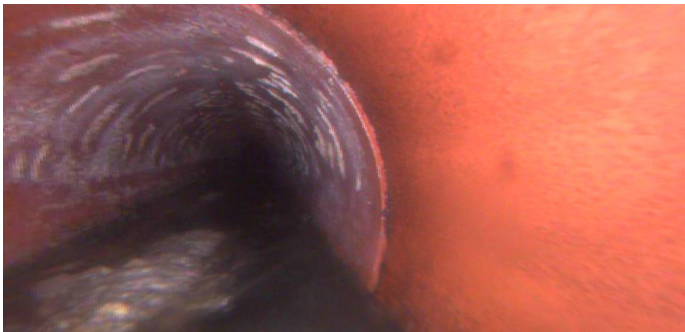
Code:	DSZ
Description:	Deposits Settled Other

Distance (ft):	23.6
Structural Grade:	0
O&M Grade:	2
Clock Start/From:	6
Clock To:	
1st Value:	
2nd Value:	
Value Percent:	5.000
Continuous Index:	S01
Within 8" of Joint:	NO
Remarks:	tissue

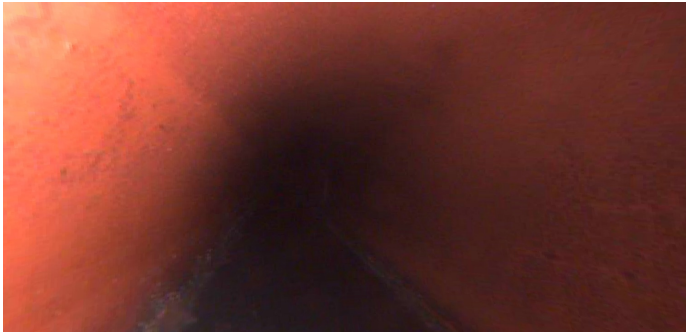
Code: **MSA**
Description: **Abandoned Survey**

Distance (ft): **49.6**
Structural Grade: **0**
O&M Grade: **0**
Clock Start/From:
Clock To:
1st Value:
2nd Value:
Value Percent:
Continuous Index:
Within 8" of Joint: **NO**
Remarks: **debris under water**

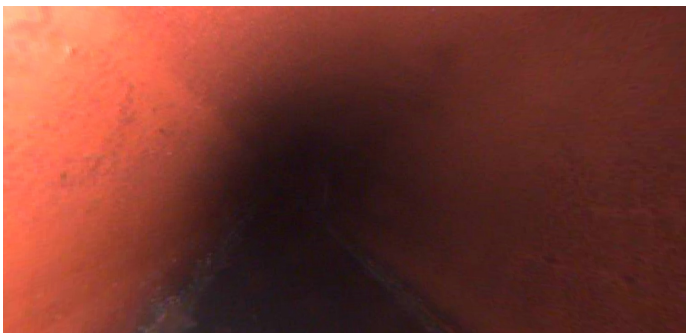
Code: **DSZ**
Description: **Deposits Settled Other**

Distance (ft): **49.6**
Structural Grade: **0**
O&M Grade: **2**
Clock Start/From: **6**
Clock To:
1st Value:
2nd Value:
Value Percent: **5.000**
Continuous Index: **F01**
Within 8" of Joint: **NO**
Remarks: **tissue**
