Profile/Photo Observation Report

Street:	Evergreen ST	Flow Control:	Not Controlled
City:	Hobart, IN	Year Renewed:	
Location:	Other	Tape/Media #:	
Purpose:	Not Known	Dia/Height:	10"
Use:	Sanitary	Material:	VCP
Drain Area:	NA	Lining:	
Category:	NA		
Comment:	cnl

Location Details:		Direction of Survey:	Upstream
US MH:	M-203-051	DS MH:	M-203-052
		Total Length Surveyed (ft):	10.4

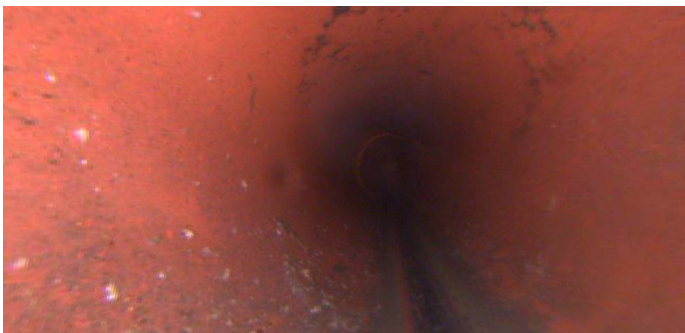
Code: **AMH**
Description: **Manhole**

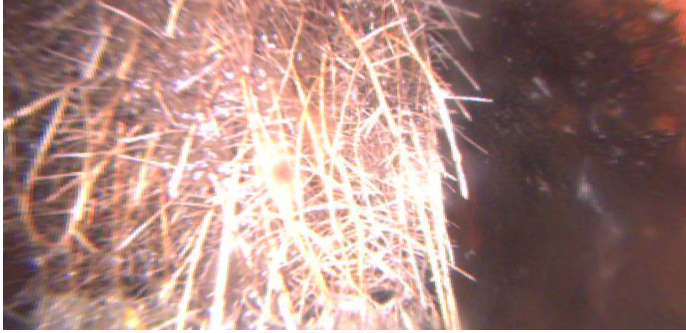
Code: **RBB**
Description: **Roots Ball Barrel**

Distance (ft): **9.1**
Structural Grade: **0**
O&M Grade: **5**
Clock Start/From: **7**
Clock To: **12**
1st Value:
2nd Value:
Value Percent: **55.000**
Continuous Index:
Within 8" of Joint: **NO**
Remarks:
