## Profile/Photo Observation Report

Street:	<b>W 38TH AVE</b>	Flow Control:	<b>Not Controlled</b>
City:	<b>Hobart, IN</b>	Year Renewed:	
Location:	<b>Other</b>	Tape/Media #:	
Purpose:	<b>Not Known</b>	Dia/Height:	<b>12"</b>
Use:	<b>Sanitary</b>	Material:	<b>VCP</b>
Drain Area:	<b>NA</b>	Lining:	
Category:	<b>NA</b>		
Comment:

Location Details:		Direction of Survey:	<b>Downstream</b>
US MH:	<b>M-203-051</b>	DS MH:	<b>M-203-056</b>
		Total Length Surveyed (ft):	<b>268.4</b>

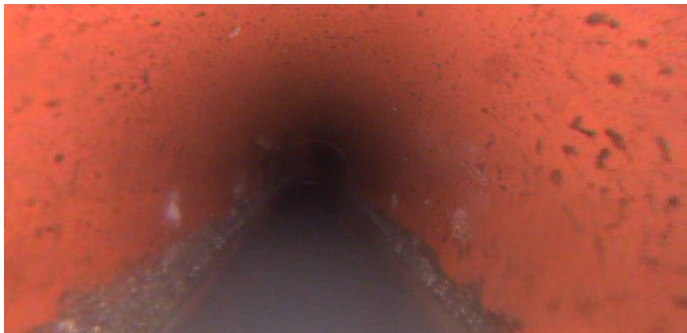
Code: **AMH**  
 Description: **Manhole**  
 Distance (ft): **.0**  
 Structural Grade: **0**  
 O&M Grade: **0**  
 Clock Start/From:  
 Clock To:  
 1st Value:  
 2nd Value:  
 Value Percent:  
 Continuous Index:  
 Within 8" of Joint: **NO**  
 Remarks: **M-203-051**

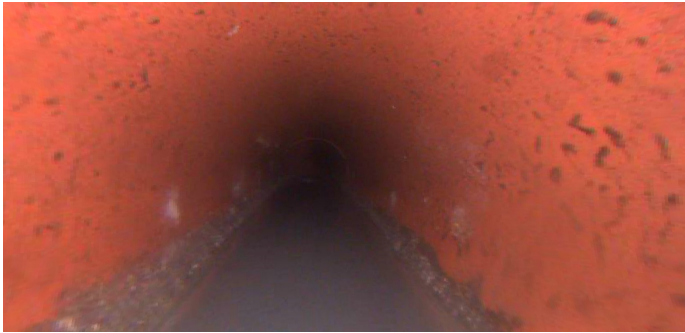
Code:	<b>MWL</b>
Description:	<b>Water Level</b>

Distance (ft):	<b>.0</b>
Structural Grade:	<b>0</b>
O&M Grade:	<b>0</b>
Clock Start/From:	
Clock To:	
1st Value:	
2nd Value:	
Value Percent:	<b>5.000</b>
Continuous Index:	
Within 8" of Joint:	<b>NO</b>
Remarks:

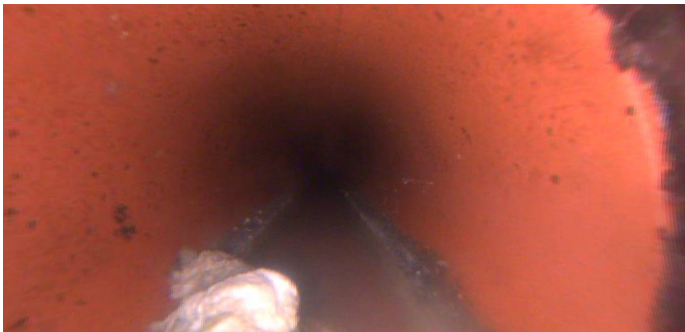
Code:	<b>DSZ</b>
Description:	<b>Deposits Settled Other</b>

Distance (ft):	<b>29.6</b>
Structural Grade:	<b>0</b>
O&M Grade:	<b>2</b>
Clock Start/From:	<b>6</b>
Clock To:	
1st Value:	
2nd Value:	
Value Percent:	<b>5.000</b>
Continuous Index:	
Within 8" of Joint:	<b>NO</b>
Remarks:	<b>tissue</b>

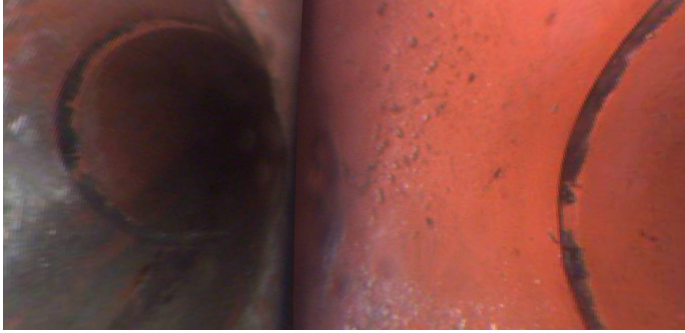
Code: **TF**  
Description: **Tap Factory**

Distance (ft): **41.2**  
Structural Grade: **0**  
O&M Grade: **0**  
Clock Start/From: **9**  
Clock To:  
1st Value: **4.000**  
2nd Value:  
Value Percent:  
Continuous Index:  
Within 8" of Joint: **YES**  
Remarks:

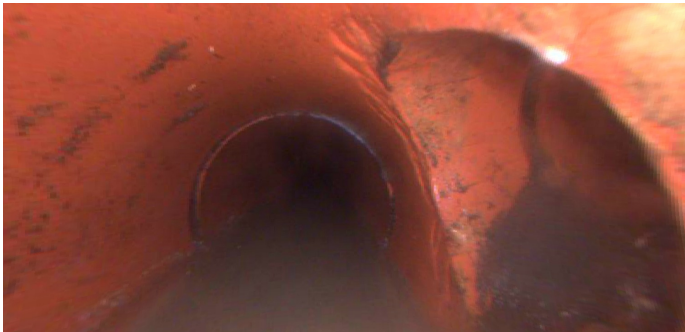
Code: **TF**  
Description: **Tap Factory**

Distance (ft): **62.8**  
Structural Grade: **0**  
O&M Grade: **0**  
Clock Start/From: **3**  
Clock To:  
1st Value: **4.000**  
2nd Value:  
Value Percent:  
Continuous Index:  
Within 8" of Joint: **YES**  
Remarks:

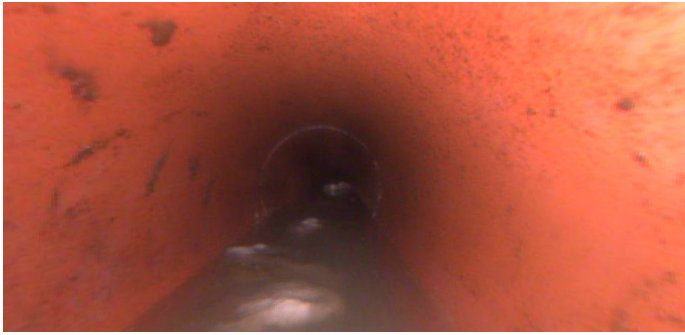
Code: **DSZ**  
Description: **Deposits Settled Other**

Distance (ft): **102.4**  
Structural Grade: **0**  
O&M Grade: **2**  
Clock Start/From: **6**  
Clock To:  
1st Value:  
2nd Value:  
Value Percent: **5.000**  
Continuous Index: **S01**  
Within 8" of Joint: **NO**  
Remarks: **tissue**

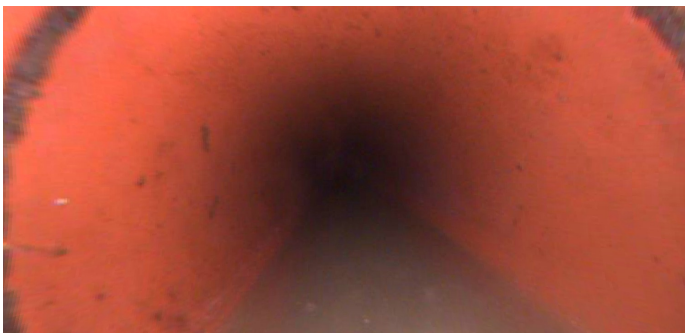
Code: **DSZ**  
Description: **Deposits Settled Other**

Distance (ft): **109.1**  
Structural Grade: **0**  
O&M Grade: **2**  
Clock Start/From: **6**  
Clock To:  
1st Value:  
2nd Value:  
Value Percent: **5.000**  
Continuous Index: **F01**  
Within 8" of Joint: **NO**  
Remarks: **tissue**

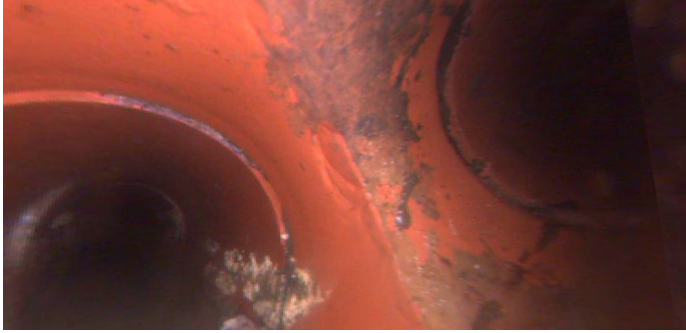
Code: **TF**  
Description: **Tap Factory**

Distance (ft): **115.6**  
Structural Grade: **0**  
O&M Grade: **0**  
Clock Start/From: **2**  
Clock To:  
1st Value: **4.000**  
2nd Value:  
Value Percent:  
Continuous Index:  
Within 8" of Joint: **YES**  
Remarks:

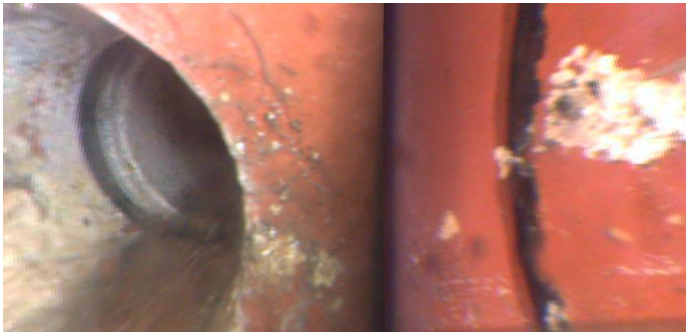
Code: **TF**  
Description: **Tap Factory**

Distance (ft): **118.1**  
Structural Grade: **0**  
O&M Grade: **0**  
Clock Start/From: **10**  
Clock To:  
1st Value: **4.000**  
2nd Value:  
Value Percent:  
Continuous Index:  
Within 8" of Joint: **YES**  
Remarks:

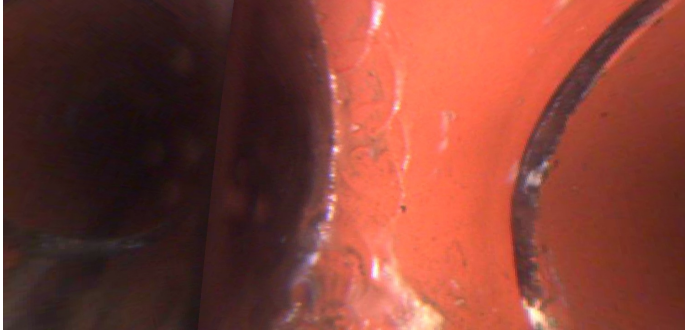
Code: **TF**  
Description: **Tap Factory**

Distance (ft): **155.4**  
Structural Grade: **0**  
O&M Grade: **0**  
Clock Start/From: **9**  
Clock To:  
1st Value: **4.000**  
2nd Value:  
Value Percent:  
Continuous Index:  
Within 8" of Joint: **YES**  
Remarks:

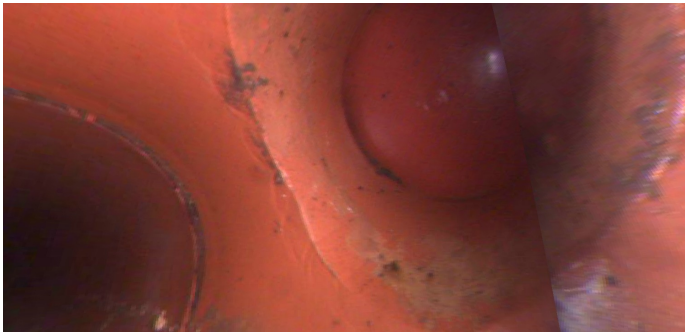
Code: **TFC**  
Description: **Tap Factory Capped**

Distance (ft): **157.1**  
Structural Grade: **0**  
O&M Grade: **0**  
Clock Start/From: **2**  
Clock To:  
1st Value: **4.000**  
2nd Value:  
Value Percent:  
Continuous Index:  
Within 8" of Joint: **YES**  
Remarks:

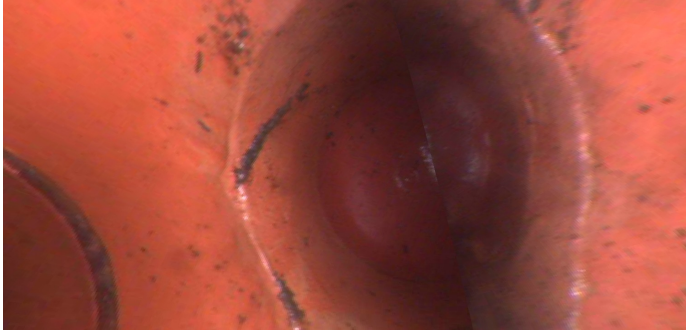
Code: **TFC**  
Description: **Tap Factory Capped**

Distance (ft): **204.7**  
Structural Grade: **0**  
O&M Grade: **0**  
Clock Start/From: **2**  
Clock To:  
1st Value: **4.000**  
2nd Value:  
Value Percent:  
Continuous Index:  
Within 8" of Joint: **YES**  
Remarks:

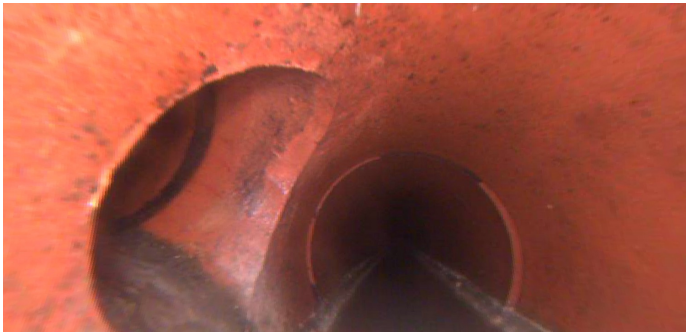
Code: **TF**  
Description: **Tap Factory**

Distance (ft): **226.5**  
Structural Grade: **0**  
O&M Grade: **0**  
Clock Start/From: **10**  
Clock To:  
1st Value: **4.000**  
2nd Value:  
Value Percent:  
Continuous Index:  
Within 8" of Joint: **YES**  
Remarks:

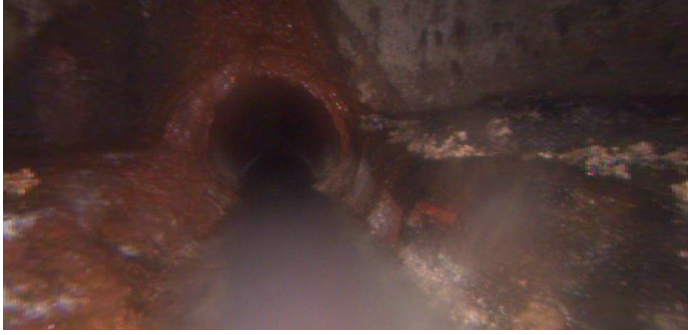
Code:	<b>AMH</b>
Description:	<b>Manhole</b>
Distance (ft):	<b>268.4</b>
Structural Grade:	<b>0</b>
O&M Grade:	<b>0</b>
Clock Start/From:	
Clock To:	
1st Value:	
2nd Value:	
Value Percent:	
Continuous Index:	
Within 8" of Joint:	<b>NO</b>
Remarks:	<b>M-203-056</b>
