## Profile/Photo Observation Report

Street:	<b>E 38th Ave</b>	Flow Control:	<b>Not Controlled</b>
City:	<b>Hobart, IN</b>	Year Renewed:	
Location:	<b>Other</b>	Tape/Media #:	
Purpose:	<b>Not Known</b>	Dia/Height:	<b>12"</b>
Use:	<b>Sanitary</b>	Material:	<b>VCP</b>
Drain Area:	<b>NA</b>	Lining:	
Category:	<b>NA</b>		
Comment:

Location Details:		Direction of Survey:	<b>Downstream</b>
US MH:	<b>M-203-051</b>	DS MH:	<b>M-203-056</b>
		Total Length Surveyed (ft):	<b>268.4</b>

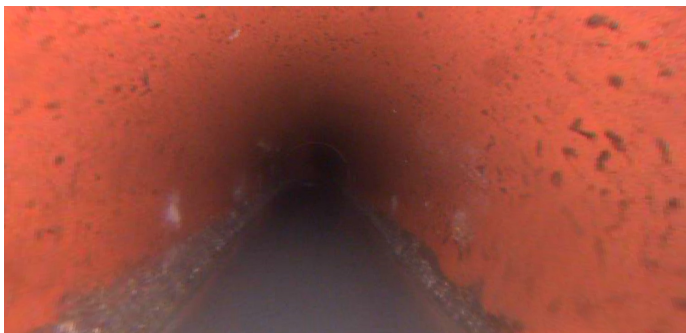
Code: **AMH**  
Description: **Manhole**

Distance (ft): **.0**  
Structural Grade: **0**  
O&M Grade: **0**  
Clock Start/From:  
Clock To:  
1st Value:  
2nd Value:  
Value Percent:  
Continuous Index:  
Within 8" of Joint: **NO**  
Remarks: **M-203-051**

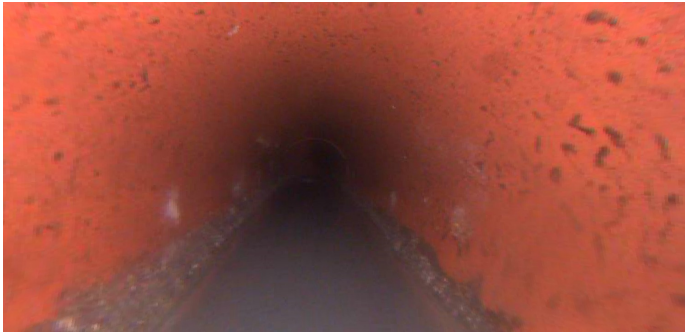
Code:	<b>MWL</b>
Description:	<b>Water Level</b>

Distance (ft):	<b>.0</b>
Structural Grade:	<b>0</b>
O&M Grade:	<b>0</b>
Clock Start/From:	
Clock To:	
1st Value:	
2nd Value:	
Value Percent:	<b>5.000</b>
Continuous Index:	
Within 8" of Joint:	<b>NO</b>
Remarks:

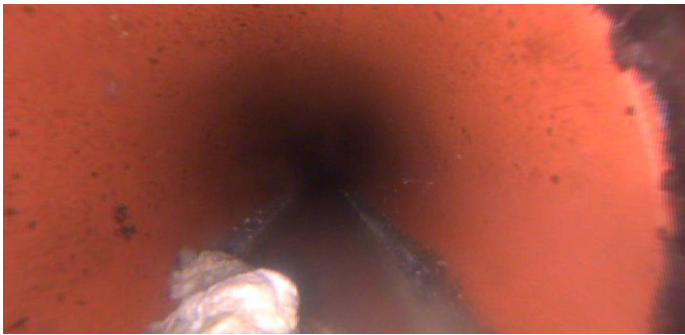
Code:	<b>DSZ</b>
Description:	<b>Deposits Settled Other</b>

Distance (ft):	<b>29.6</b>
Structural Grade:	<b>0</b>
O&M Grade:	<b>2</b>
Clock Start/From:	<b>6</b>
Clock To:	
1st Value:	
2nd Value:	
Value Percent:	<b>5.000</b>
Continuous Index:	
Within 8" of Joint:	<b>NO</b>
Remarks:	<b>tissue</b>

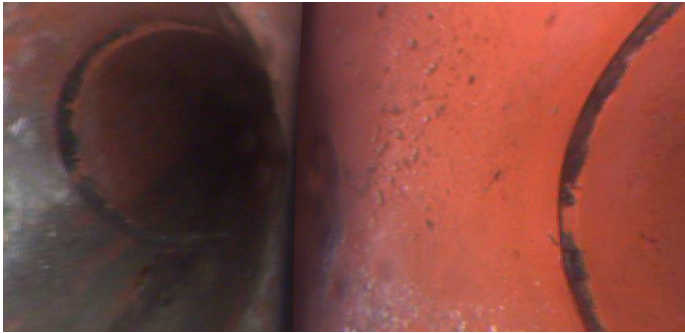
Code: **TF**  
Description: **Tap Factory**

Distance (ft): **41.2**  
Structural Grade: **0**  
O&M Grade: **0**  
Clock Start/From: **9**  
Clock To:  
1st Value: **4.000**  
2nd Value:  
Value Percent:  
Continuous Index:  
Within 8" of Joint: **YES**  
Remarks:

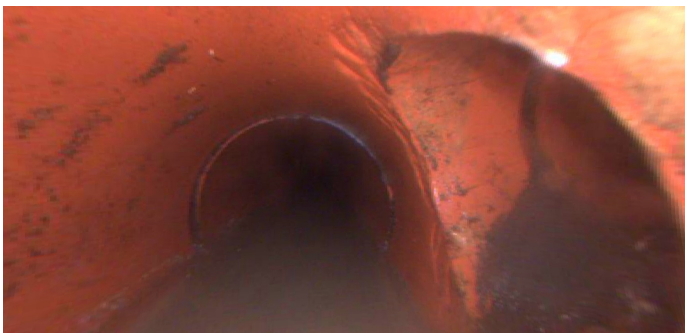
Code: **TF**  
Description: **Tap Factory**

Distance (ft): **62.8**  
Structural Grade: **0**  
O&M Grade: **0**  
Clock Start/From: **3**  
Clock To:  
1st Value: **4.000**  
2nd Value:  
Value Percent:  
Continuous Index:  
Within 8" of Joint: **YES**  
Remarks:

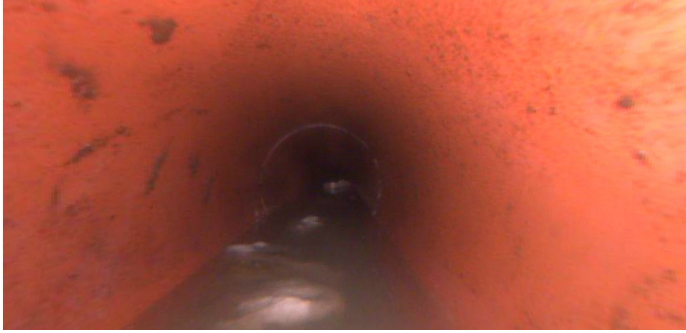
Code: **DSZ**  
Description: **Deposits Settled Other**

Distance (ft): **102.4**  
Structural Grade: **0**  
O&M Grade: **2**  
Clock Start/From: **6**  
Clock To:  
1st Value:  
2nd Value:  
Value Percent: **5.000**  
Continuous Index: **S01**  
Within 8" of Joint: **NO**  
Remarks: **tissue**

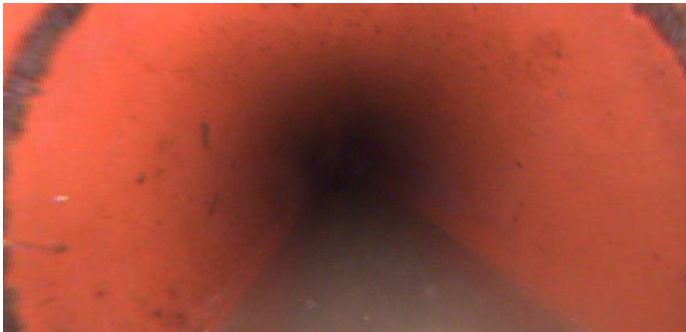
Code: **DSZ**  
Description: **Deposits Settled Other**

Distance (ft): **109.1**  
Structural Grade: **0**  
O&M Grade: **2**  
Clock Start/From: **6**  
Clock To:  
1st Value:  
2nd Value:  
Value Percent: **5.000**  
Continuous Index: **F01**  
Within 8" of Joint: **NO**  
Remarks: **tissue**

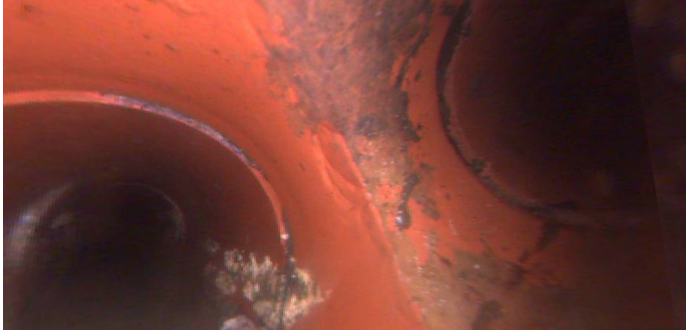
Code: **TF**  
Description: **Tap Factory**

Distance (ft): **115.6**  
Structural Grade: **0**  
O&M Grade: **0**  
Clock Start/From: **2**  
Clock To:  
1st Value: **4.000**  
2nd Value:  
Value Percent:  
Continuous Index:  
Within 8" of Joint: **YES**  
Remarks:

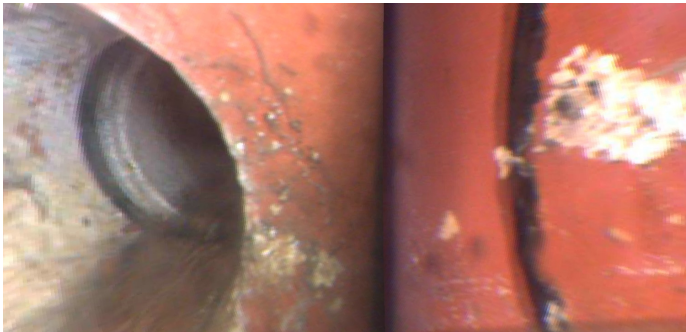
Code: **TF**  
Description: **Tap Factory**

Distance (ft): **118.1**  
Structural Grade: **0**  
O&M Grade: **0**  
Clock Start/From: **10**  
Clock To:  
1st Value: **4.000**  
2nd Value:  
Value Percent:  
Continuous Index:  
Within 8" of Joint: **YES**  
Remarks:

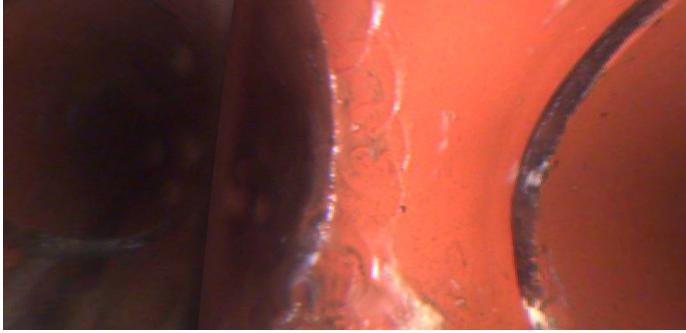
Code: **TF**  
Description: **Tap Factory**

Distance (ft): **155.4**  
Structural Grade: **0**  
O&M Grade: **0**  
Clock Start/From: **9**  
Clock To:  
1st Value: **4.000**  
2nd Value:  
Value Percent:  
Continuous Index:  
Within 8" of Joint: **YES**  
Remarks:

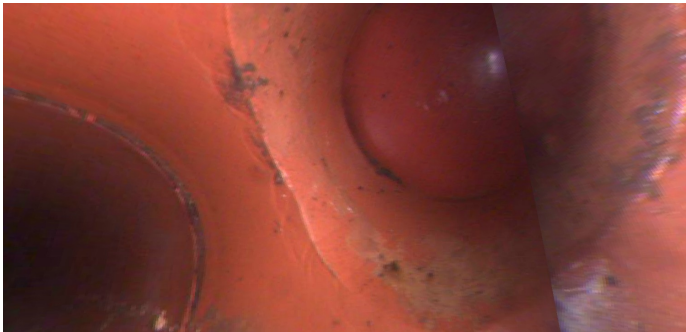
Code: **TFC**  
Description: **Tap Factory Capped**

Distance (ft): **157.1**  
Structural Grade: **0**  
O&M Grade: **0**  
Clock Start/From: **2**  
Clock To:  
1st Value: **4.000**  
2nd Value:  
Value Percent:  
Continuous Index:  
Within 8" of Joint: **YES**  
Remarks:

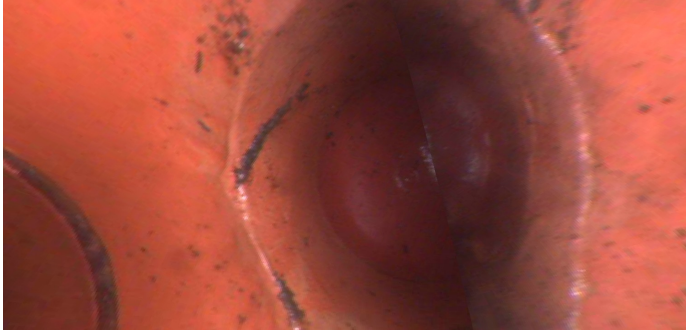
Code: **TFC**  
Description: **Tap Factory Capped**

Distance (ft): **204.7**  
Structural Grade: **0**  
O&M Grade: **0**  
Clock Start/From: **2**  
Clock To:  
1st Value: **4.000**  
2nd Value:  
Value Percent:  
Continuous Index:  
Within 8" of Joint: **YES**  
Remarks:

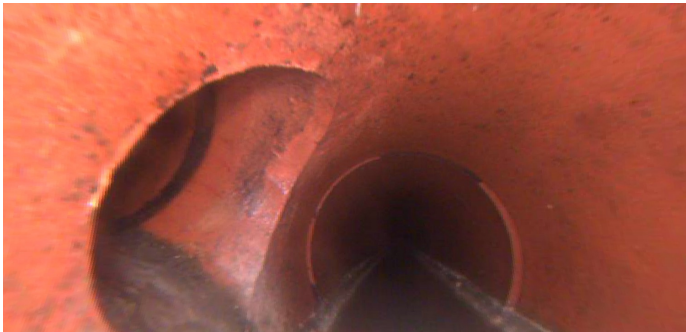
Code: **TF**  
Description: **Tap Factory**

Distance (ft): **226.5**  
Structural Grade: **0**  
O&M Grade: **0**  
Clock Start/From: **10**  
Clock To:  
1st Value: **4.000**  
2nd Value:  
Value Percent:  
Continuous Index:  
Within 8" of Joint: **YES**  
Remarks:

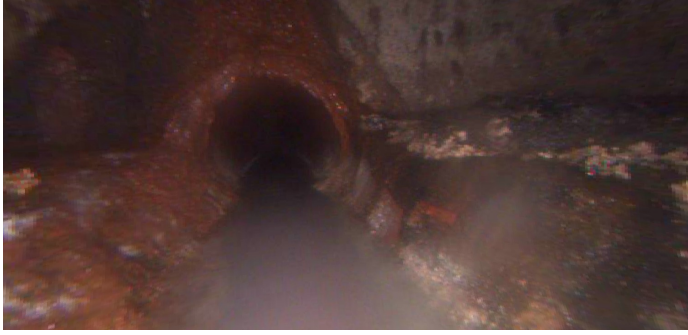
Code:	<b>AMH</b>
Description:	<b>Manhole</b>
Distance (ft):	<b>268.4</b>
Structural Grade:	<b>0</b>
O&M Grade:	<b>0</b>
Clock Start/From:	
Clock To:	
1st Value:	
2nd Value:	
Value Percent:	
Continuous Index:	
Within 8" of Joint:	<b>NO</b>
Remarks:	<b>M-203-056</b>
