## Profile/Photo Observation Report

Street:	<b>ALLEY BETWEEN SANDUSKY ST &amp; EV</b>	Flow Control:	<b>Not Controlled</b>
City:	<b>Hobart, IN</b>	Year Renewed:	
Location:	<b>Other</b>	Tape/Media #:	
Purpose:	<b>Not Known</b>	Dia/Height:	<b>10"</b>
Use:	<b>Sanitary</b>	Material:	<b>VCP</b>
Drain Area:	<b>NA</b>	Lining:	
Category:	<b>NA</b>		
Comment:	<b>Heavy grease and debris</b>

Location Details:		Direction of Survey:	<b>Downstream</b>
US MH:	<b>M-203-052</b>	DS MH:	<b>M-203-054</b>
		Total Length Surveyed (ft):	<b>244.7</b>

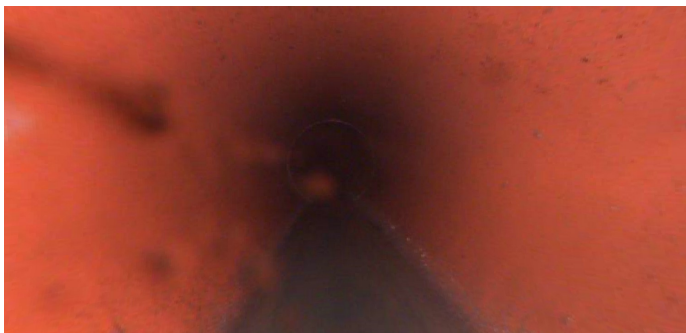
Code: **AMH**  
Description: **Manhole**

Distance (ft): **.0**  
Structural Grade: **0**  
O&M Grade: **0**  
Clock Start/From:  
Clock To:  
1st Value:  
2nd Value:  
Value Percent:  
Continuous Index:  
Within 8" of Joint: **NO**  
Remarks: **M-203-052**

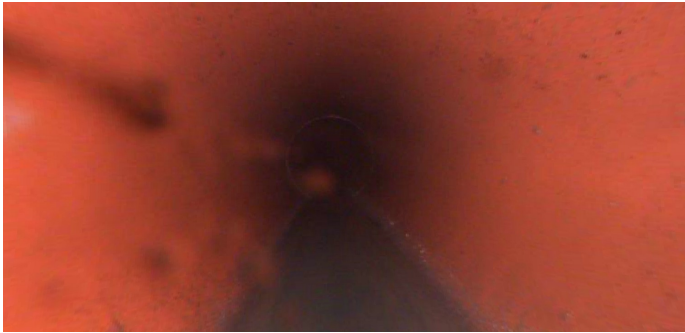
Code:	<b>MWL</b>
Description:	<b>Water Level</b>

Distance (ft):	<b>.0</b>
Structural Grade:	<b>0</b>
O&M Grade:	<b>0</b>
Clock Start/From:	
Clock To:	
1st Value:	
2nd Value:	
Value Percent:	<b>5.000</b>
Continuous Index:	
Within 8" of Joint:	<b>NO</b>
Remarks:

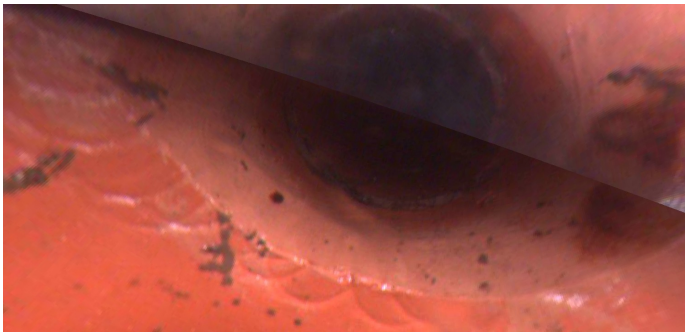
Code:	<b>TF</b>
Description:	<b>Tap Factory</b>

Distance (ft):	<b>25.1</b>
Structural Grade:	<b>0</b>
O&M Grade:	<b>0</b>
Clock Start/From:	<b>12</b>
Clock To:	
1st Value:	<b>4.000</b>
2nd Value:	
Value Percent:	
Continuous Index:	
Within 8" of Joint:	<b>YES</b>
Remarks:

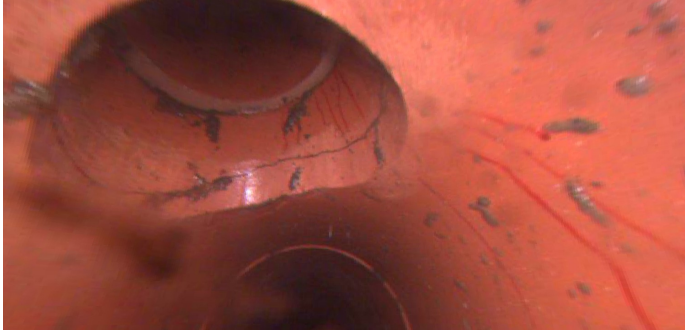
Code: **TF**  
Description: **Tap Factory**

Distance (ft): **31.4**  
Structural Grade: **0**  
O&M Grade: **0**  
Clock Start/From: **11**  
Clock To:  
1st Value: **4.000**  
2nd Value:  
Value Percent:  
Continuous Index:  
Within 8" of Joint: **YES**  
Remarks:

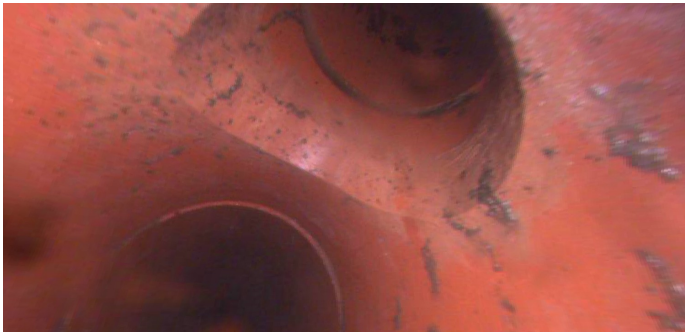
Code: **TF**  
Description: **Tap Factory**

Distance (ft): **69.1**  
Structural Grade: **0**  
O&M Grade: **0**  
Clock Start/From: **1**  
Clock To:  
1st Value: **4.000**  
2nd Value:  
Value Percent:  
Continuous Index:  
Within 8" of Joint: **YES**  
Remarks:

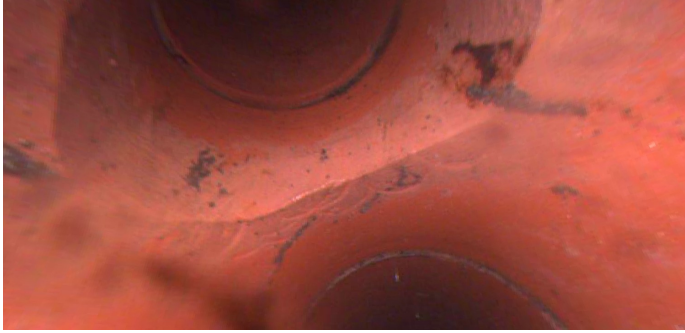
Code: **TF**  
Description: **Tap Factory**

Distance (ft): **76.3**  
Structural Grade: **0**  
O&M Grade: **0**  
Clock Start/From: **11**  
Clock To:  
1st Value: **4.000**  
2nd Value:  
Value Percent:  
Continuous Index:  
Within 8" of Joint: **YES**  
Remarks:

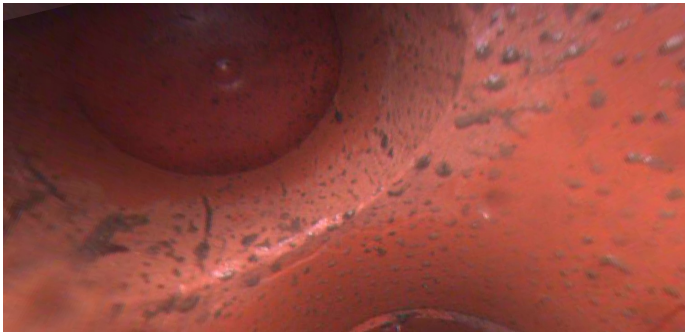
Code: **TFC**  
Description: **Tap Factory Capped**

Distance (ft): **118.5**  
Structural Grade: **0**  
O&M Grade: **0**  
Clock Start/From: **11**  
Clock To:  
1st Value: **4.000**  
2nd Value:  
Value Percent:  
Continuous Index:  
Within 8" of Joint: **YES**  
Remarks:

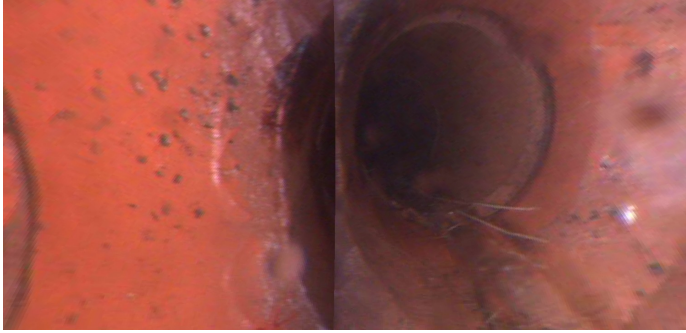
Code: **TF**  
Description: **Tap Factory**

Distance (ft): **141.2**  
Structural Grade: **0**  
O&M Grade: **0**  
Clock Start/From: **2**  
Clock To:  
1st Value: **4.000**  
2nd Value:  
Value Percent:  
Continuous Index:  
Within 8" of Joint: **YES**  
Remarks:

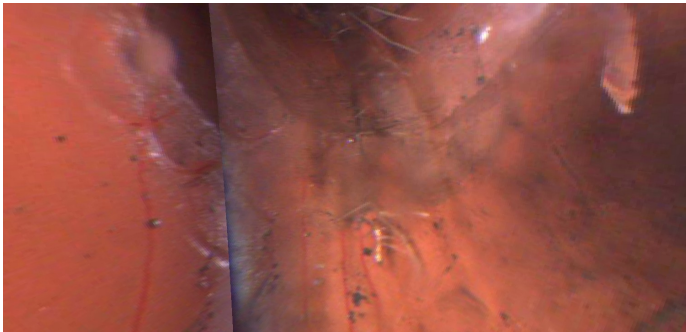
Code: **RFL**  
Description: **Roots Fine Lateral**

Distance (ft): **141.2**  
Structural Grade: **0**  
O&M Grade: **1**  
Clock Start/From: **3**  
Clock To:  
1st Value:  
2nd Value:  
Value Percent:  
Continuous Index:  
Within 8" of Joint: **NO**  
Remarks:

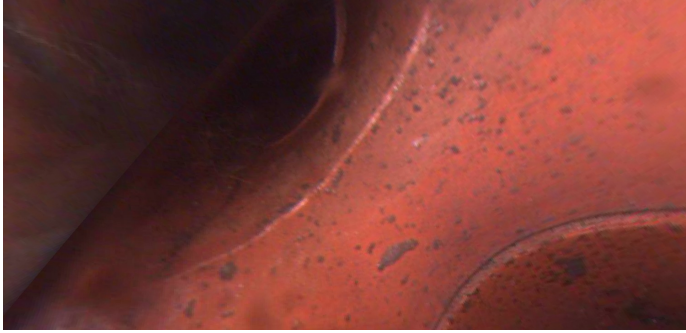
Code: **TF**  
Description: **Tap Factory**

Distance (ft): **178.5**  
Structural Grade: **0**  
O&M Grade: **0**  
Clock Start/From: **11**  
Clock To:  
1st Value: **4.000**  
2nd Value:  
Value Percent:  
Continuous Index:  
Within 8" of Joint: **YES**  
Remarks:

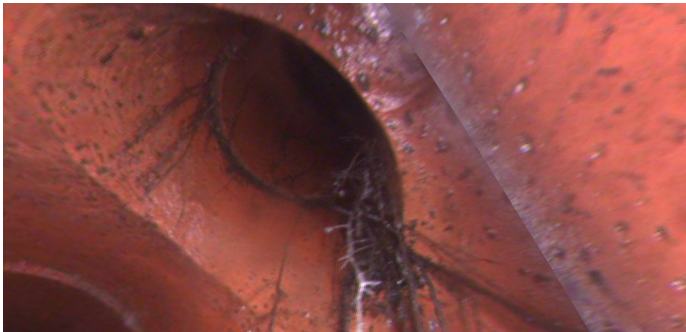
Code: **TF**  
Description: **Tap Factory**

Distance (ft): **185.0**  
Structural Grade: **0**  
O&M Grade: **0**  
Clock Start/From: **2**  
Clock To:  
1st Value: **4.000**  
2nd Value:  
Value Percent:  
Continuous Index:  
Within 8" of Joint: **YES**  
Remarks:

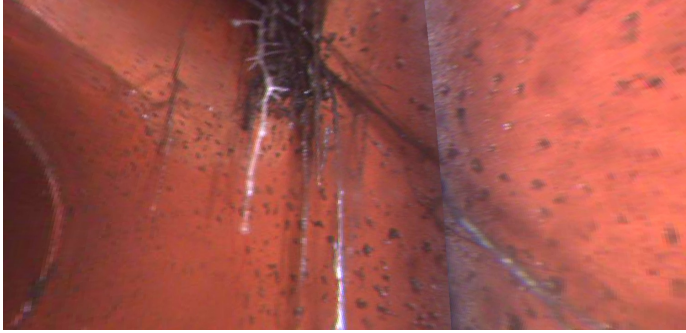
Code: **RFL**  
Description: **Roots Fine Lateral**

Distance (ft): **185.0**  
Structural Grade: **0**  
O&M Grade: **1**  
Clock Start/From: **3**  
Clock To: **5**  
1st Value:  
2nd Value:  
Value Percent:  
Continuous Index:  
Within 8" of Joint: **NO**  
Remarks:

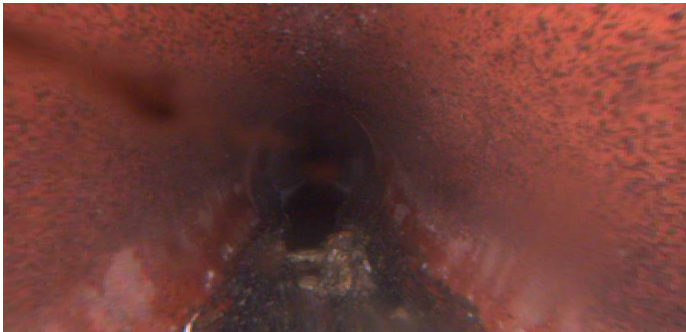
Code: **DSZ**  
Description: **Deposits Settled Other**

Distance (ft): **234.9**  
Structural Grade: **0**  
O&M Grade: **2**  
Clock Start/From: **6**  
Clock To:  
1st Value:  
2nd Value:  
Value Percent: **5.000**  
Continuous Index:  
Within 8" of Joint: **NO**  
Remarks: **debris**

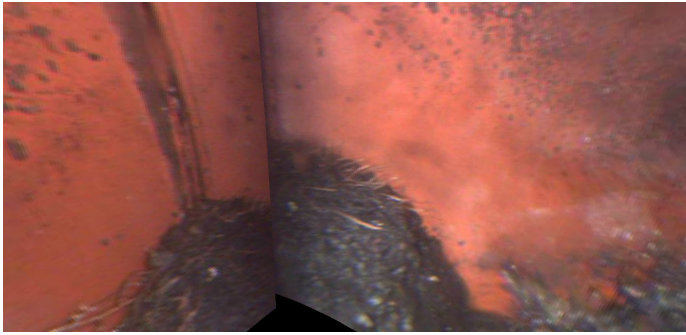
Code: **RMJ**  
Description: **Roots Medium Joint**

Distance (ft): **236.6**  
Structural Grade: **0**  
O&M Grade: **3**  
Clock Start/From: **7**  
Clock To: **5**  
1st Value:  
2nd Value:  
Value Percent: **5.000**  
Continuous Index:  
Within 8" of Joint: **YES**  
Remarks: **7 and 5**

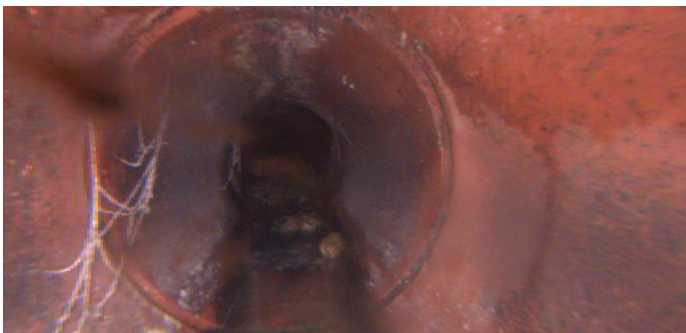
Code: **RFJ**  
Description: **Roots Fine Joint**

Distance (ft): **241.0**  
Structural Grade: **0**  
O&M Grade: **1**  
Clock Start/From: **10**  
Clock To:  
1st Value:  
2nd Value:  
Value Percent:  
Continuous Index:  
Within 8" of Joint: **YES**  
Remarks:

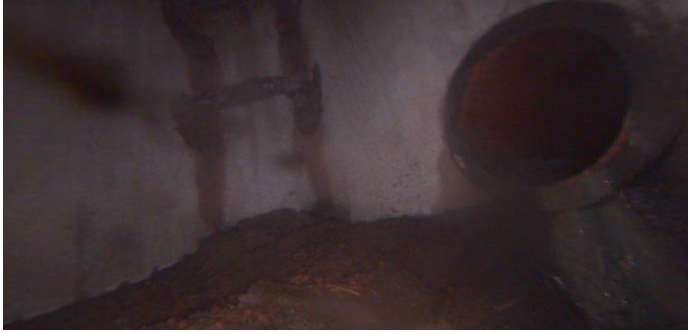
Code:	AMH
Description:	Manhole
Distance (ft):	244.7
Structural Grade:	0
O&M Grade:	0
Clock Start/From:	
Clock To:	
1st Value:	
2nd Value:	
Value Percent:	
Continuous Index:	
Within 8" of Joint:	NO
Remarks:	M-203-054
