Profile/Photo Observation Report

Street:	E 38th Ave	Flow Control:	Not Controlled
City:	Hobart, IN	Year Renewed:	
Location:	Other	Tape/Media #:	
Purpose:	Not Known	Dia/Height:	10"
Use:	Sanitary	Material:	VCP
Drain Area:	NA	Lining:	
Category:	NA		
Comment:	Heavy grease and debris

Location Details:		Direction of Survey:	Downstream
US MH:	M-203-052	DS MH:	M-203-054
		Total Length Surveyed (ft):	244.7

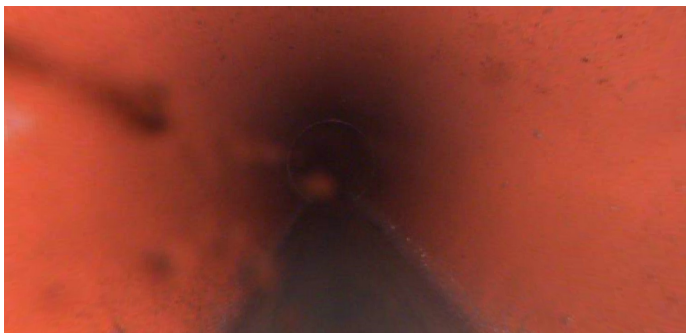
Code: **AMH**
Description: **Manhole**

Distance (ft): **.0**
Structural Grade: **0**
O&M Grade: **0**
Clock Start/From:
Clock To:
1st Value:
2nd Value:
Value Percent:
Continuous Index:
Within 8" of Joint: **NO**
Remarks: **M-203-052**

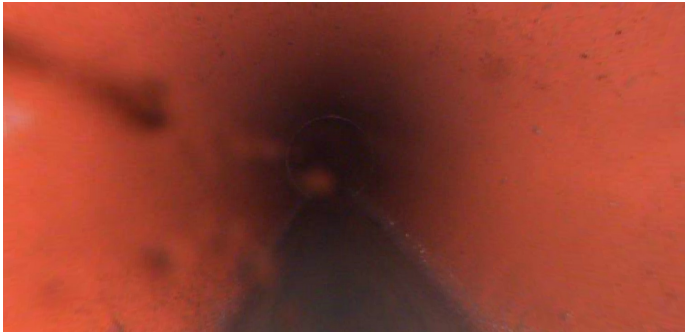
Code:	MWL
Description:	Water Level

Distance (ft):	.0
Structural Grade:	0
O&M Grade:	0
Clock Start/From:	
Clock To:	
1st Value:	
2nd Value:	
Value Percent:	5.000
Continuous Index:	
Within 8" of Joint:	NO
Remarks:

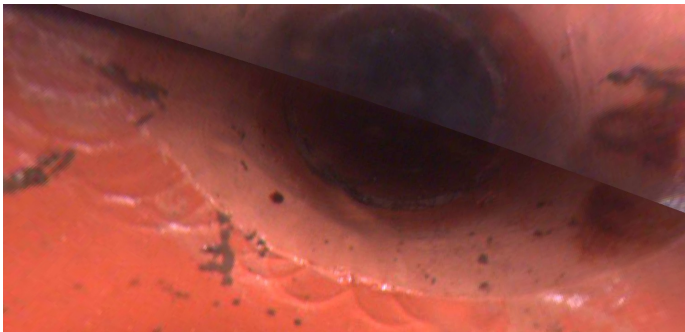
Code:	TF
Description:	Tap Factory

Distance (ft):	25.1
Structural Grade:	0
O&M Grade:	0
Clock Start/From:	12
Clock To:	
1st Value:	4.000
2nd Value:	
Value Percent:	
Continuous Index:	
Within 8" of Joint:	YES
Remarks:

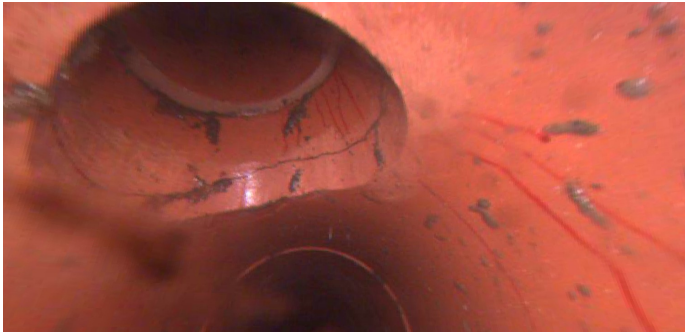
Code: **TF**
Description: **Tap Factory**

Distance (ft): **31.4**
Structural Grade: **0**
O&M Grade: **0**
Clock Start/From: **11**
Clock To:
1st Value: **4.000**
2nd Value:
Value Percent:
Continuous Index:
Within 8" of Joint: **YES**
Remarks:

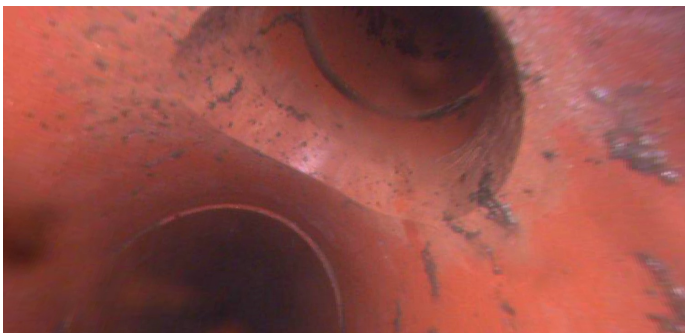
Code: **TF**
Description: **Tap Factory**

Distance (ft): **69.1**
Structural Grade: **0**
O&M Grade: **0**
Clock Start/From: **1**
Clock To:
1st Value: **4.000**
2nd Value:
Value Percent:
Continuous Index:
Within 8" of Joint: **YES**
Remarks:

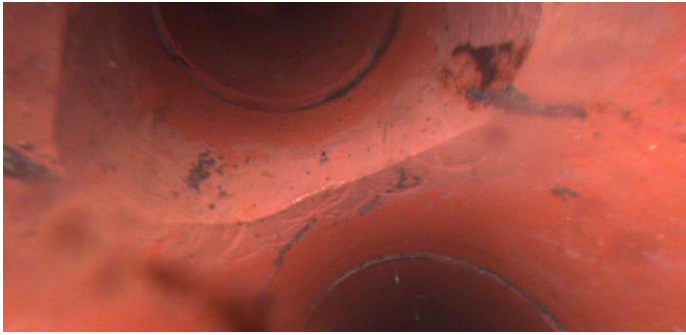
Code: **TF**
Description: **Tap Factory**

Distance (ft): **76.3**
Structural Grade: **0**
O&M Grade: **0**
Clock Start/From: **11**
Clock To:
1st Value: **4.000**
2nd Value:
Value Percent:
Continuous Index:
Within 8" of Joint: **YES**
Remarks:

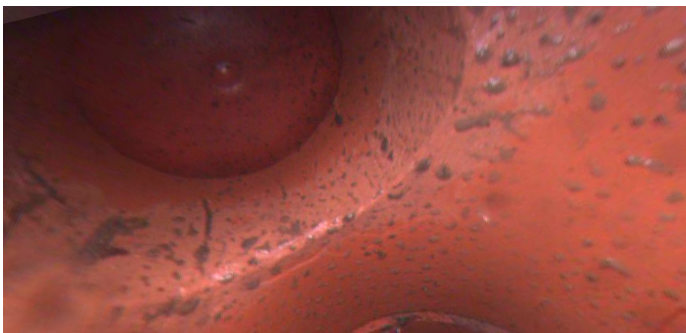
Code: **TFC**
Description: **Tap Factory Capped**

Distance (ft): **118.5**
Structural Grade: **0**
O&M Grade: **0**
Clock Start/From: **11**
Clock To:
1st Value: **4.000**
2nd Value:
Value Percent:
Continuous Index:
Within 8" of Joint: **YES**
Remarks:

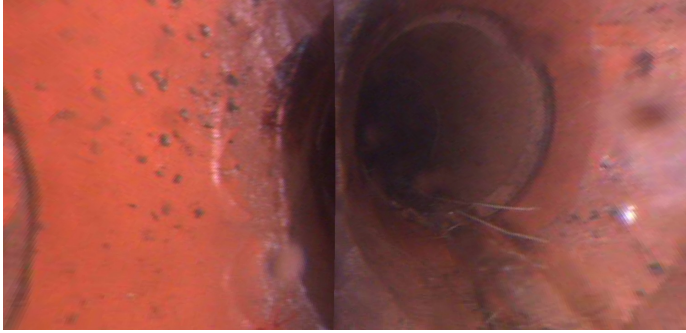
Code: **TF**
Description: **Tap Factory**

Distance (ft): **141.2**
Structural Grade: **0**
O&M Grade: **0**
Clock Start/From: **2**
Clock To:
1st Value: **4.000**
2nd Value:
Value Percent:
Continuous Index:
Within 8" of Joint: **YES**
Remarks:

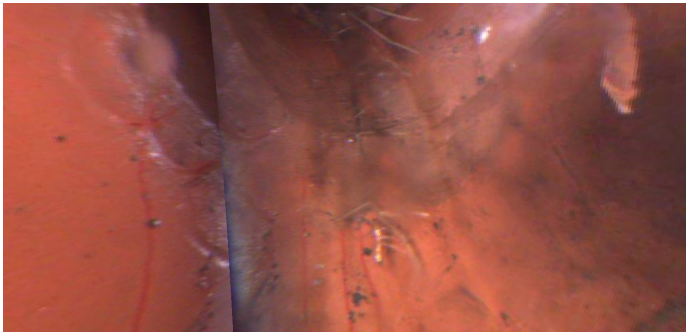
Code: **RFL**
Description: **Roots Fine Lateral**

Distance (ft): **141.2**
Structural Grade: **0**
O&M Grade: **1**
Clock Start/From: **3**
Clock To:
1st Value:
2nd Value:
Value Percent:
Continuous Index:
Within 8" of Joint: **NO**
Remarks:

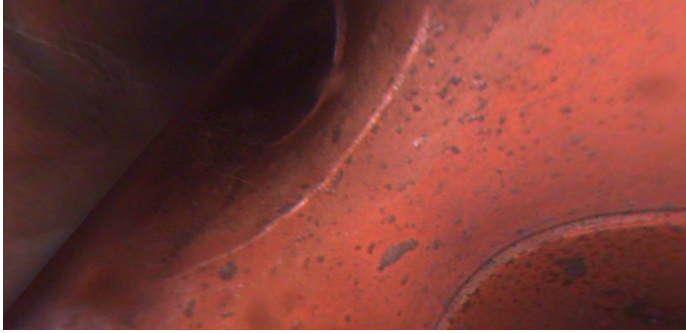
Code: **TF**
Description: **Tap Factory**

Distance (ft): **178.5**
Structural Grade: **0**
O&M Grade: **0**
Clock Start/From: **11**
Clock To:
1st Value: **4.000**
2nd Value:
Value Percent:
Continuous Index:
Within 8" of Joint: **YES**
Remarks:

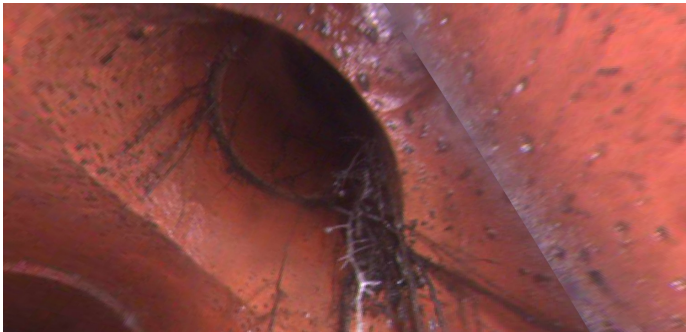
Code: **TF**
Description: **Tap Factory**

Distance (ft): **185.0**
Structural Grade: **0**
O&M Grade: **0**
Clock Start/From: **2**
Clock To:
1st Value: **4.000**
2nd Value:
Value Percent:
Continuous Index:
Within 8" of Joint: **YES**
Remarks:

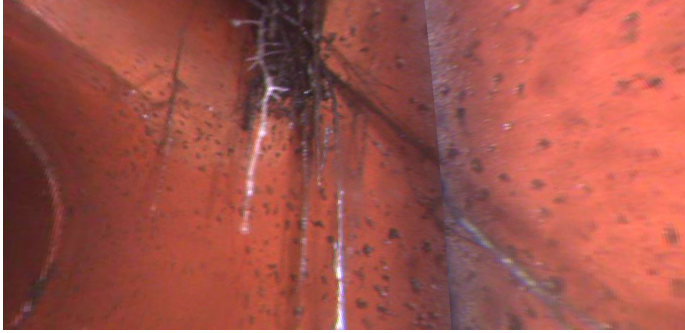
Code: **RFL**
Description: **Roots Fine Lateral**

Distance (ft): **185.0**
Structural Grade: **0**
O&M Grade: **1**
Clock Start/From: **3**
Clock To: **5**
1st Value:
2nd Value:
Value Percent:
Continuous Index:
Within 8" of Joint: **NO**
Remarks:

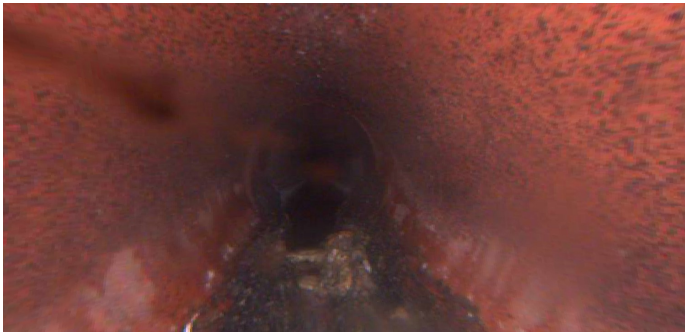
Code: **DSZ**
Description: **Deposits Settled Other**

Distance (ft): **234.9**
Structural Grade: **0**
O&M Grade: **2**
Clock Start/From: **6**
Clock To:
1st Value:
2nd Value:
Value Percent: **5.000**
Continuous Index:
Within 8" of Joint: **NO**
Remarks: **debris**

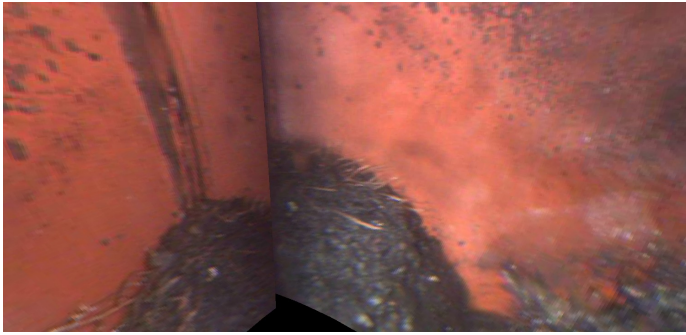
Code: **RMJ**
Description: **Roots Medium Joint**

Distance (ft): **236.6**
Structural Grade: **0**
O&M Grade: **3**
Clock Start/From: **7**
Clock To: **5**
1st Value:
2nd Value:
Value Percent: **5.000**
Continuous Index:
Within 8" of Joint: **YES**
Remarks: **7 and 5**

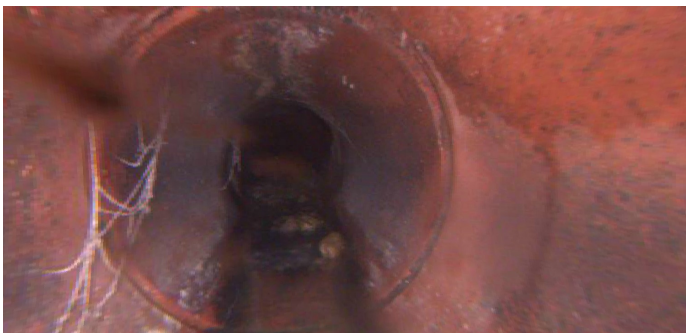
Code: **RFJ**
Description: **Roots Fine Joint**

Distance (ft): **241.0**
Structural Grade: **0**
O&M Grade: **1**
Clock Start/From: **10**
Clock To:
1st Value:
2nd Value:
Value Percent:
Continuous Index:
Within 8" of Joint: **YES**
Remarks:

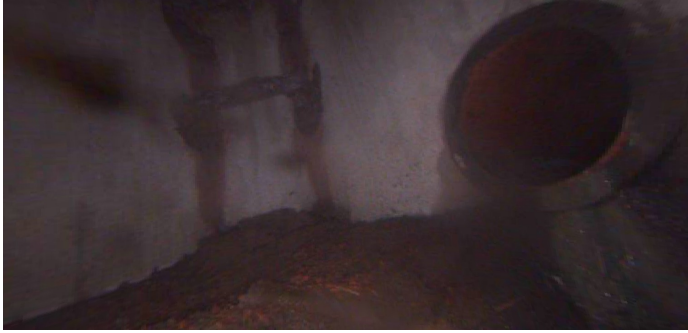
Code:	AMH
Description:	Manhole
Distance (ft):	244.7
Structural Grade:	0
O&M Grade:	0
Clock Start/From:	
Clock To:	
1st Value:	
2nd Value:	
Value Percent:	
Continuous Index:	
Within 8" of Joint:	NO
Remarks:	M-203-054
