Profile/Photo Observation Report

Date:	03/24/2018	Weather:		Coding:	PACP 6.0
Pipe Length (ft):	130.9	Owner:	NA	Pre Clean:	Not Known
P.O.#:		Surveyor:	Byrd Fitzgerald	PSR:	P-203-053-054
Customer:		Clean Date:	01/01/1900	Shape:	C

Street:	E 38th Ave	Flow Control:	Not Controlled
City:	Hobart, IN	Year Renewed:	
Location:	Other	Tape/Media #:	
Purpose:	Not Known	Dia/Height:	10"
Use:	Sanitary	Material:	VCP
Drain Area:	NA	Lining:	
Category:	NA		
Comment:	6 inch

Location Details:		Direction of Survey:	Downstream
US MH:	M-203-054	DS MH:	M-203-053
		Total Length Surveyed (ft):	70.2

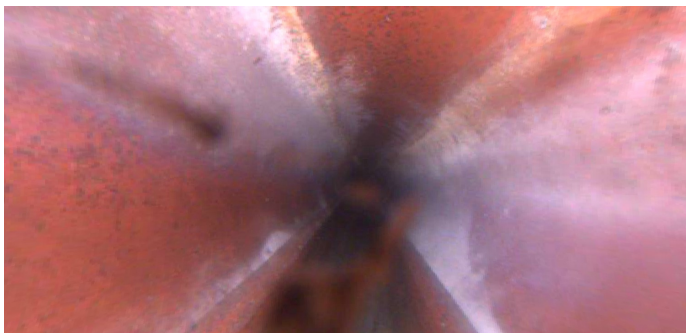
Code: **AMH**
Description: **Manhole**

Distance (ft): **.0**
Structural Grade: **0**
O&M Grade: **0**
Clock Start/From:
Clock To:
1st Value:
2nd Value:
Value Percent:
Continuous Index:
Within 8" of Joint: **NO**
Remarks: **M-203-054**

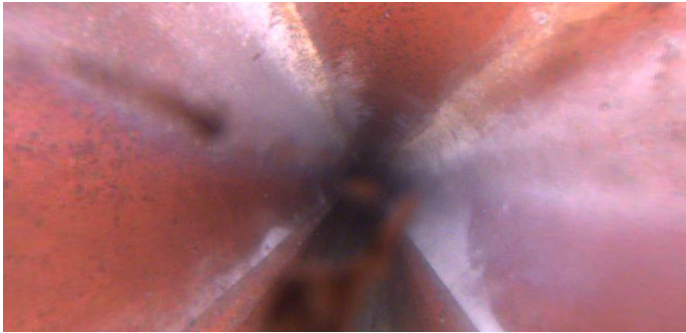
Code:	MWL
Description:	Water Level

Distance (ft):	.0
Structural Grade:	0
O&M Grade:	0
Clock Start/From:	
Clock To:	
1st Value:	
2nd Value:	
Value Percent:	5.000
Continuous Index:	
Within 8" of Joint:	NO
Remarks:

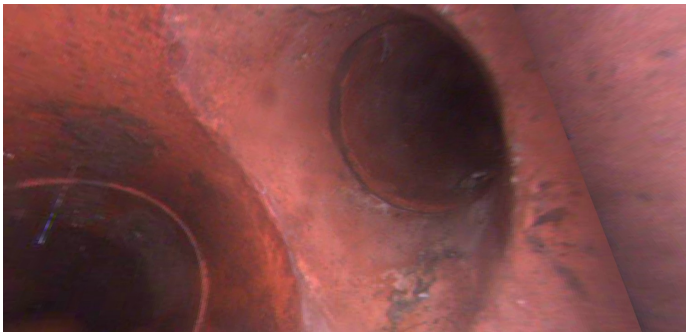
Code:	TF
Description:	Tap Factory

Distance (ft):	20.7
Structural Grade:	0
O&M Grade:	0
Clock Start/From:	2
Clock To:	
1st Value:	4.000
2nd Value:	
Value Percent:	
Continuous Index:	
Within 8" of Joint:	YES
Remarks:

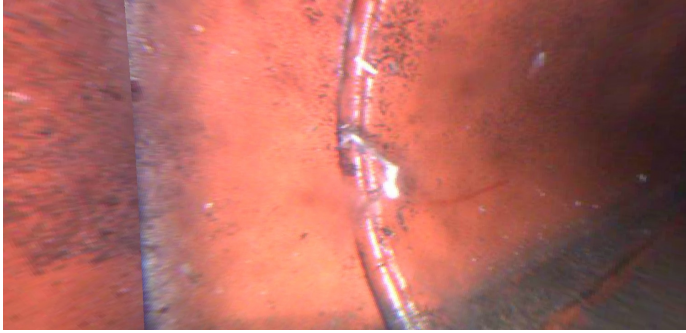
Code: **RFJ**
Description: **Roots Fine Joint**

Distance (ft): **47.1**
Structural Grade: **0**
O&M Grade: **1**
Clock Start/From: **3**
Clock To:
1st Value:
2nd Value:
Value Percent:
Continuous Index:
Within 8" of Joint: **YES**
Remarks:

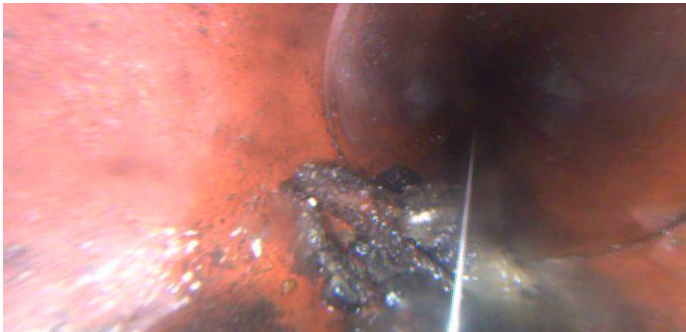
Code: **DAZ**
Description: **Deposits Attached Other**

Distance (ft): **62.5**
Structural Grade: **0**
O&M Grade: **2**
Clock Start/From: **4**
Clock To: **5**
1st Value:
2nd Value:
Value Percent: **5.000**
Continuous Index:
Within 8" of Joint: **YES**
Remarks:

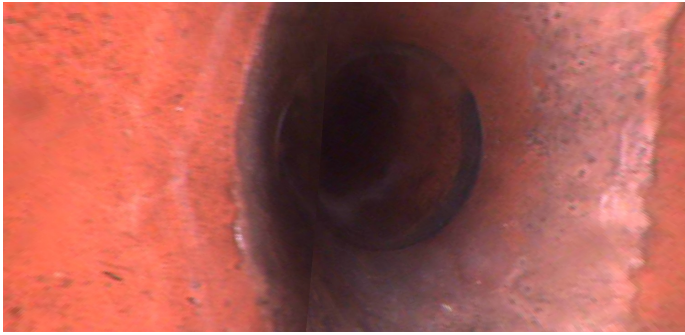
Code: **TF**
Description: **Tap Factory**

Distance (ft): **68.3**
Structural Grade: **0**
O&M Grade: **0**
Clock Start/From: **2**
Clock To:
1st Value: **4.000**
2nd Value:
Value Percent:
Continuous Index:
Within 8" of Joint: **YES**
Remarks:

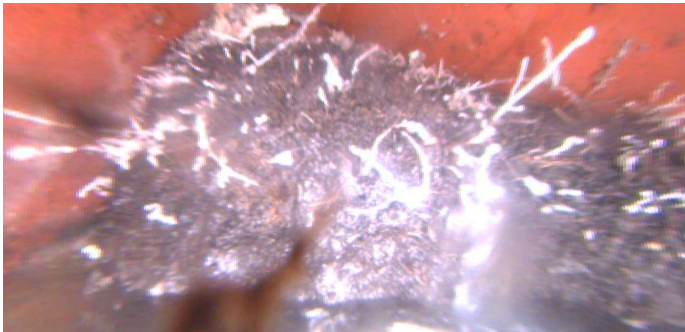
Code: **RBB**
Description: **Roots Ball Barrel**

Distance (ft): **69.8**
Structural Grade: **0**
O&M Grade: **5**
Clock Start/From: **12**
Clock To: **12**
1st Value:
2nd Value:
Value Percent: **100.000**
Continuous Index:
Within 8" of Joint: **NO**
Remarks:

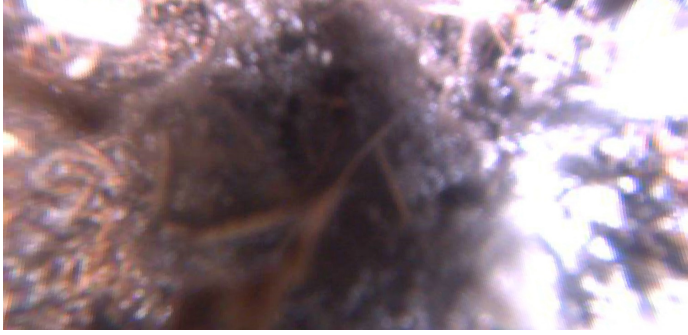
Code:	MSA
Description:	Abandoned Survey
Distance (ft):	70.2
Structural Grade:	0
O&M Grade:	0
Clock Start/From:	
Clock To:	
1st Value:	
2nd Value:	
Value Percent:	
Continuous Index:	
Within 8" of Joint:	NO
Remarks:	rbb
