Profile/Photo Observation Report

Location Details:		Direction of Survey:	Downstream
US MH:	M-203-054	DS MH:	M-203-055
		Total Length Surveyed (ft):	79.0

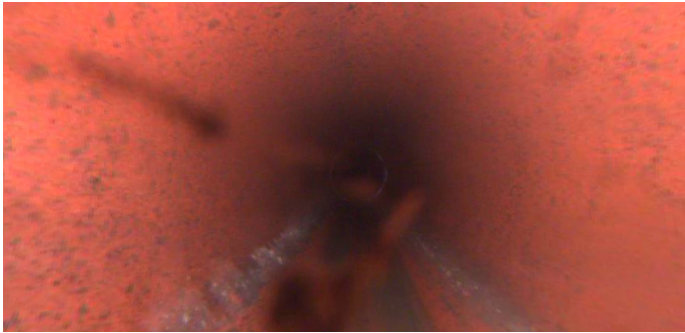
Code:	MWL
Description:	Water Level

Distance (ft):	.0
Structural Grade:	0
O&M Grade:	0
Clock Start/From:	
Clock To:	
1st Value:	
2nd Value:	
Value Percent:	5.000
Continuous Index:	
Within 8" of Joint:	NO
Remarks:

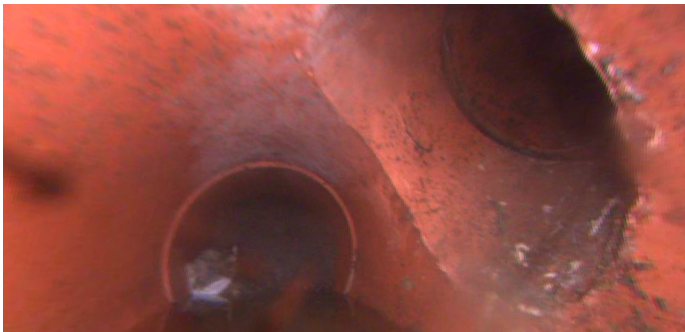
Code:	TF
Description:	Tap Factory

Distance (ft):	77.5
Structural Grade:	0
O&M Grade:	0
Clock Start/From:	2
Clock To:	
1st Value:	4.000
2nd Value:	
Value Percent:	
Continuous Index:	
Within 8" of Joint:	YES
Remarks:

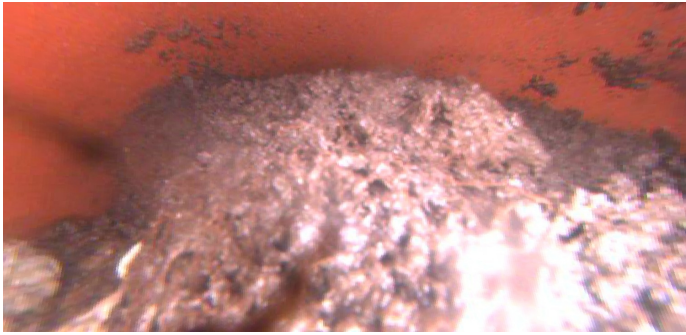
Code: **RBB**
Description: **Roots Ball Barrel**

Distance (ft): **78.9**
Structural Grade: **0**
O&M Grade: **5**
Clock Start/From: **12**
Clock To: **12**
1st Value:
2nd Value:
Value Percent: **100.000**
Continuous Index:
Within 8" of Joint: **NO**
Remarks:

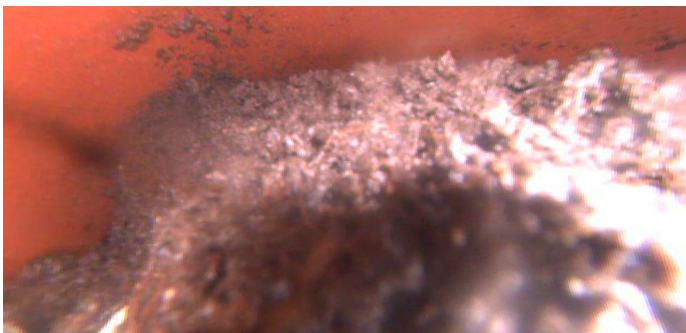
Code: **MSA**
Description: **Abandoned Survey**

Distance (ft): **79.0**
Structural Grade: **0**
O&M Grade: **0**
Clock Start/From:
Clock To:
1st Value:
2nd Value:
Value Percent:
Continuous Index:
Within 8" of Joint: **NO**
Remarks: **rbb**
