Profile/Photo Observation Report

Date:	03/24/2018	Weather:		Coding:	PACP 6.0
Pipe Length (ft):	94.7	Owner:	NA	Pre Clean:	Not Known
P.O.#:		Surveyor:	Byrd Fitzgerald	PSR:	P-203-055-054
Customer:		Clean Date:	01/01/1900	Shape:	C

Street:	E 38th Ave	Flow Control:	Not Controlled
City:	Hobart, IN	Year Renewed:	
Location:	Other	Tape/Media #:	
Purpose:	Not Known	Dia/Height:	10"
Use:	Sanitary	Material:	VCP
Drain Area:	NA	Lining:	
Category:	NA		
Comment:	6 inch

Location Details:		Direction of Survey:	Downstream
US MH:	M-203-054	DS MH:	M-203-055
		Total Length Surveyed (ft):	79.0

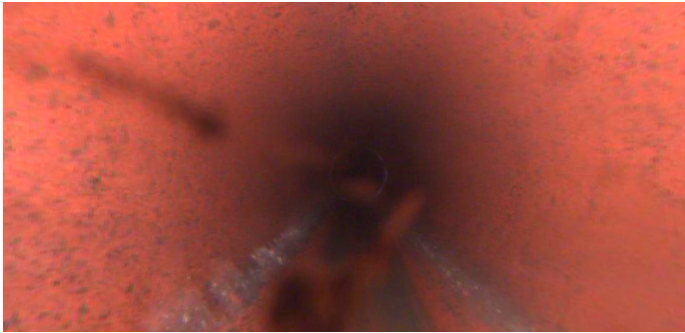
Code:	MWL
Description:	Water Level

Distance (ft):	.0
Structural Grade:	0
O&M Grade:	0
Clock Start/From:	
Clock To:	
1st Value:	
2nd Value:	
Value Percent:	5.000
Continuous Index:	
Within 8" of Joint:	NO
Remarks:

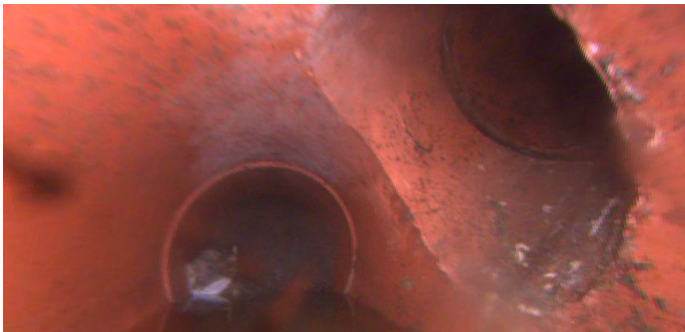
Code:	TF
Description:	Tap Factory

Distance (ft):	77.5
Structural Grade:	0
O&M Grade:	0
Clock Start/From:	2
Clock To:	
1st Value:	4.000
2nd Value:	
Value Percent:	
Continuous Index:	
Within 8" of Joint:	YES
Remarks:

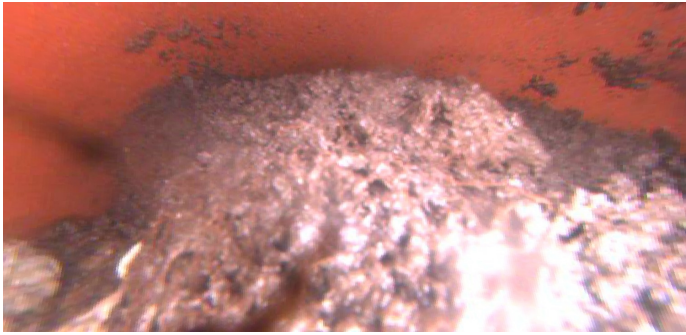
Code: **RBB**
Description: **Roots Ball Barrel**

Distance (ft): **78.9**
Structural Grade: **0**
O&M Grade: **5**
Clock Start/From: **12**
Clock To: **12**
1st Value:
2nd Value:
Value Percent: **100.000**
Continuous Index:
Within 8" of Joint: **NO**
Remarks:

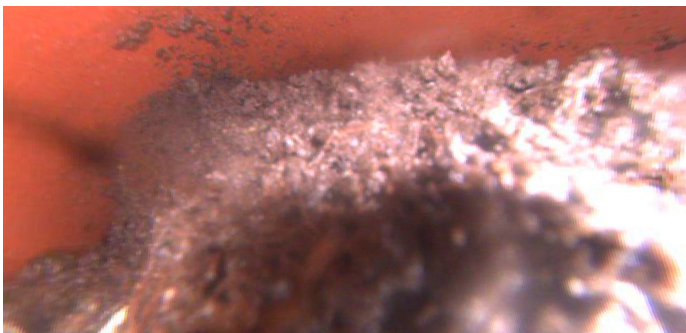
Code: **MSA**
Description: **Abandoned Survey**

Distance (ft): **79.0**
Structural Grade: **0**
O&M Grade: **0**
Clock Start/From:
Clock To:
1st Value:
2nd Value:
Value Percent:
Continuous Index:
Within 8" of Joint: **NO**
Remarks: **rbb**
