Profile/Photo Observation Report

Location Details:		Direction of Survey:	Downstream
US MH:	M-203-058	DS MH:	M-203-059
		Total Length Surveyed (ft):	86.2

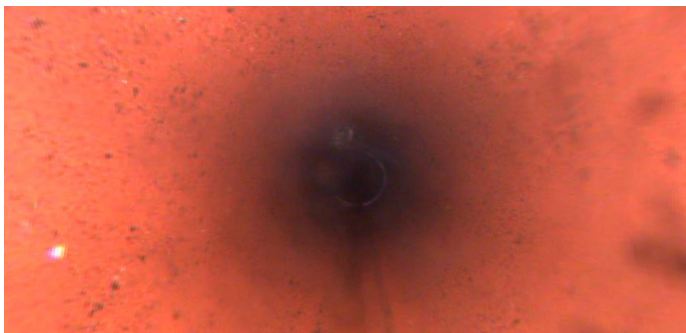
Code: **AMH**
Description: **Manhole**

Distance (ft): **.0**
Structural Grade: **0**
O&M Grade: **0**
Clock Start/From:
Clock To:
1st Value:
2nd Value:
Value Percent:
Continuous Index:
Within 8" of Joint: **NO**
Remarks: **M-203-058**

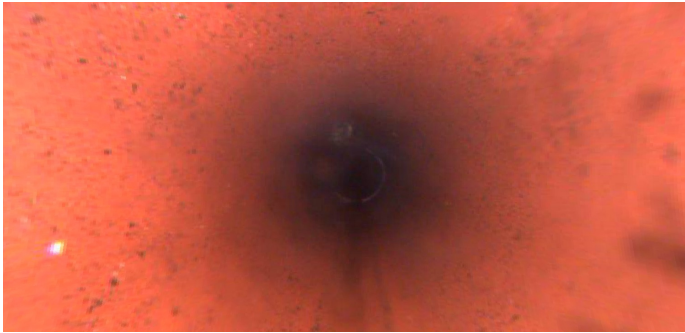
Code:	MWL
Description:	Water Level

Distance (ft):	.0
Structural Grade:	0
O&M Grade:	0
Clock Start/From:	
Clock To:	
1st Value:	
2nd Value:	
Value Percent:	5.000
Continuous Index:	
Within 8" of Joint:	NO
Remarks:

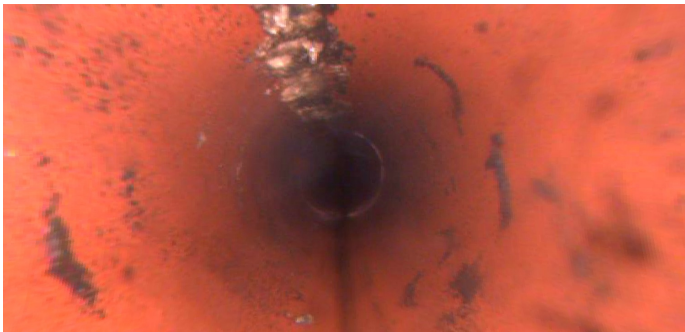
Code:	DAGS
Description:	Deposits Attached Grease

Distance (ft):	2.5
Structural Grade:	0
O&M Grade:	2
Clock Start/From:	12
Clock To:	
1st Value:	
2nd Value:	
Value Percent:	5.000
Continuous Index:	S01
Within 8" of Joint:	NO
Remarks:	wandering

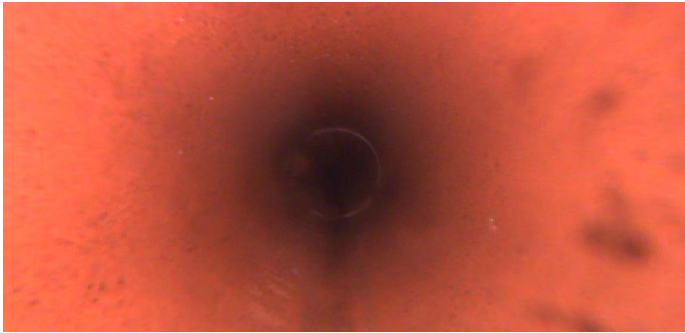
Code: **DAGS**
Description: **Deposits Attached Grease**

Distance (ft): **7.4**
Structural Grade: **0**
O&M Grade: **2**
Clock Start/From: **12**
Clock To:
1st Value:
2nd Value:
Value Percent: **5.000**
Continuous Index: **F01**
Within 8" of Joint: **NO**
Remarks: **wandering**

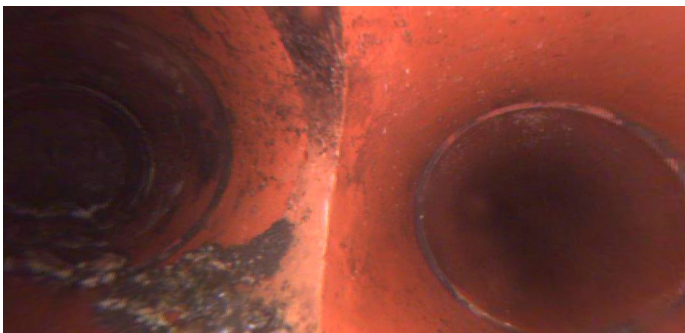
Code: **TF**
Description: **Tap Factory**

Distance (ft): **35.2**
Structural Grade: **0**
O&M Grade: **0**
Clock Start/From: **9**
Clock To:
1st Value: **4.000**
2nd Value:
Value Percent:
Continuous Index:
Within 8" of Joint: **YES**
Remarks:

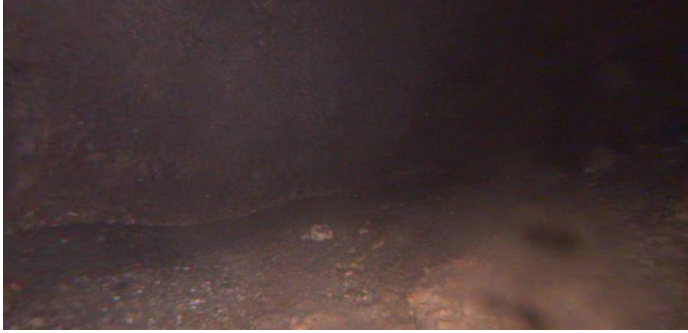
Code:	AMH
Description:	Manhole
Distance (ft):	86.2
Structural Grade:	0
O&M Grade:	0
Clock Start/From:	
Clock To:	
1st Value:	
2nd Value:	
Value Percent:	
Continuous Index:	
Within 8" of Joint:	NO
Remarks:	M-203-059
