Profile/Photo Observation Report

Street:	W 38TH AVE	Flow Control:	Not Controlled
City:	Hobart, IN	Year Renewed:	
Location:	Other	Tape/Media #:	
Purpose:	Not Known	Dia/Height:	12"
Use:	Sanitary	Material:	VCP
Drain Area:	NA	Lining:	
Category:	NA		
Comment:

Location Details:		Direction of Survey:	Downstream
US MH:	M-203-060	DS MH:	M-203-051
		Total Length Surveyed (ft):	10.5

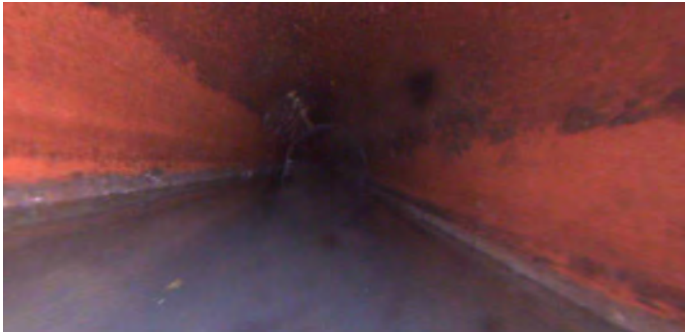
Code:	MWL
Description:	Water Level

Distance (ft):	.0
Structural Grade:	0
O&M Grade:	0
Clock Start/From:	
Clock To:	
1st Value:	
2nd Value:	
Value Percent:	30.000
Continuous Index:	
Within 8" of Joint:	NO
Remarks:

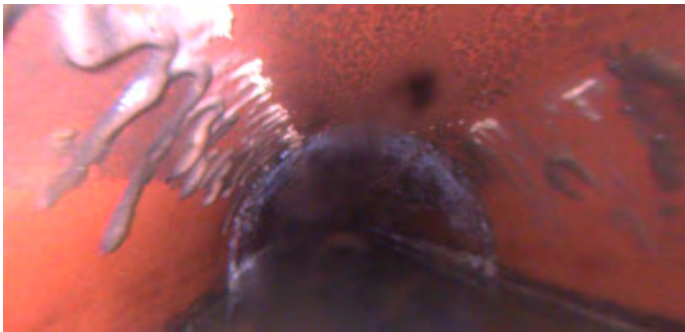
Code:	DAGS
Description:	Deposits Attached Grease

Distance (ft):	3.5
Structural Grade:	0
O&M Grade:	2
Clock Start/From:	8
Clock To:	4
1st Value:	
2nd Value:	
Value Percent:	5.000
Continuous Index:	
Within 8" of Joint:	NO
Remarks:

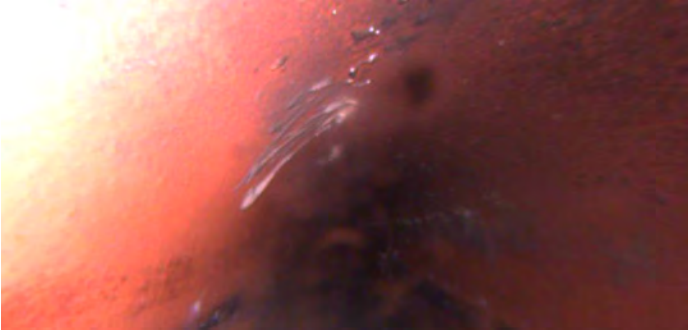
Code:	MSA
Description:	Abandoned Survey
Distance (ft):	10.5
Structural Grade:	0
O&M Grade:	0
Clock Start/From:	
Clock To:	
1st Value:	
2nd Value:	
Value Percent:	
Continuous Index:	
Within 8" of Joint:	NO
Remarks:	UNKNOWN
