Profile/Photo Observation Report

Date:	03/24/2018	Weather:		Coding:	PACP 6.0
Pipe Length (ft):	328.8	Owner:	NA	Pre Clean:	Not Known
P.O.#:		Surveyor:	Byrd Fitzgerald	PSR:	P-203-051-060
Customer:		Clean Date:	01/01/1900	Shape:	C

Location Details:		Direction of Survey:	Upstream
US MH:	M-203-060	DS MH:	M-203-051
		Total Length Surveyed (ft):	39.3

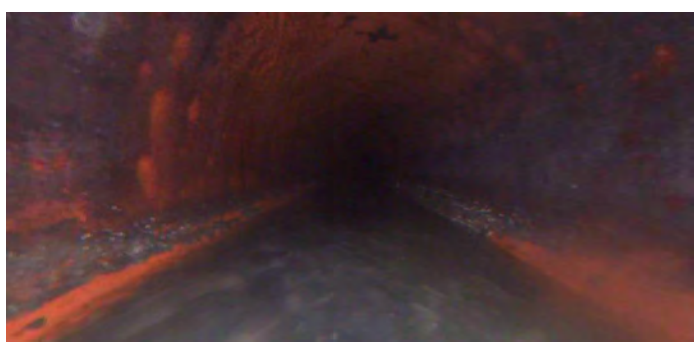
Code: **AMH**
Description: **Manhole**

Distance (ft): **.0**
Structural Grade: **0**
O&M Grade: **0**
Clock Start/From:
Clock To:
1st Value:
2nd Value:
Value Percent:
Continuous Index:
Within 8" of Joint: **NO**
Remarks: **M-203-051**

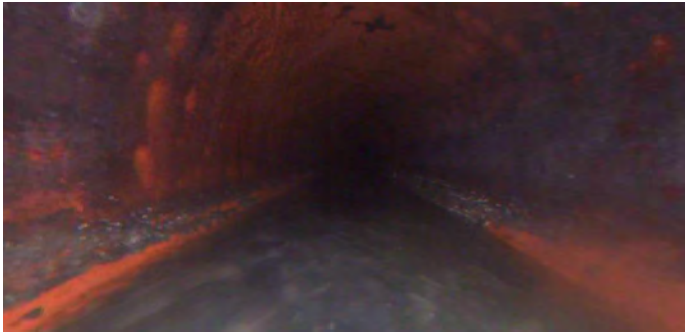
Code:	MWL
Description:	Water Level

Distance (ft):	.0
Structural Grade:	0
O&M Grade:	0
Clock Start/From:	
Clock To:	
1st Value:	
2nd Value:	
Value Percent:	5.000
Continuous Index:	
Within 8" of Joint:	NO
Remarks:

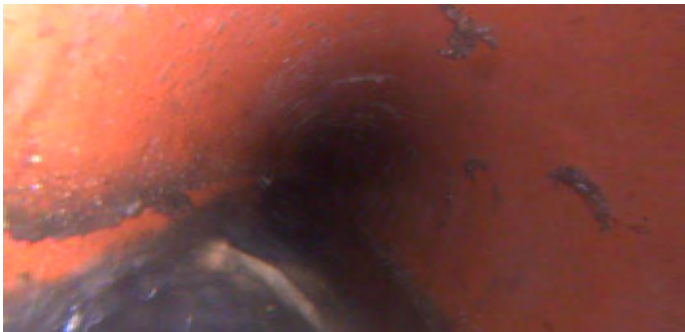
Code:	MSA
Description:	Abandoned Survey

Distance (ft):	39.3
Structural Grade:	0
O&M Grade:	0
Clock Start/From:	
Clock To:	
1st Value:	
2nd Value:	
Value Percent:	
Continuous Index:	
Within 8" of Joint:	NO
Remarks:	camera flipped
