Profile/Photo Observation Report

Street:	ALLEY BETWEEN SANDUSKY ST & CO	Flow Control:	Not Controlled
City:	Hobart, IN	Year Renewed:	
Location:	Other	Tape/Media #:	
Purpose:	Not Known	Dia/Height:	8"
Use:	Sanitary	Material:	PVC
Drain Area:	NA	Lining:	
Category:	NA		
Comment:

Location Details:		Direction of Survey:	Downstream
US MH:	M-203-063	DS MH:	M-203-062
		Total Length Surveyed (ft):	76.5

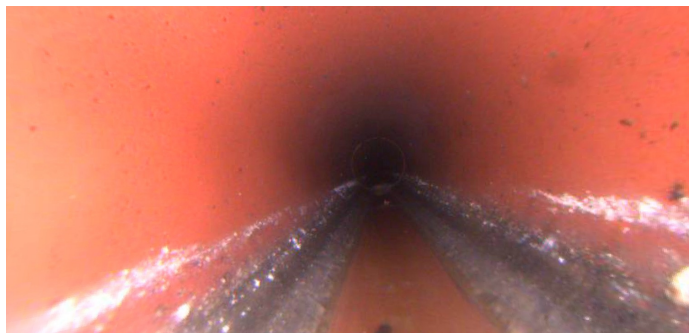
Code: **AMH**
Description: **Manhole**

Distance (ft): **.0**
Structural Grade: **0**
O&M Grade: **0**
Clock Start/From:
Clock To:
1st Value:
2nd Value:
Value Percent:
Continuous Index:
Within 8" of Joint: **NO**
Remarks: **M-203-063**

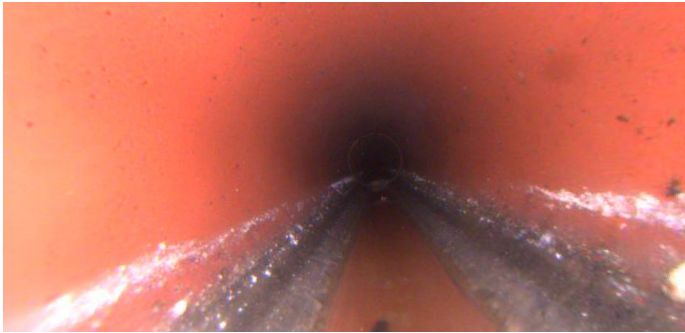
Code:	MWL
Description:	Water Level

Distance (ft):	.0
Structural Grade:	0
O&M Grade:	0
Clock Start/From:	
Clock To:	
1st Value:	
2nd Value:	
Value Percent:	5.000
Continuous Index:	
Within 8" of Joint:	NO
Remarks:

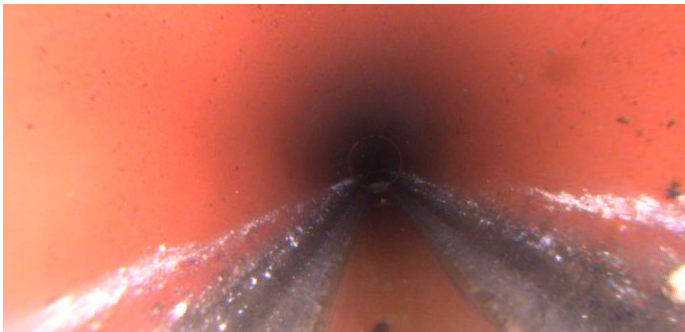
Code:	DAGS
Description:	Deposits Attached Grease

Distance (ft):	.0
Structural Grade:	0
O&M Grade:	2
Clock Start/From:	7
Clock To:	5
1st Value:	
2nd Value:	
Value Percent:	5.000
Continuous Index:	S01
Within 8" of Joint:	NO
Remarks:

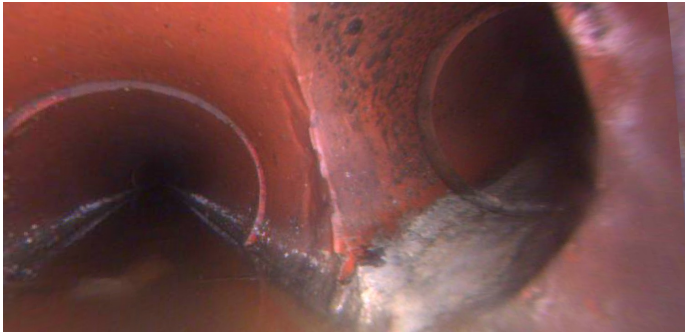
Code: **TFA**
Description: **Tap Factory Active**

Distance (ft): **6.5**
Structural Grade: **0**
O&M Grade: **0**
Clock Start/From: **3**
Clock To:
1st Value: **4.000**
2nd Value:
Value Percent:
Continuous Index:
Within 8" of Joint:
Remarks:

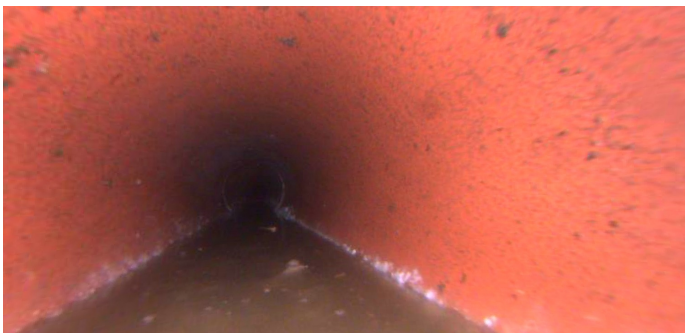
Code: **DAGS**
Description: **Deposits Attached Grease**

Distance (ft): **33.7**
Structural Grade: **0**
O&M Grade: **2**
Clock Start/From: **7**
Clock To: **5**
1st Value:
2nd Value:
Value Percent: **5.000**
Continuous Index: **F01**
Within 8" of Joint: **NO**
Remarks:

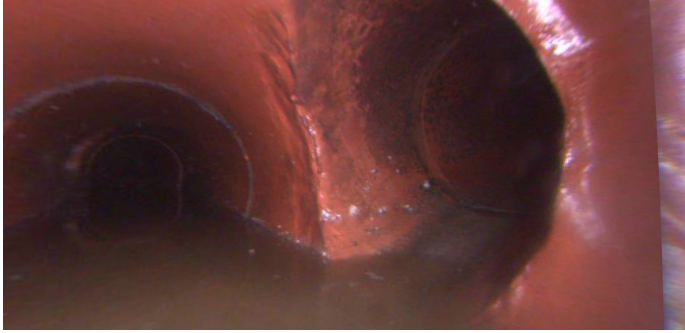
Code: **TFA**
Description: **Tap Factory Active**

Distance (ft): **62.8**
Structural Grade: **0**
O&M Grade: **0**
Clock Start/From: **3**
Clock To:
1st Value: **4.000**
2nd Value:
Value Percent:
Continuous Index:
Within 8" of Joint:
Remarks:

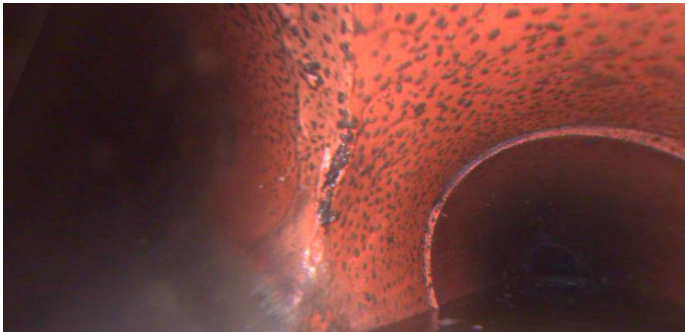
Code: **TFA**
Description: **Tap Factory Active**

Distance (ft): **65.1**
Structural Grade: **0**
O&M Grade: **0**
Clock Start/From: **9**
Clock To:
1st Value: **4.000**
2nd Value:
Value Percent:
Continuous Index:
Within 8" of Joint:
Remarks:

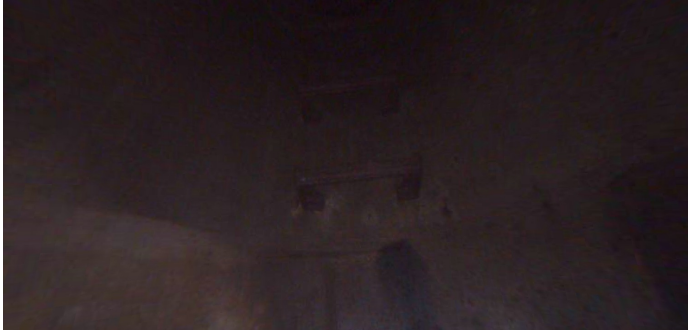
Code:	AMH
Description:	Manhole
Distance (ft):	76.5
Structural Grade:	0
O&M Grade:	0
Clock Start/From:	
Clock To:	
1st Value:	
2nd Value:	
Value Percent:	
Continuous Index:	
Within 8" of Joint:	NO
Remarks:	M-203-062
