Profile/Photo Observation Report

| Street: | E 38th Ave | Flow Control: | Not Controlled |

| US MH: | M-203-063 | DS MH: | M-203-062 |

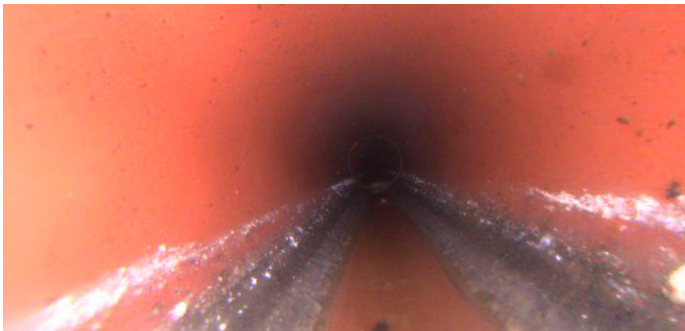
Code: **AMH**
Description: **Manhole**

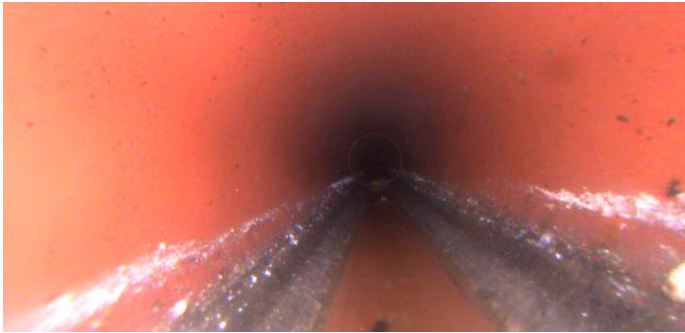
| Code: | MWL |
| Description: | Water Level |

| Value Percent: | 5.000 |

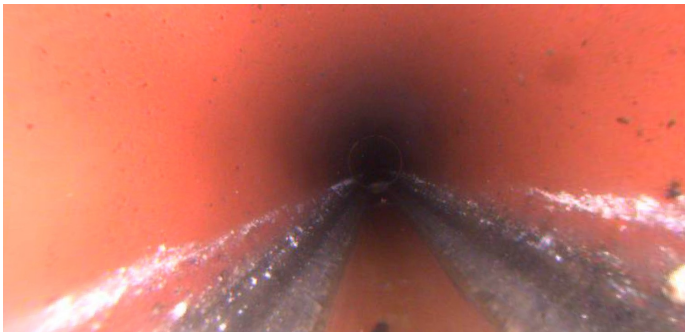
| Code: | DAGS |
| Description: | Deposits Attached Grease |

| Distance (ft): | .0 |
| O&M Grade: | 2 |
| Clock Start/From: | 7 |
| Clock To: | 5 |
| Value Percent: | 5.000 |

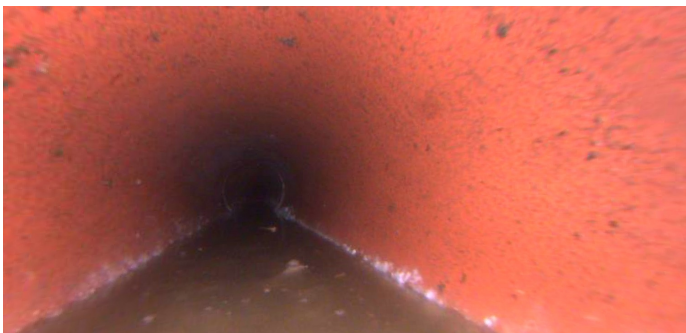
Code: **DAGS**
Description: **Deposits Attached Grease**

Distance (ft): **33.7**
Structural Grade: **0**
O&M Grade: **2**
Clock Start/From: **7**
Clock To: **5**
1st Value:
2nd Value:
Value Percent: **5.000**
Continuous Index: **F01**
Within 8" of Joint: **NO**
Remarks:

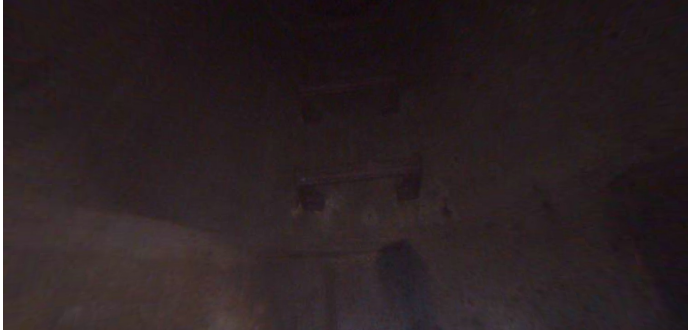
| Code: | AMH |
| Description: | Manhole |
| Distance (ft): | 76.5 |
| Remarks: | M-203-062 |
