## Profile/Photo Observation Report

Street:	<b>ALLEY BETWEEN SANDUSKY ST &amp; CO</b>	Flow Control:	<b>Not Controlled</b>
City:	<b>Hobart, IN</b>	Year Renewed:	
Location:	<b>Other</b>	Tape/Media #:	
Purpose:	<b>Not Known</b>	Dia/Height:	<b>8"</b>
Use:	<b>Sanitary</b>	Material:	<b>VCP</b>
Drain Area:	<b>NA</b>	Lining:	
Category:	<b>NA</b>		
Comment:

Location Details:		Direction of Survey:	<b>Downstream</b>
US MH:	<b>M-203-063</b>	DS MH:	<b>M-203-064</b>
		Total Length Surveyed (ft):	<b>73.7</b>

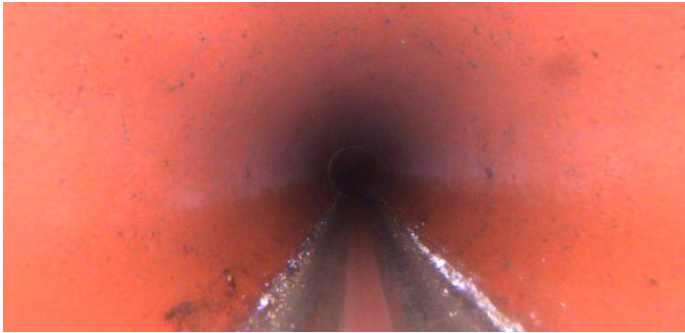
Code:	<b>MWL</b>
Description:	<b>Water Level</b>

Distance (ft):	<b>.0</b>
Structural Grade:	<b>0</b>
O&M Grade:	<b>0</b>
Clock Start/From:	
Clock To:	
1st Value:	
2nd Value:	
Value Percent:	<b>5.000</b>
Continuous Index:	
Within 8" of Joint:	<b>NO</b>
Remarks:

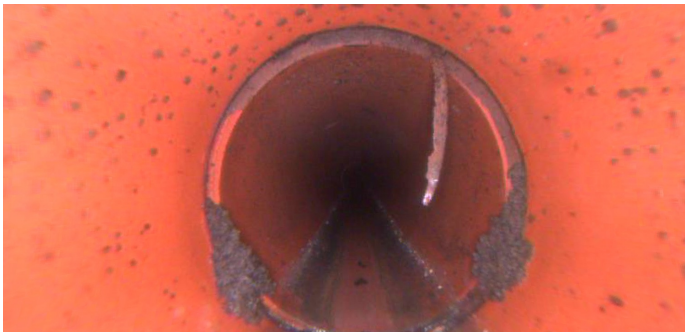
Code:	<b>DAZ</b>
Description:	<b>Deposits Attached Other</b>

Distance (ft):	<b>9.2</b>
Structural Grade:	<b>0</b>
O&M Grade:	<b>2</b>
Clock Start/From:	<b>8</b>
Clock To:	<b>4</b>
1st Value:	
2nd Value:	
Value Percent:	<b>5.000</b>
Continuous Index:	
Within 8" of Joint:	<b>YES</b>
Remarks:

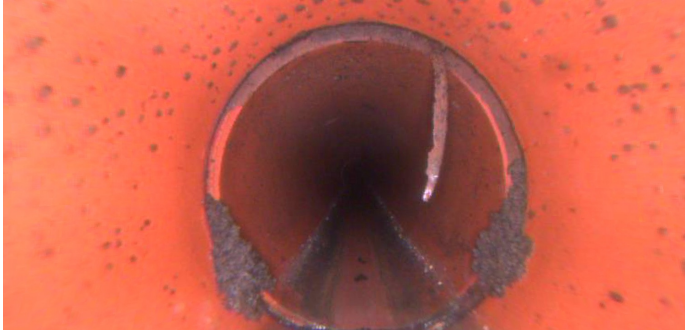
Code: **ISSRB**  
Description: **Intruding Sealing Ring Broken**

Distance (ft): **9.2**  
Structural Grade: **0**  
O&M Grade: **2**  
Clock Start/From: **12**  
Clock To: **1**  
1st Value:  
2nd Value:  
Value Percent: **5.000**  
Continuous Index:  
Within 8" of Joint: **NO**  
Remarks:

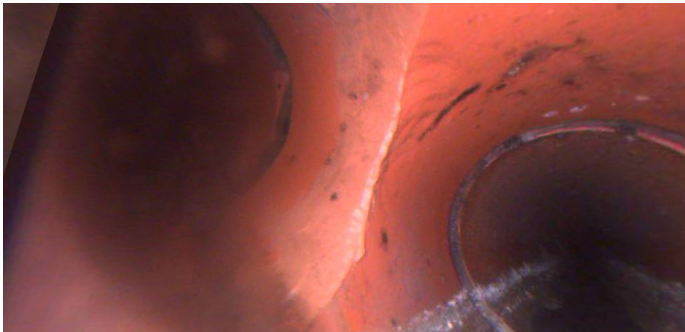
Code: **TF**  
Description: **Tap Factory**

Distance (ft): **36.6**  
Structural Grade: **0**  
O&M Grade: **0**  
Clock Start/From: **9**  
Clock To:  
1st Value: **4.000**  
2nd Value:  
Value Percent:  
Continuous Index:  
Within 8" of Joint:  
Remarks:

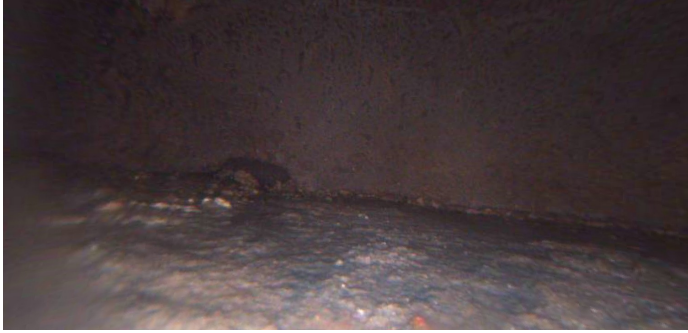
Code:	AMH
Description:	Manhole
Distance (ft):	73.7
Structural Grade:	0
O&M Grade:	0
Clock Start/From:	
Clock To:	
1st Value:	
2nd Value:	
Value Percent:	
Continuous Index:	
Within 8" of Joint:	NO
Remarks:	M-203-064
