Profile/Photo Observation Report

Street:	Off 37th Avenue	Flow Control:	
City:	Hobart, IN	Year Renewed:	
Location:	Easement/Right of Way	Tape/Media #:	802
Purpose:	Routine Assessment	Dia/Height:	10"
Use:	Sanitary	Material:	VCP
Drain Area:		Lining:	
Category:	NA		
Comment:

Location Details:		Direction of Survey:	Downstream
US MH:	M-203-67	DS MH:	M-203-65
		Total Length Surveyed (ft):	242.5

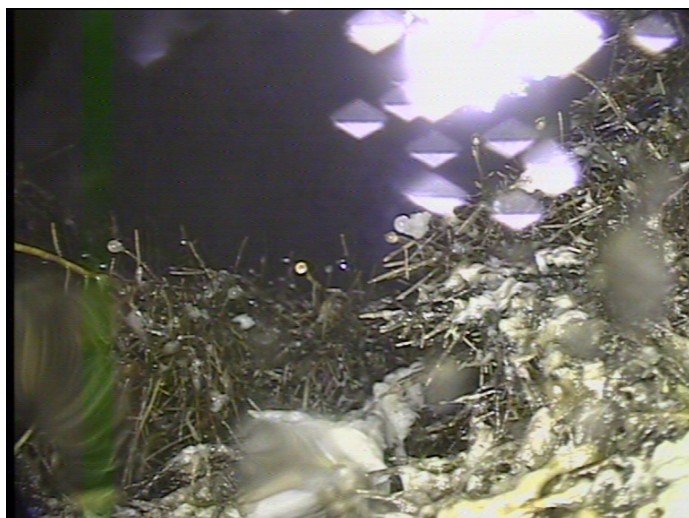
Code: **AMH**
Description: **Manhole**

Distance (ft): **.0**
Structural Grade: **0**
O&M Grade: **0**
Clock Start/From:
Clock To:
1st Value:
2nd Value:
Value Percent:
Continuous Index:
Within 8" of Joint: **NO**
Remarks: **M-203-67**

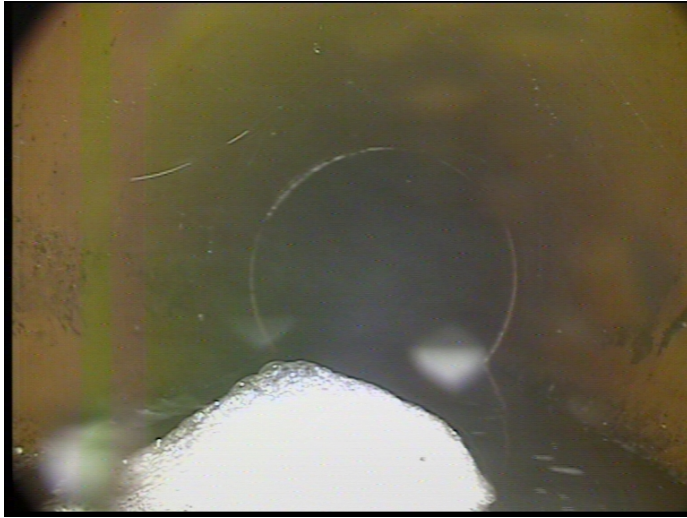
Code: **MWL**
Description: **Water Level**

Distance (ft): **.0**
Structural Grade: **0**
O&M Grade: **0**
Clock Start/From:
Clock To:
1st Value:
2nd Value:
Value Percent: **5.000**
Continuous Index:
Within 8" of Joint: **NO**
Remarks:

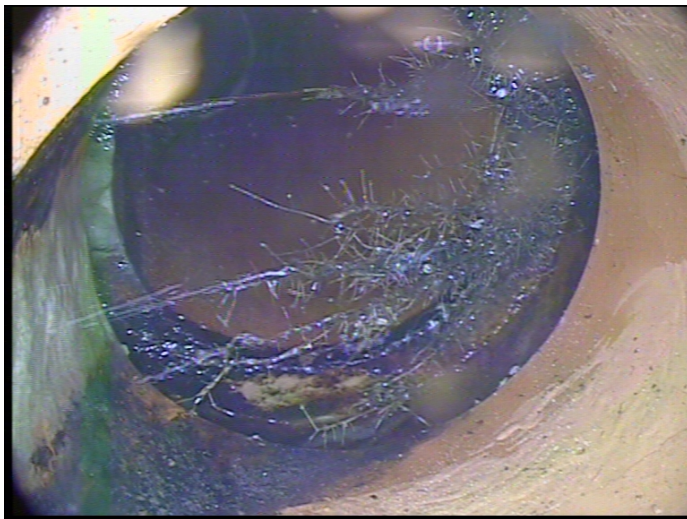
Code: **TFD**
Description: **Tap Factory Defective**

Distance (ft): **35.0**
Structural Grade: **0**
O&M Grade: **2**
Clock Start/From: **9**
Clock To:
1st Value: **4.000**
2nd Value:
Value Percent:
Continuous Index:
Within 8" of Joint: **NO**
Remarks: **roots and infiltration**

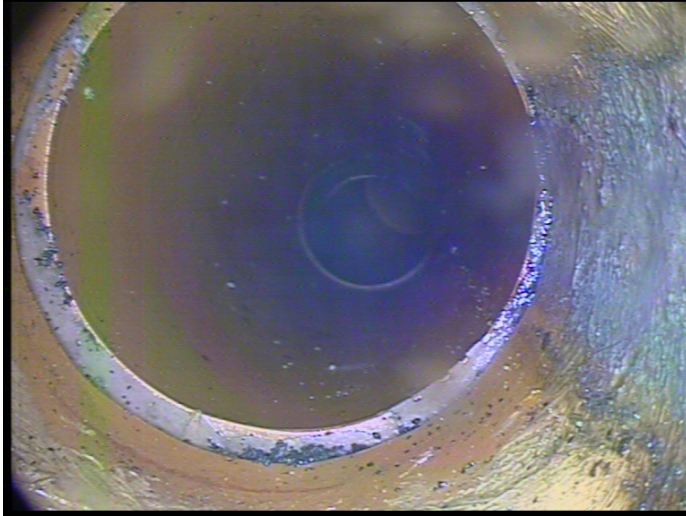
Code: **TF**
Description: **Tap Factory**

Distance (ft): **47.4**
Structural Grade: **0**
O&M Grade: **0**
Clock Start/From: **3**
Clock To:
1st Value: **4.000**
2nd Value:
Value Percent:
Continuous Index:
Within 8" of Joint: **NO**
Remarks:

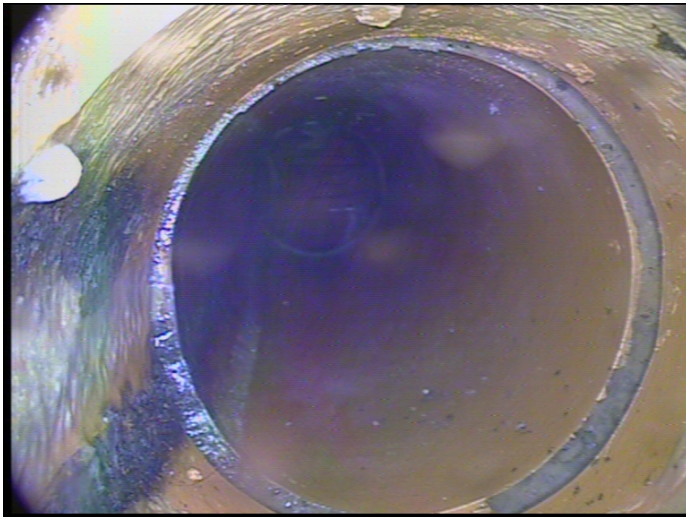
Code: **TFA**
Description: **Tap Factory Active**

Distance (ft): **94.4**
Structural Grade: **0**
O&M Grade: **0**
Clock Start/From: **10**
Clock To:
1st Value: **4.000**
2nd Value:
Value Percent:
Continuous Index:
Within 8" of Joint: **NO**
Remarks:

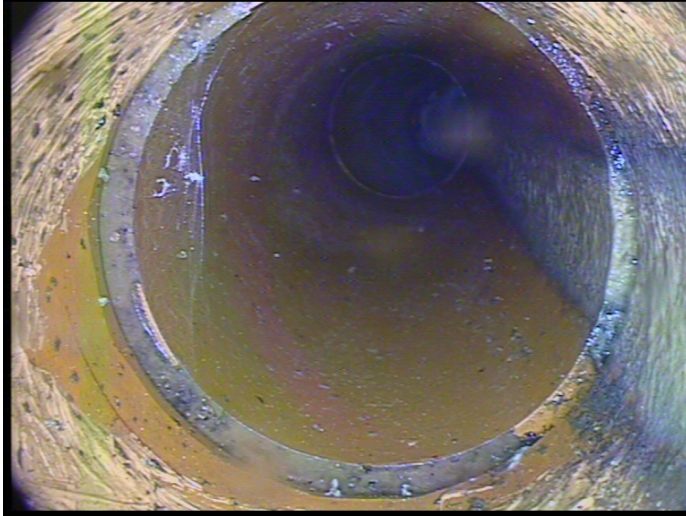
Code: **TF**
Description: **Tap Factory**

Distance (ft): **121.3**
Structural Grade: **0**
O&M Grade: **0**
Clock Start/From: **3**
Clock To:
1st Value: **4.000**
2nd Value:
Value Percent:
Continuous Index:
Within 8" of Joint: **NO**
Remarks:

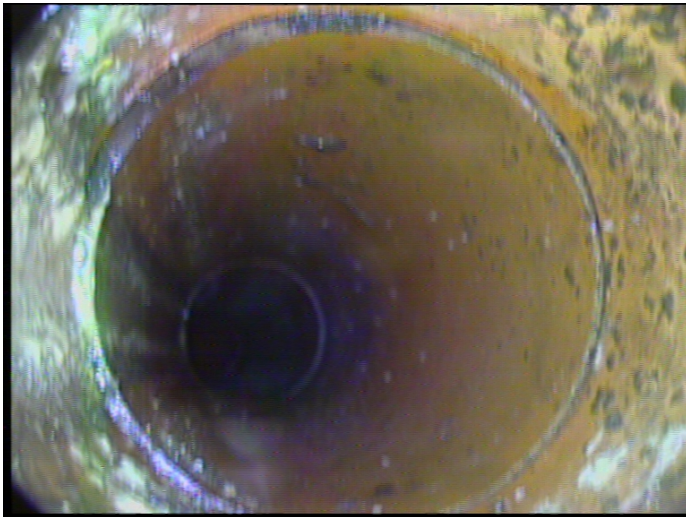
Code: **TF**
Description: **Tap Factory**

Distance (ft): **133.4**
Structural Grade: **0**
O&M Grade: **0**
Clock Start/From: **9**
Clock To:
1st Value: **4.000**
2nd Value:
Value Percent:
Continuous Index:
Within 8" of Joint: **NO**
Remarks:

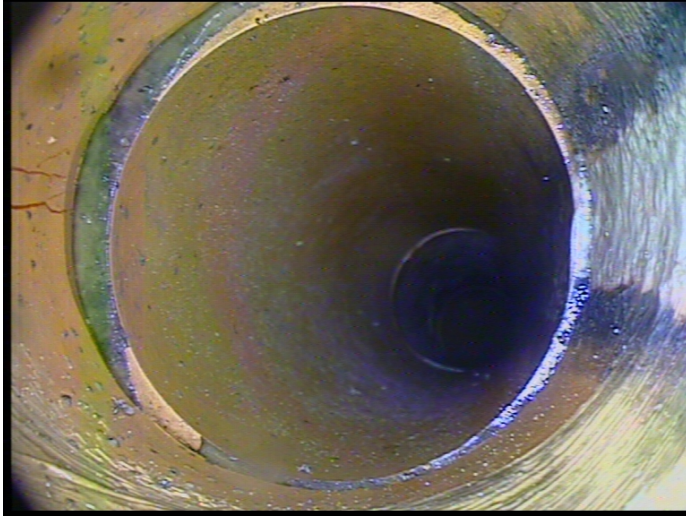
Code: **TF**
Description: **Tap Factory**

Distance (ft): **176.1**
Structural Grade: **0**
O&M Grade: **0**
Clock Start/From: **3**
Clock To:
1st Value: **4.000**
2nd Value:
Value Percent:
Continuous Index:
Within 8" of Joint: **NO**
Remarks:

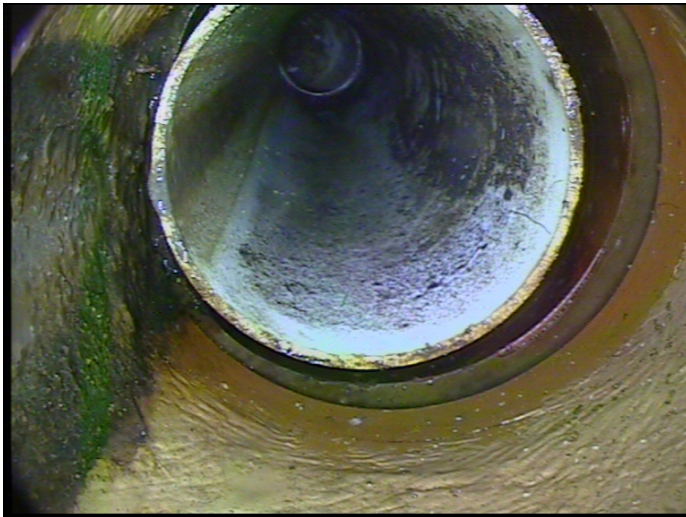
Code: **TB**
Description: **Tap Break-in**

Distance (ft): **198.3**
Structural Grade: **0**
O&M Grade: **0**
Clock Start/From: **10**
Clock To:
1st Value: **4.000**
2nd Value:
Value Percent:
Continuous Index:
Within 8" of Joint: **NO**
Remarks:

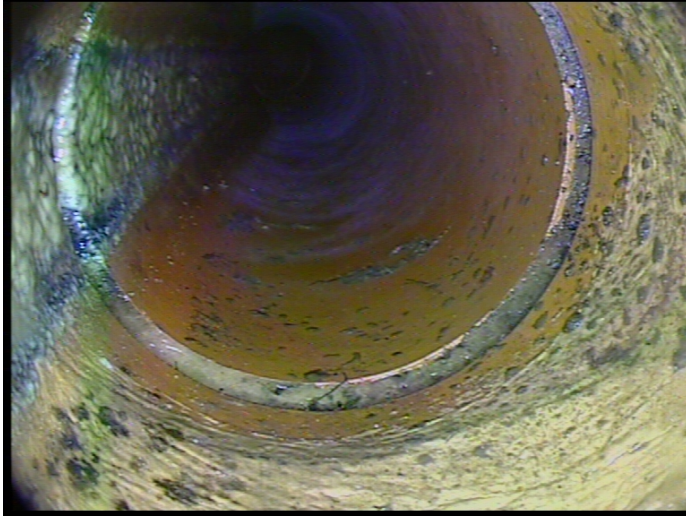
Code: **TF**
Description: **Tap Factory**

Distance (ft): **235.5**
Structural Grade: **0**
O&M Grade: **0**
Clock Start/From: **9**
Clock To:
1st Value: **4.000**
2nd Value:
Value Percent:
Continuous Index:
Within 8" of Joint: **NO**
Remarks:

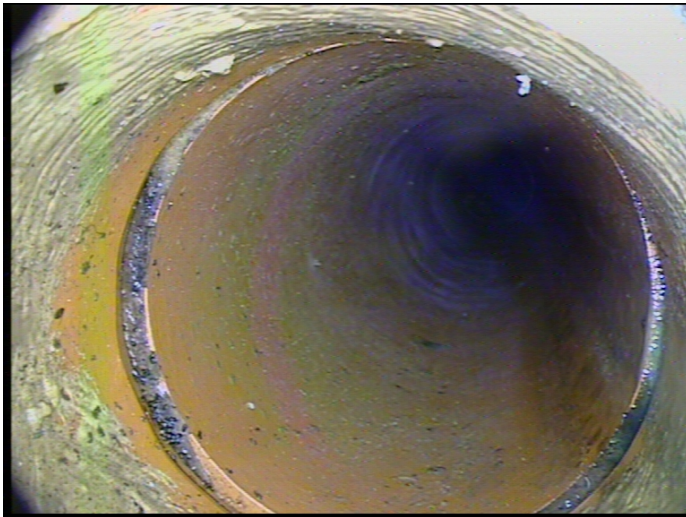
Code: **TF**
Description: **Tap Factory**

Distance (ft): **237.4**
Structural Grade: **0**
O&M Grade: **0**
Clock Start/From: **3**
Clock To:
1st Value: **4.000**
2nd Value:
Value Percent:
Continuous Index:
Within 8" of Joint: **NO**
Remarks:

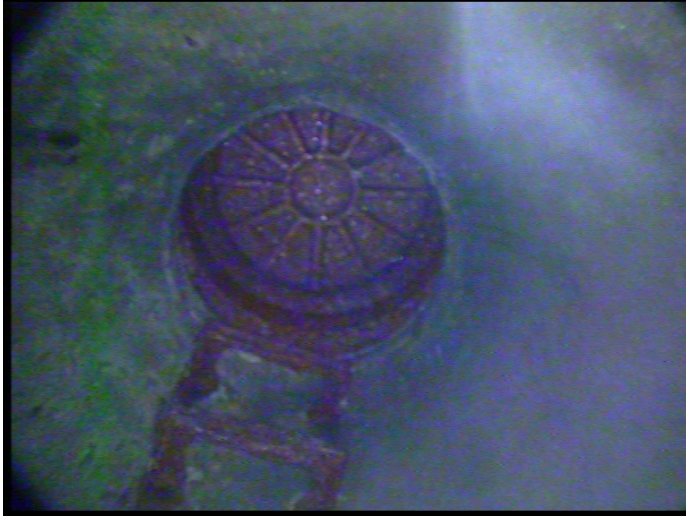
Code:	AMH
Description:	Manhole
Distance (ft):	242.5
Structural Grade:	0
O&M Grade:	0
Clock Start/From:	
Clock To:	
1st Value:	
2nd Value:	
Value Percent:	
Continuous Index:	
Within 8" of Joint:	NO
Remarks:	M-203-65
