## Profile/Photo Observation Report

Date:	<b>04/13/2018</b>	Weather:		Coding:	<b>PACP 6.0</b>
Pipe Length (ft):		Owner:	<b>City of Hobart</b>	Pre Clean:	<b>No Pre-Cleaning</b>
P.O.#:	<b>43-1</b>	Surveyor:	<b>M. Pielacha</b>	PSR:	<b>M-203-067-M-203-066</b>
Customer:	<b>City of Hobart</b>	Clean Date:		Shape:	<b>C</b>

Street:	<b>Off 37th Street</b>	Flow Control:	<b>Not Controlled</b>
City:	<b>Hobart, IN</b>	Year Renewed:	
Location:	<b>Light Highway</b>	Tape/Media #:	<b>DEP 43</b>
Purpose:	<b>Routine Assessment</b>	Dia/Height:	<b>8"</b>
Use:	<b>Sanitary</b>	Material:	<b>VCP</b>
Drain Area:		Lining:	
Category:	<b>NA</b>		
Comment:			
Location Details:		Direction of Survey:	<b>Downstream</b>
US MH:	<b>M-203-067</b>	DS MH:	<b>M-203-066</b>
		Total Length Surveyed (ft):	<b>5.2</b>

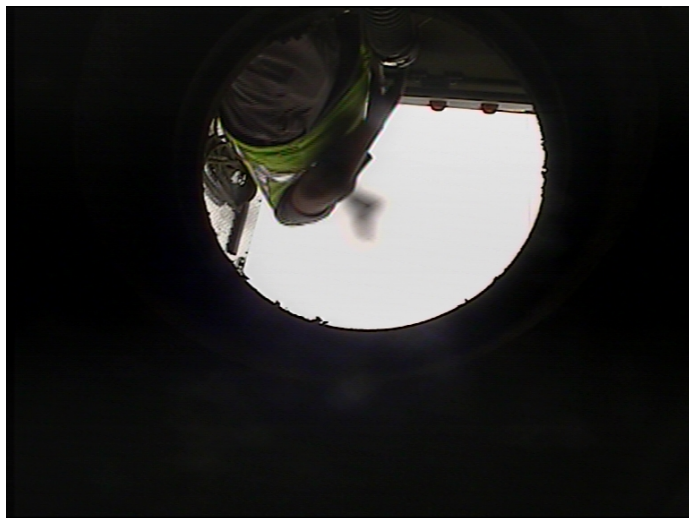
Code: **AMH**  
Description: **Manhole**

Distance (ft): **.0**  
Structural Grade: **0**  
O&M Grade: **0**  
Clock Start/From:  
Clock To:  
1st Value:  
2nd Value:  
Value Percent:  
Continuous Index:  
Within 8" of Joint: **NO**  
Remarks: **M-203-067**

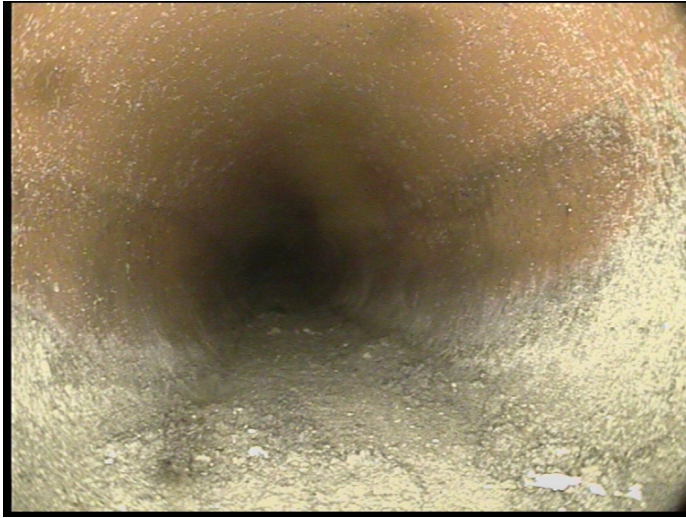
Code: **MWL**  
Description: **Water Level**

Distance (ft): **.0**  
Structural Grade: **0**  
O&M Grade: **0**  
Clock Start/From:  
Clock To:  
1st Value:  
2nd Value:  
Value Percent: **0.000**  
Continuous Index:  
Within 8" of Joint: **NO**  
Remarks:

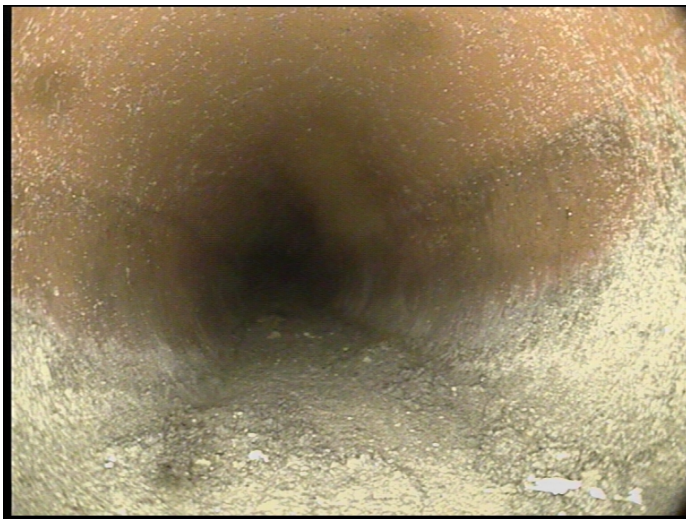
Code: **DSF**  
Description: **Deposits Settled Fine**

Distance (ft): **.0**  
Structural Grade: **0**  
O&M Grade: **2**  
Clock Start/From: **5**  
Clock To: **7**  
1st Value:  
2nd Value:  
Value Percent: **10.000**  
Continuous Index: **S01**  
Within 8" of Joint: **YES**  
Remarks:

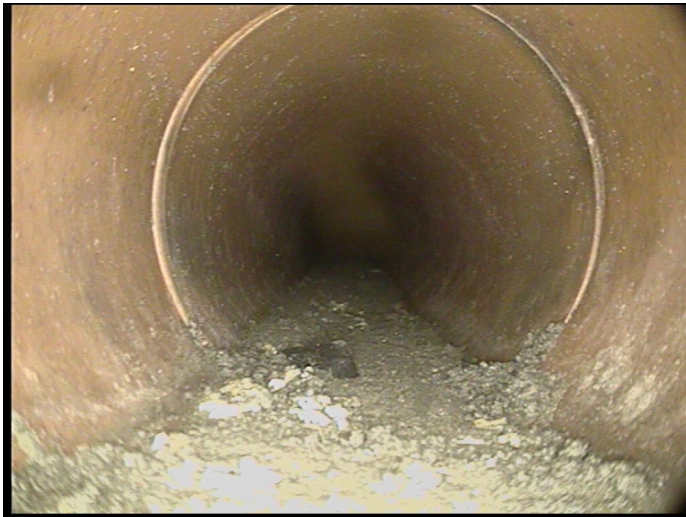
Code: **DSF**  
Description: **Deposits Settled Fine**

Distance (ft): **4.6**  
Structural Grade: **0**  
O&M Grade: **3**  
Clock Start/From: **5**  
Clock To: **7**  
1st Value:  
2nd Value:  
Value Percent: **15.000**  
Continuous Index: **F01**  
Within 8" of Joint: **NO**  
Remarks:

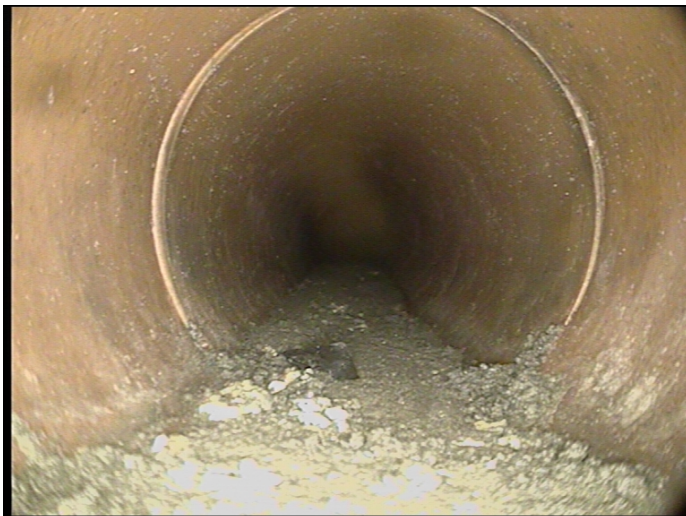
Code: **MSA**  
Description: **Abandoned Survey**

Distance (ft): **4.6**  
Structural Grade: **0**  
O&M Grade: **0**  
Clock Start/From:  
Clock To:  
1st Value:  
2nd Value:  
Value Percent:  
Continuous Index:  
Within 8" of Joint: **NO**  
Remarks: **sediment**
