Profile/Photo Observation Report

Street:	16TH ST	Flow Control:	Not Controlled
City:	Hobart, IN	Year Renewed:	
Location:	Light Highway	Tape/Media #:	
Purpose:	Routine Assessment	Dia/Height:	8"
Use:	Sanitary	Material:	VCP
Drain Area:	NA	Lining:	
Category:	NA		
Comment:	R_M at 54 ft build up at a joint . Flow direction wrong		
Location Details:		Direction of Survey:	Upstream
US MH:	M-208-007	DS MH:	M-208-008
		Total Length Surveyed (ft):	55.4

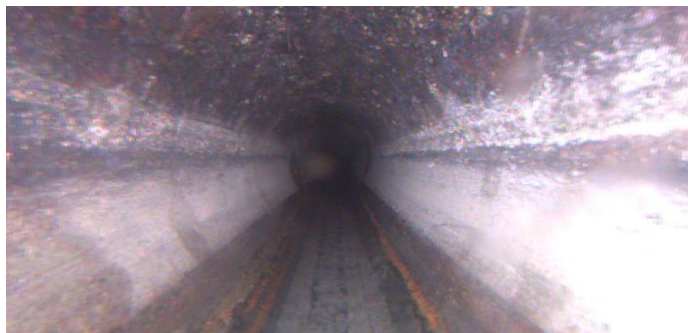
Code: **AMH**
Description: **Manhole**

Distance (ft): **.0**
Structural Grade: **0**
O&M Grade: **0**
Clock Start/From:
Clock To:
1st Value:
2nd Value:
Value Percent:
Continuous Index:
Within 8" of Joint: **NO**
Remarks: **M-208-008**

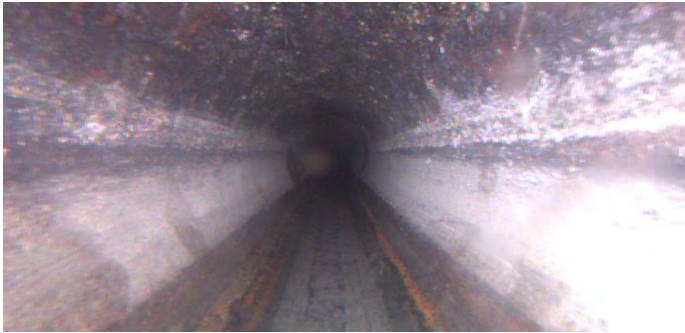
Code:	MWL
Description:	Water Level

Distance (ft):	.0
Structural Grade:	0
O&M Grade:	0
Clock Start/From:	
Clock To:	
1st Value:	
2nd Value:	
Value Percent:	5.000
Continuous Index:	
Within 8" of Joint:	NO
Remarks:

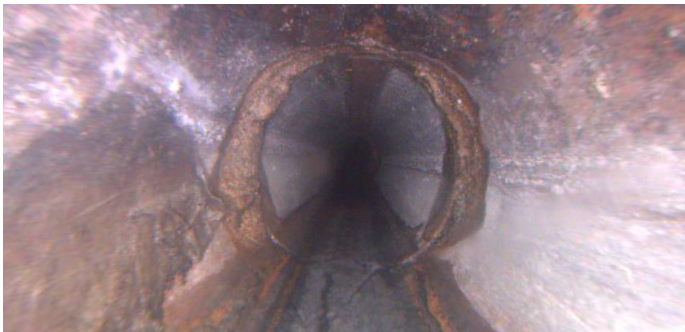
Code:	DAE
Description:	Deposits Attached Encrustation

Distance (ft):	3.1
Structural Grade:	0
O&M Grade:	2
Clock Start/From:	8
Clock To:	4
1st Value:	
2nd Value:	
Value Percent:	5.000
Continuous Index:	
Within 8" of Joint:	YES
Remarks:

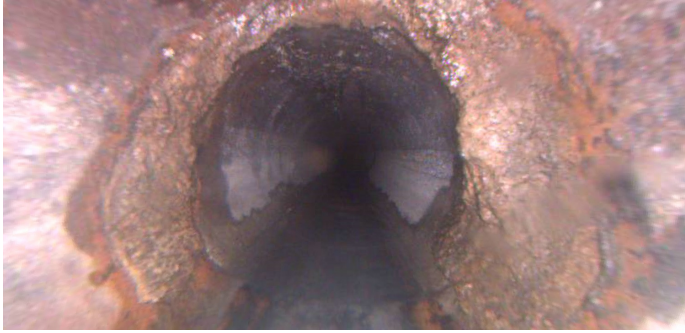
Code: **DAE**
Description: **Deposits Attached Encrustation**

Distance (ft): **6.2**
Structural Grade: **0**
O&M Grade: **2**
Clock Start/From: **8**
Clock To: **4**
1st Value:
2nd Value:
Value Percent: **10.000**
Continuous Index: **S01**
Within 8" of Joint: **NO**
Remarks:

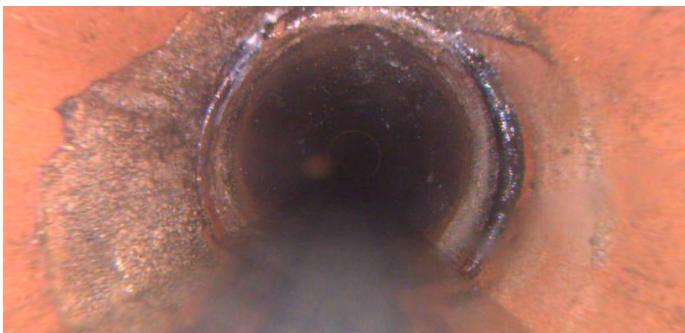
Code: **IW**
Description: **Infil Weeper**

Distance (ft): **24.1**
Structural Grade: **0**
O&M Grade: **2**
Clock Start/From: **8**
Clock To: **4**
1st Value:
2nd Value:
Value Percent:
Continuous Index:
Within 8" of Joint: **YES**
Remarks:

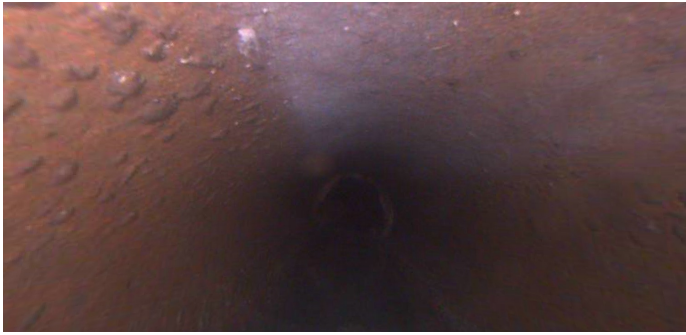
Code: **DAE**
Description: **Deposits Attached Encrustation**

Distance (ft): **55.4**
Structural Grade: **0**
O&M Grade: **2**
Clock Start/From: **8**
Clock To: **4**
1st Value:
2nd Value:
Value Percent: **10.000**
Continuous Index: **F01**
Within 8" of Joint: **NO**
Remarks:

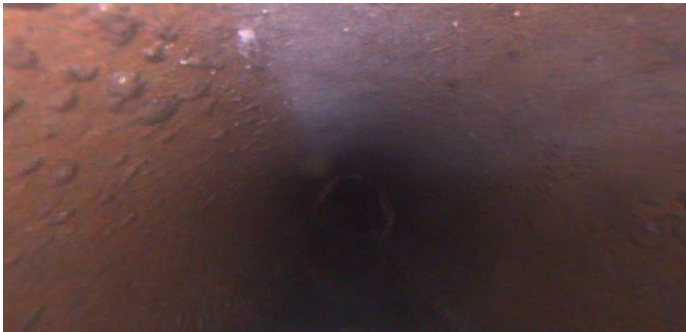
Code: **MSA**
Description: **Abandoned Survey**

Distance (ft): **55.4**
Structural Grade: **0**
O&M Grade: **0**
Clock Start/From:
Clock To:
1st Value:
2nd Value:
Value Percent:
Continuous Index:
Within 8" of Joint: **NO**
Remarks: **camera stopped**
