Profile/Photo Observation Report

Street:	FOXCROFT STREET	Flow Control:	Not Controlled
City:	Hobart, IN	Year Renewed:	
Location:	Light Highway	Tape/Media #:	
Purpose:	Routine Assessment	Dia/Height:	8"
Use:	Sanitary	Material:	VCP
Drain Area:	NA	Lining:	
Category:	NA		
Comment:	R_M at 54 ft build up at a joint . Flow direction wrong		
Location Details:		Direction of Survey:	Upstream
US MH:	M-208-007	DS MH:	M-208-008
		Total Length Surveyed (ft):	55.4

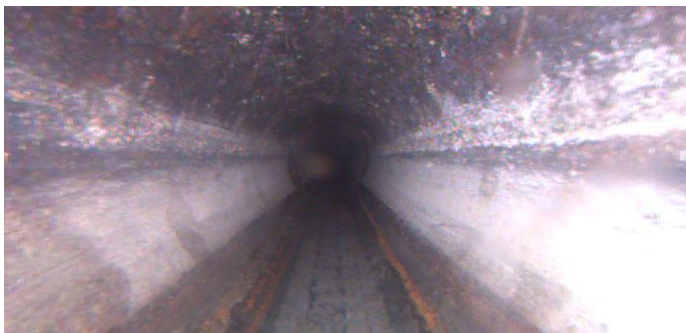
Code: **AMH**
Description: **Manhole**

Distance (ft): **.0**
Structural Grade: **0**
O&M Grade: **0**
Clock Start/From:
Clock To:
1st Value:
2nd Value:
Value Percent:
Continuous Index:
Within 8" of Joint: **NO**
Remarks: **M-208-008**

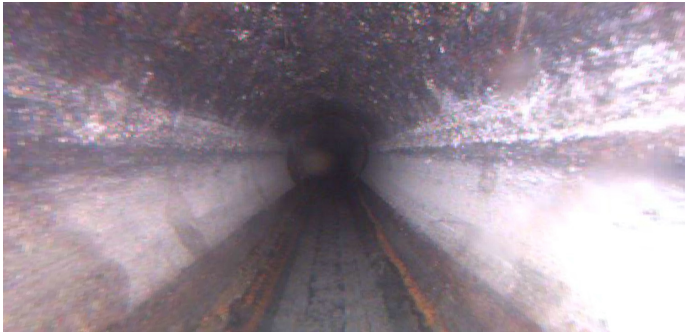
Code:	MWL
Description:	Water Level

Distance (ft):	.0
Structural Grade:	0
O&M Grade:	0
Clock Start/From:	
Clock To:	
1st Value:	
2nd Value:	
Value Percent:	5.000
Continuous Index:	
Within 8" of Joint:	NO
Remarks:

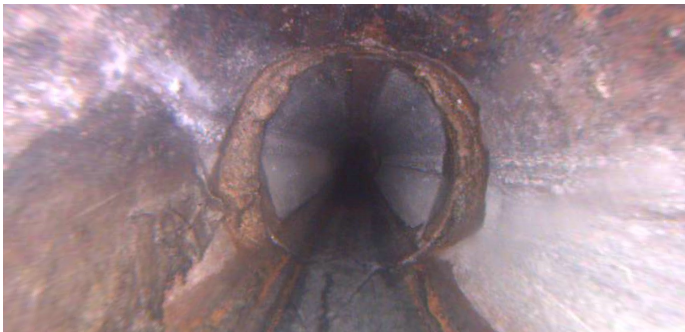
Code:	DAE
Description:	Deposits Attached Encrustation

Distance (ft):	3.1
Structural Grade:	0
O&M Grade:	2
Clock Start/From:	8
Clock To:	4
1st Value:	
2nd Value:	
Value Percent:	5.000
Continuous Index:	
Within 8" of Joint:	YES
Remarks:

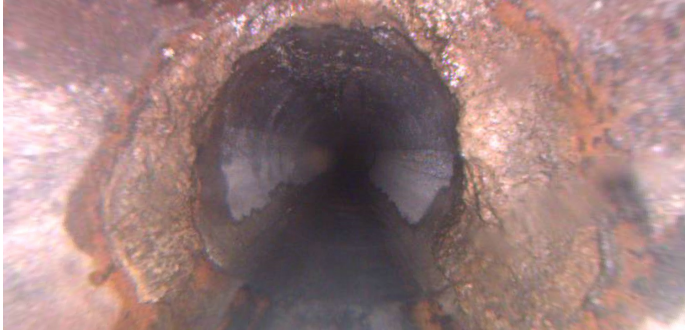
Code: **DAE**
Description: **Deposits Attached Encrustation**

Distance (ft): **6.2**
Structural Grade: **0**
O&M Grade: **2**
Clock Start/From: **8**
Clock To: **4**
1st Value:
2nd Value:
Value Percent: **10.000**
Continuous Index: **S01**
Within 8" of Joint: **NO**
Remarks:

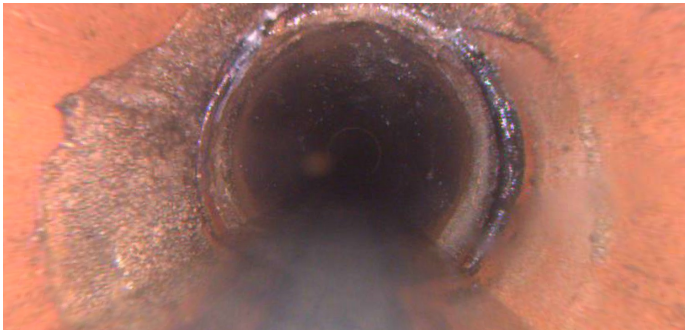
Code: **IW**
Description: **Infil Weeper**

Distance (ft): **24.1**
Structural Grade: **0**
O&M Grade: **2**
Clock Start/From: **8**
Clock To: **4**
1st Value:
2nd Value:
Value Percent:
Continuous Index:
Within 8" of Joint: **YES**
Remarks:

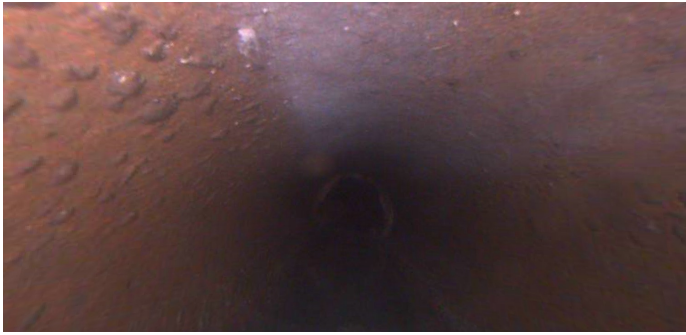
Code: **DAE**
Description: **Deposits Attached Encrustation**

Distance (ft): **55.4**
Structural Grade: **0**
O&M Grade: **2**
Clock Start/From: **8**
Clock To: **4**
1st Value:
2nd Value:
Value Percent: **10.000**
Continuous Index: **F01**
Within 8" of Joint: **NO**
Remarks:

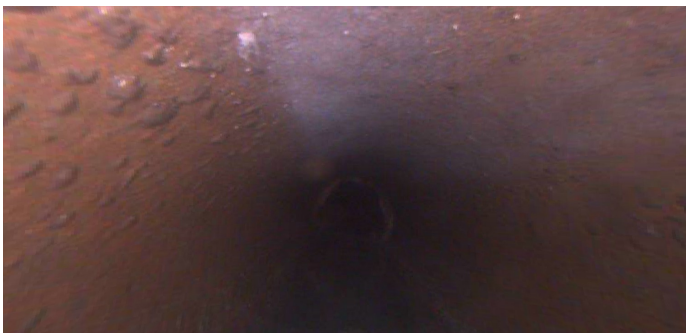
Code: **MSA**
Description: **Abandoned Survey**

Distance (ft): **55.4**
Structural Grade: **0**
O&M Grade: **0**
Clock Start/From:
Clock To:
1st Value:
2nd Value:
Value Percent:
Continuous Index:
Within 8" of Joint: **NO**
Remarks: **camera stopped**
