Profile/Photo Observation Report

Street:	16TH ST	Flow Control:	Not Controlled
City:	Hobart, IN	Year Renewed:	
Location:	Light Highway	Tape/Media #:	
Purpose:	Routine Assessment	Dia/Height:	12"
Use:	Sanitary	Material:	VCP
Drain Area:	NA	Lining:	
Category:	NA		
Comment:	P_C at 105 ft debris

Location Details:		Direction of Survey:	Downstream
US MH:	M-208-007	DS MH:	M-208-008
		Total Length Surveyed (ft):	106.2

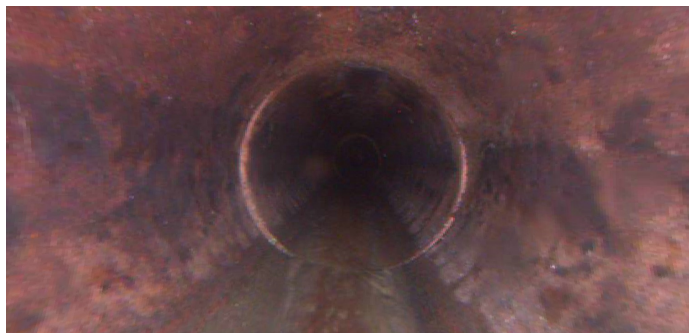
Code: **AMH**
 Description: **Manhole**
 Distance (ft): **.0**
 Structural Grade: **0**
 O&M Grade: **0**
 Clock Start/From:
 Clock To:
 1st Value:
 2nd Value:
 Value Percent:
 Continuous Index:
 Within 8" of Joint: **NO**
 Remarks: **M-208-007**

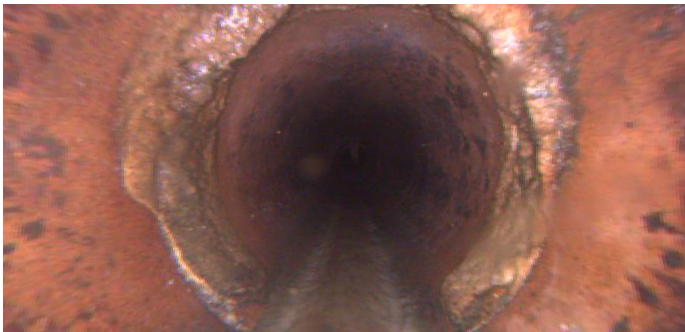
Code:	DAE
Description:	Deposits Attached Encrustation

Distance (ft):	4.5
Structural Grade:	0
O&M Grade:	2
Clock Start/From:	7
Clock To:	5
1st Value:	
2nd Value:	
Value Percent:	5.000
Continuous Index:	S01
Within 8" of Joint:	YES
Remarks:	WANDER

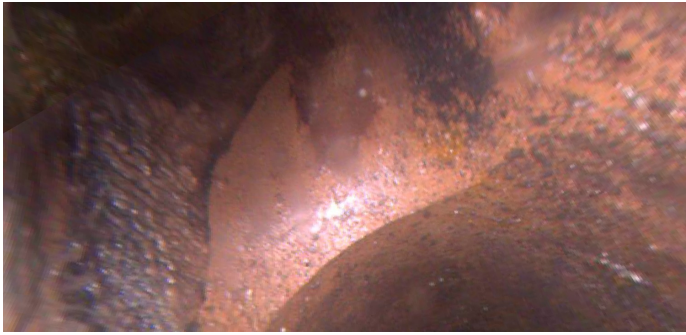
Code: **TF**
Description: **Tap Factory**

Distance (ft): **8.4**
Structural Grade: **0**
O&M Grade: **0**
Clock Start/From: **11**
Clock To:
1st Value: **4.000**
2nd Value:
Value Percent:
Continuous Index:
Within 8" of Joint:
Remarks:

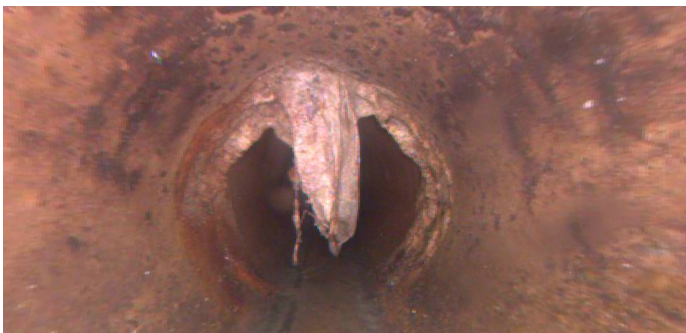
Code: **DAR**
Description: **Deposits Attached Ragging**

Distance (ft): **10.1**
Structural Grade: **0**
O&M Grade: **3**
Clock Start/From: **11**
Clock To: **1**
1st Value:
2nd Value:
Value Percent: **20.000**
Continuous Index:
Within 8" of Joint: **YES**
Remarks: **TOILET TISSUE**

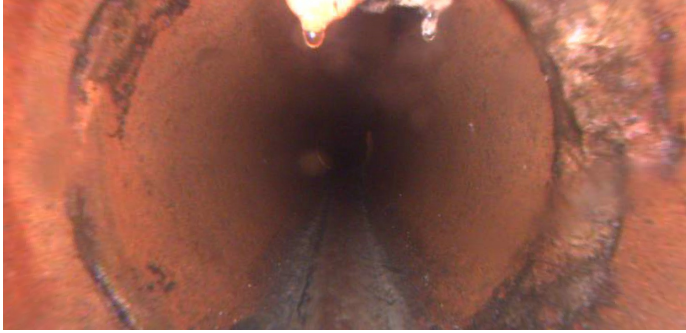
Code: ID
Description: Infil Dripper

Distance (ft): 22.6
Structural Grade: 0
O&M Grade: 3
Clock Start/From: 12
Clock To:
1st Value:
2nd Value:
Value Percent:
Continuous Index:
Within 8" of Joint: YES
Remarks:

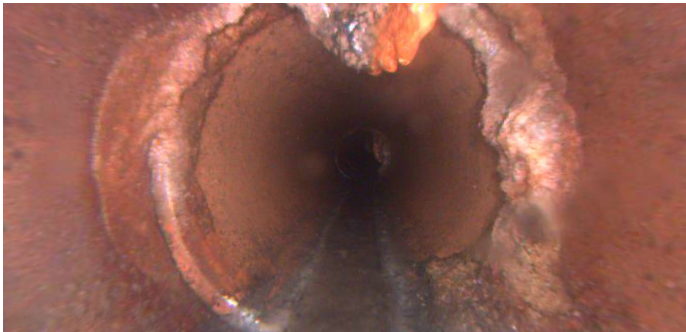
Code: ID
Description: Infil Dripper

Distance (ft): 37.4
Structural Grade: 0
O&M Grade: 3
Clock Start/From: 12
Clock To:
1st Value:
2nd Value:
Value Percent:
Continuous Index:
Within 8" of Joint: YES
Remarks:

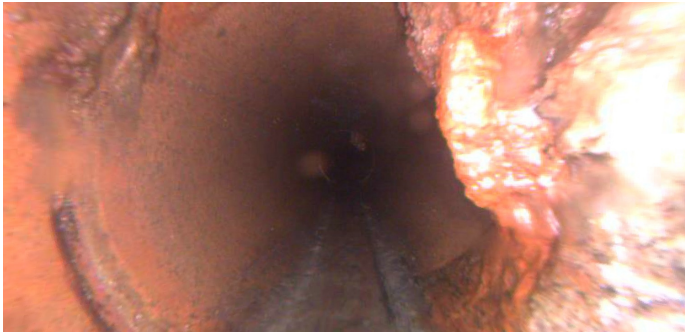
Code: **IW**
Description: **Infil Weeper**

Distance (ft): **40.5**
Structural Grade: **0**
O&M Grade: **2**
Clock Start/From: **1**
Clock To: **4**
1st Value:
2nd Value:
Value Percent:
Continuous Index:
Within 8" of Joint: **YES**
Remarks:

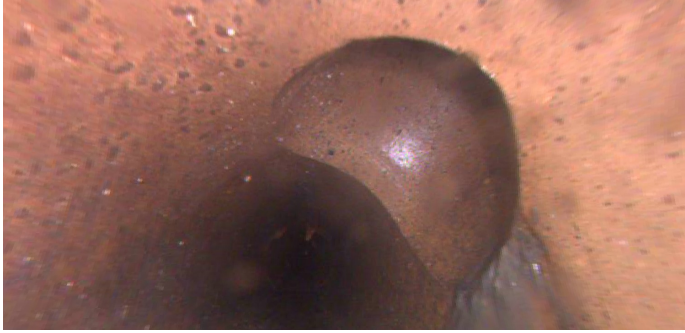
Code: **TF**
Description: **Tap Factory**

Distance (ft): **47.1**
Structural Grade: **0**
O&M Grade: **0**
Clock Start/From: **1**
Clock To:
1st Value: **4.000**
2nd Value:
Value Percent:
Continuous Index:
Within 8" of Joint:
Remarks:

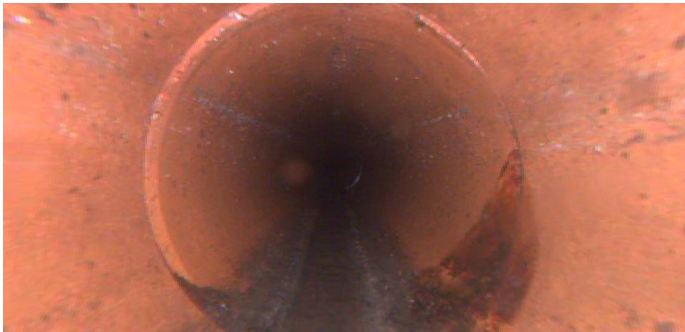
Code: **IW**
Description: **Infil Weeper**

Distance (ft): **73.5**
Structural Grade: **0**
O&M Grade: **2**
Clock Start/From: **7**
Clock To: **5**
1st Value:
2nd Value:
Value Percent:
Continuous Index: **S02**
Within 8" of Joint: **YES**
Remarks:

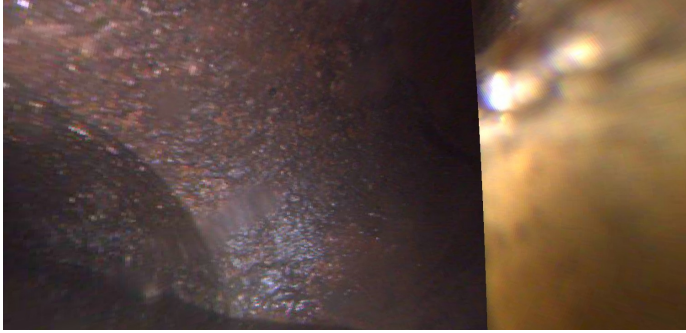
Code: **TF**
Description: **Tap Factory**

Distance (ft): **104.5**
Structural Grade: **0**
O&M Grade: **0**
Clock Start/From: **3**
Clock To:
1st Value: **4.000**
2nd Value:
Value Percent:
Continuous Index:
Within 8" of Joint:
Remarks:

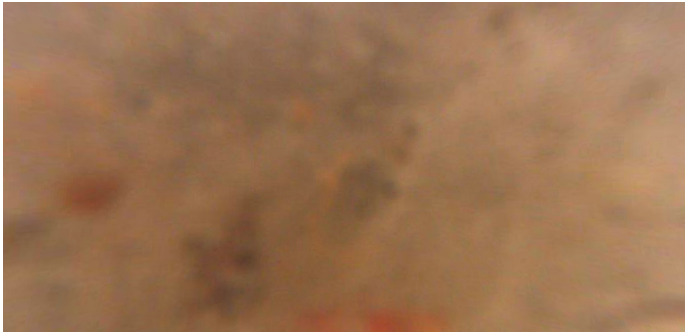
Code: **MCU**
Description: **Camera Underwater**

Distance (ft): **105.6**
Structural Grade: **0**
O&M Grade: **4**
Clock Start/From:
Clock To:
1st Value:
2nd Value:
Value Percent:
Continuous Index:
Within 8" of Joint: **NO**
Remarks:
