Profile/Photo Observation Report

Street:	FOXCROFT STREET	Flow Control:	Not Controlled
City:	Hobart, IN	Year Renewed:	
Location:	Light Highway	Tape/Media #:	
Purpose:	Routine Assessment	Dia/Height:	12"
Use:	Sanitary	Material:	VCP
Drain Area:	NA	Lining:	
Category:	NA		
Comment:	P_C at 105 ft debris

Location Details:		Direction of Survey:	Downstream
US MH:	M-208-007	DS MH:	M-208-008
		Total Length Surveyed (ft):	106.2

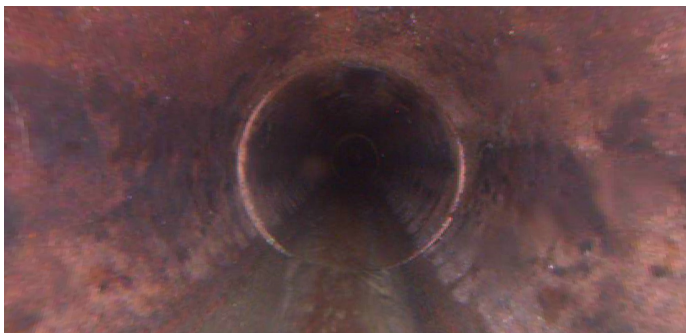
Code: **AMH**
Description: **Manhole**

Distance (ft): **.0**
Structural Grade: **0**
O&M Grade: **0**
Clock Start/From:
Clock To:
1st Value:
2nd Value:
Value Percent:
Continuous Index:
Within 8" of Joint: **NO**
Remarks: **M-208-007**

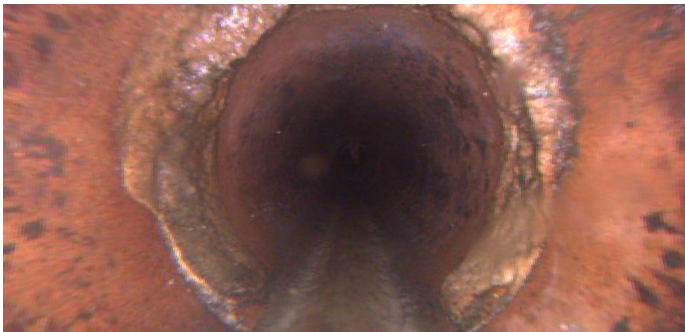
Code:	DAE
Description:	Deposits Attached Encrustation

Distance (ft):	4.5
Structural Grade:	0
O&M Grade:	2
Clock Start/From:	7
Clock To:	5
1st Value:	
2nd Value:	
Value Percent:	5.000
Continuous Index:	S01
Within 8" of Joint:	YES
Remarks:	WANDER

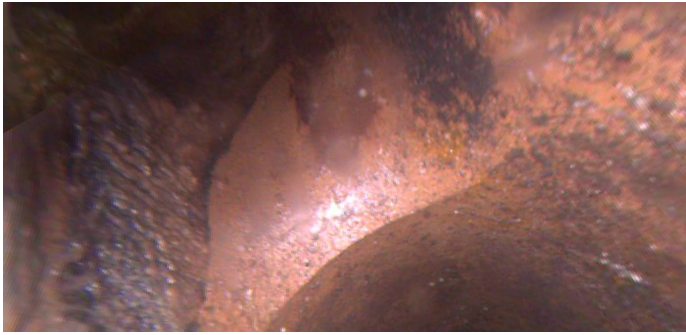
Code: **TF**
Description: **Tap Factory**

Distance (ft): **8.4**
Structural Grade: **0**
O&M Grade: **0**
Clock Start/From: **11**
Clock To:
1st Value: **4.000**
2nd Value:
Value Percent:
Continuous Index:
Within 8" of Joint:
Remarks:

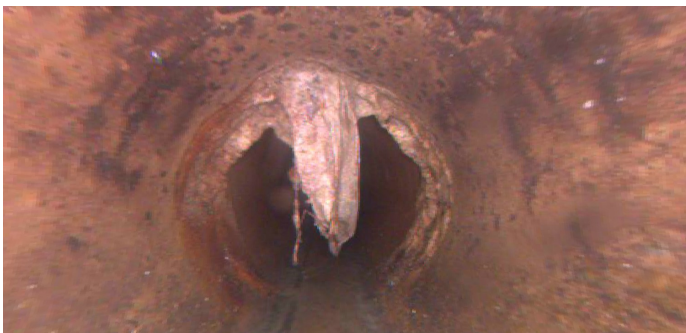
Code: **DAR**
Description: **Deposits Attached Ragging**

Distance (ft): **10.1**
Structural Grade: **0**
O&M Grade: **3**
Clock Start/From: **11**
Clock To: **1**
1st Value:
2nd Value:
Value Percent: **20.000**
Continuous Index:
Within 8" of Joint: **YES**
Remarks: **TOILET TISSUE**

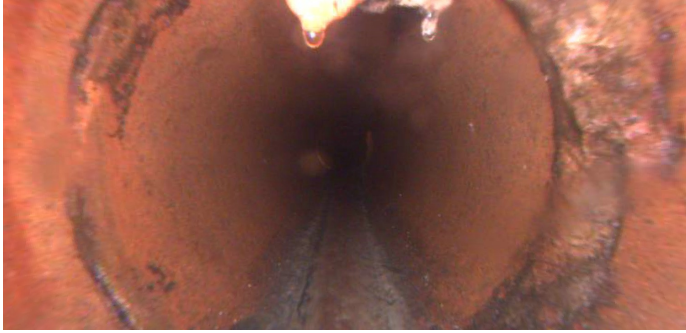
Code: ID
Description: Infil Dripper

Distance (ft): 22.6
Structural Grade: 0
O&M Grade: 3
Clock Start/From: 12
Clock To:
1st Value:
2nd Value:
Value Percent:
Continuous Index:
Within 8" of Joint: YES
Remarks:

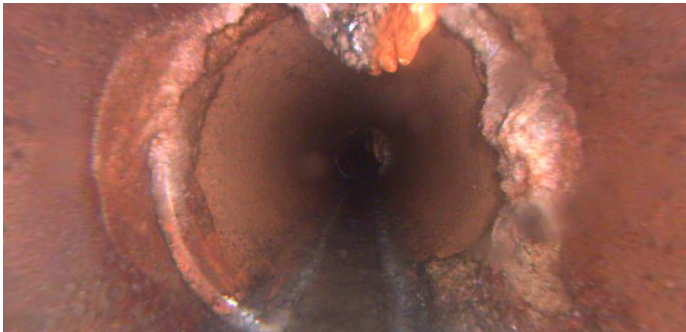
Code: ID
Description: Infil Dripper

Distance (ft): 37.4
Structural Grade: 0
O&M Grade: 3
Clock Start/From: 12
Clock To:
1st Value:
2nd Value:
Value Percent:
Continuous Index:
Within 8" of Joint: YES
Remarks:

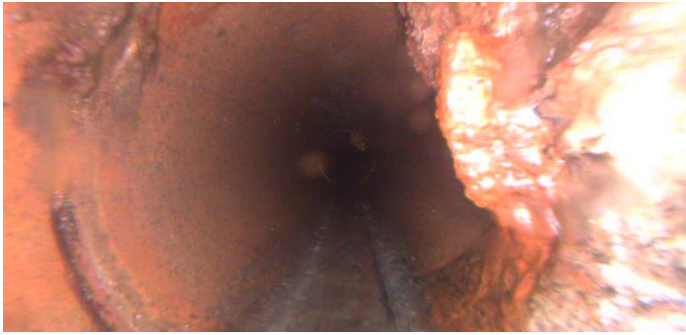
Code: **IW**
Description: **Infil Weeper**

Distance (ft): **40.5**
Structural Grade: **0**
O&M Grade: **2**
Clock Start/From: **1**
Clock To: **4**
1st Value:
2nd Value:
Value Percent:
Continuous Index:
Within 8" of Joint: **YES**
Remarks:

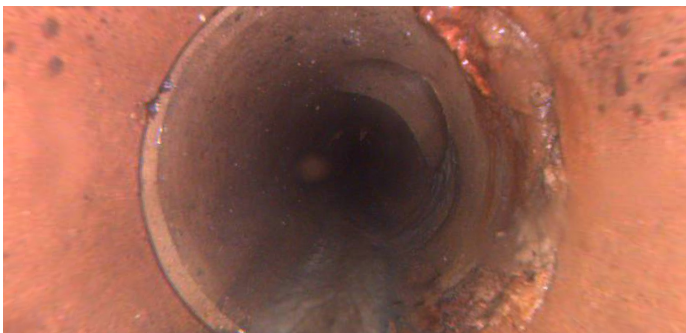
Code: **IW**
Description: **Infil Weeper**

Distance (ft): **46.5**
Structural Grade: **0**
O&M Grade: **2**
Clock Start/From: **1**
Clock To: **4**
1st Value:
2nd Value:
Value Percent:
Continuous Index:
Within 8" of Joint: **YES**
Remarks:

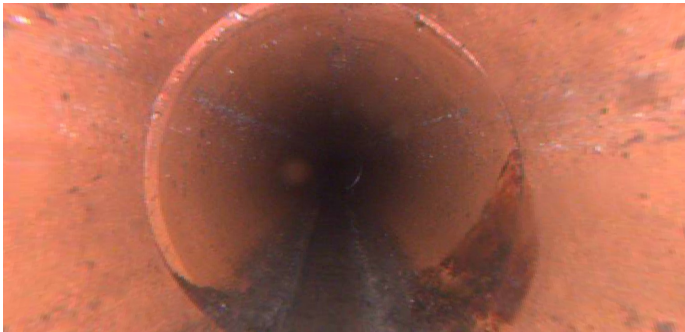
Code: **IW**
Description: **Infil Weeper**

Distance (ft): **73.5**
Structural Grade: **0**
O&M Grade: **2**
Clock Start/From: **7**
Clock To: **5**
1st Value:
2nd Value:
Value Percent:
Continuous Index: **S02**
Within 8" of Joint: **YES**
Remarks:

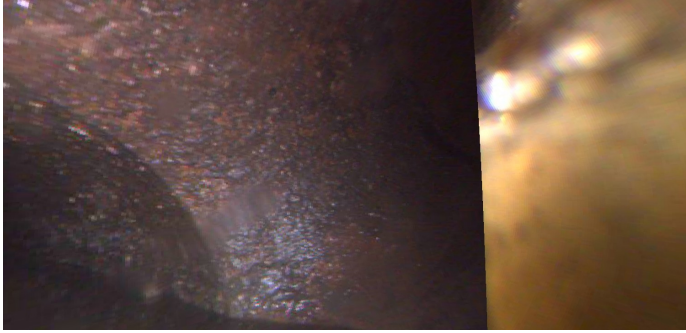
Code: **TF**
Description: **Tap Factory**

Distance (ft): **104.5**
Structural Grade: **0**
O&M Grade: **0**
Clock Start/From: **3**
Clock To:
1st Value: **4.000**
2nd Value:
Value Percent:
Continuous Index:
Within 8" of Joint:
Remarks:

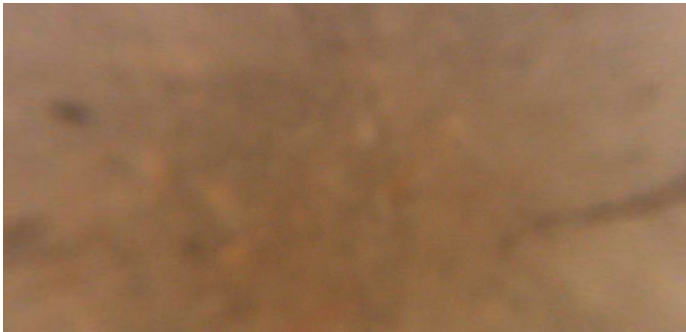
Code: **IW**
Description: **Infil Weeper**

Distance (ft): **105.6**
Structural Grade: **0**
O&M Grade: **2**
Clock Start/From: **7**
Clock To: **5**
1st Value:
2nd Value:
Value Percent:
Continuous Index: **F02**
Within 8" of Joint: **YES**
Remarks:

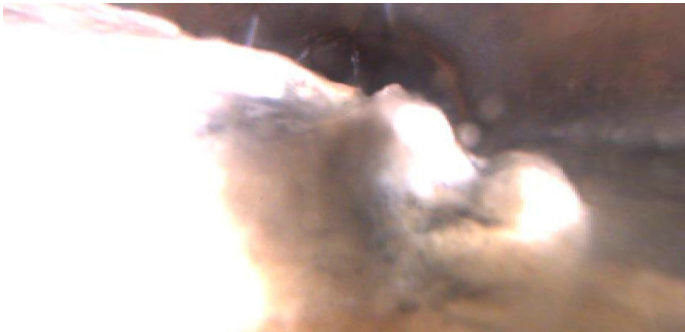
Code: **MGO**
Description: **General Observation**

Distance (ft): **106.2**
Structural Grade: **0**
O&M Grade: **0**
Clock Start/From:
Clock To:
1st Value:
2nd Value:
Value Percent:
Continuous Index:
Within 8" of Joint: **NO**
Remarks: **TOIET TISSUE**
