Profile/Photo Observation Report

Street:	FOXCROFT STREET	Flow Control:	Not Controlled
City:	Hobart, IN	Year Renewed:	
Location:	Light Highway	Tape/Media #:	
Purpose:	Routine Assessment	Dia/Height:	12"
Use:	Sanitary	Material:	VCP
Drain Area:	NA	Lining:	
Category:	NA		
Comment:	R_M at 15 ft nothing visible . Flow direction wrong		
Location Details:		Direction of Survey:	Upstream
US MH:	M-208-008	DS MH:	M-208-004
		Total Length Surveyed (ft):	16.9

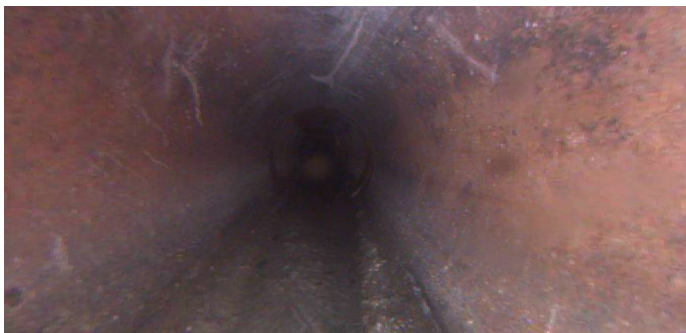
Code: **AMH**
Description: **Manhole**

Distance (ft): **.0**
Structural Grade: **0**
O&M Grade: **0**
Clock Start/From:
Clock To:
1st Value:
2nd Value:
Value Percent:
Continuous Index:
Within 8" of Joint: **NO**
Remarks: **M-208-004**

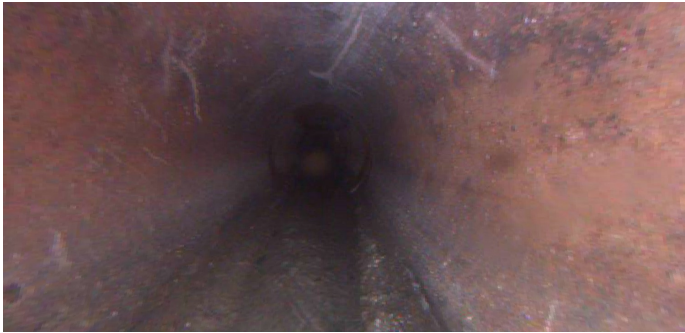
Code:	MWL
Description:	Water Level

Distance (ft):	.0
Structural Grade:	0
O&M Grade:	0
Clock Start/From:	
Clock To:	
1st Value:	
2nd Value:	
Value Percent:	5.000
Continuous Index:	
Within 8" of Joint:	NO
Remarks:

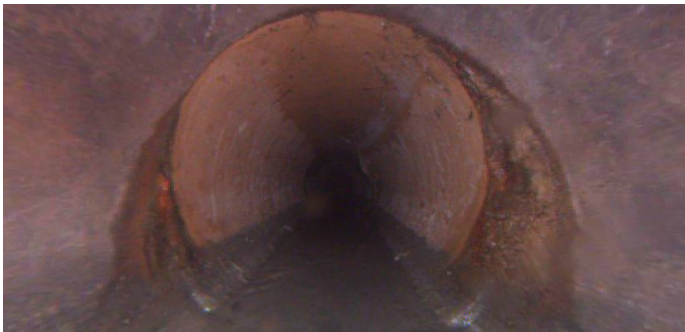
Code:	DAE
Description:	Deposits Attached Encrustation

Distance (ft):	3.1
Structural Grade:	0
O&M Grade:	2
Clock Start/From:	7
Clock To:	5
1st Value:	
2nd Value:	
Value Percent:	10.000
Continuous Index:	S01
Within 8" of Joint:	YES
Remarks:

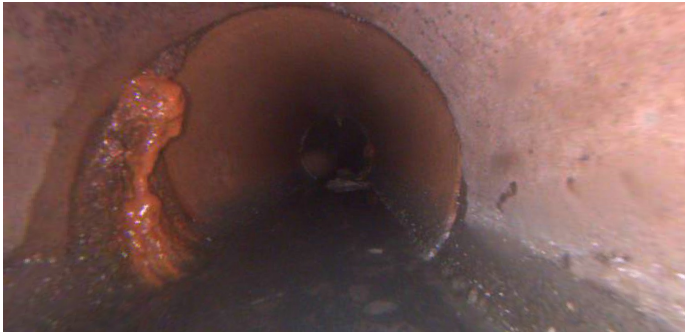
Code: **IW**
Description: **Infil Weeper**

Distance (ft): **11.9**
Structural Grade: **0**
O&M Grade: **2**
Clock Start/From: **7**
Clock To: **11**
1st Value:
2nd Value:
Value Percent:
Continuous Index:
Within 8" of Joint: **YES**
Remarks:

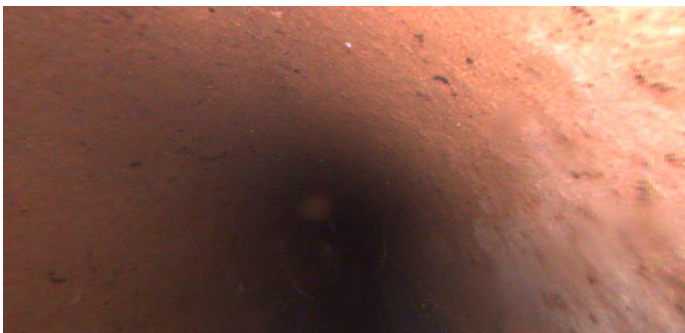
Code: **DAE**
Description: **Deposits Attached Encrustation**

Distance (ft): **16.9**
Structural Grade: **0**
O&M Grade: **2**
Clock Start/From: **7**
Clock To: **5**
1st Value:
2nd Value:
Value Percent: **10.000**
Continuous Index: **F01**
Within 8" of Joint: **YES**
Remarks:

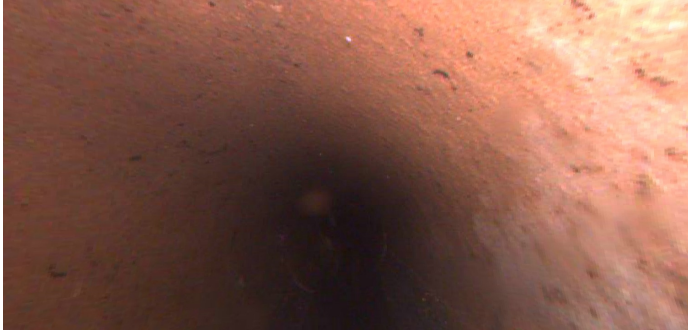
Code:	MSA
Description:	Abandoned Survey
Distance (ft):	16.9
Structural Grade:	0
O&M Grade:	0
Clock Start/From:	
Clock To:	
1st Value:	
2nd Value:	
Value Percent:	
Continuous Index:	
Within 8" of Joint:	NO
Remarks:	camera stopped
