Profile/Photo Observation Report

Date:	03/23/2018	Weather:		Coding:	PACP 6.0
Pipe Length (ft):	207.6	Owner:	NA	Pre Clean:	No Pre-Cleaning
P.O.#:		Surveyor:	Justin Gonzales	PSR:	P-208-010-011
Customer:		Clean Date:	01/01/1900	Shape:	C

Street:	ALLEY BETWEEN BROOKVIEW CT &	Flow Control:	Not Controlled
City:	Hobart, IN	Year Renewed:	
Location:	Light Highway	Tape/Media #:	
Purpose:	Routine Assessment	Dia/Height:	8"
Use:	Sanitary	Material:	VCP
Drain Area:	NA	Lining:	
Category:	NA		
Comment:	Flow direction wrong

Location Details:		Direction of Survey:	Upstream
US MH:	M-208-011	DS MH:	M-208-010
		Total Length Surveyed (ft):	200.9

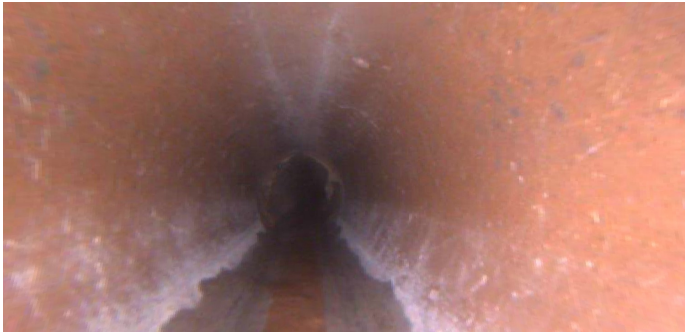
Code: **AMH**
Description: **Manhole**

Distance (ft): **.0**
Structural Grade: **0**
O&M Grade: **0**
Clock Start/From:
Clock To:
1st Value:
2nd Value:
Value Percent:
Continuous Index:
Within 8" of Joint: **NO**
Remarks: **M-208-010**

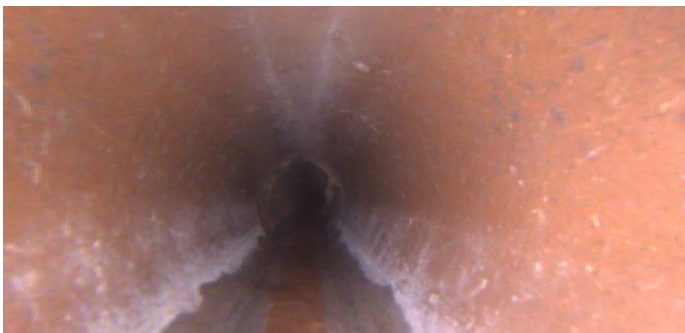
Code: **MWL**
Description: **Water Level**

Distance (ft): **.0**
Structural Grade: **0**
O&M Grade: **0**
Clock Start/From:
Clock To:
1st Value:
2nd Value:
Value Percent: **5.000**
Continuous Index:
Within 8" of Joint: **NO**
Remarks:

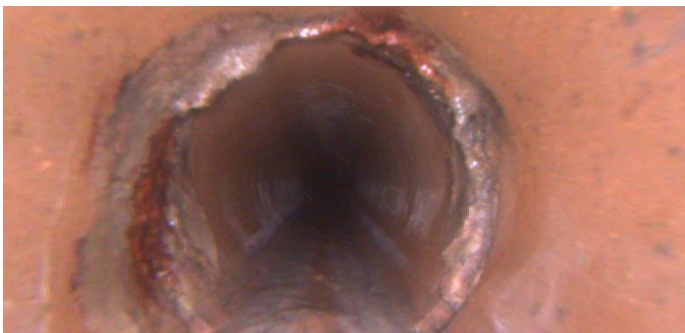
Code: **IW**
Description: **Infil Weeper**

Distance (ft): **17.7**
Structural Grade: **0**
O&M Grade: **2**
Clock Start/From: **7**
Clock To: **5**
1st Value:
2nd Value:
Value Percent:
Continuous Index: **S03**
Within 8" of Joint: **YES**
Remarks: **WANDER**

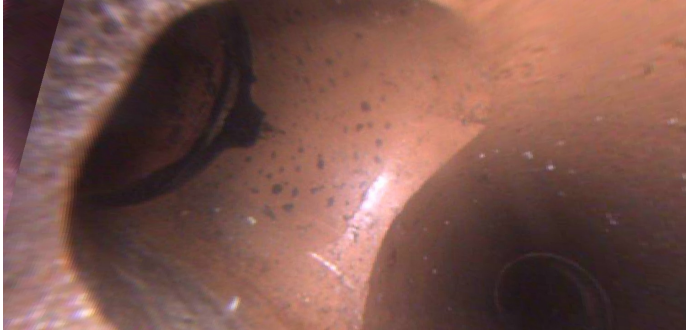
Code: **TF**
Description: **Tap Factory**

Distance (ft): **36.3**
Structural Grade: **0**
O&M Grade: **0**
Clock Start/From: **10**
Clock To:
1st Value: **4.000**
2nd Value:
Value Percent:
Continuous Index:
Within 8" of Joint:
Remarks:

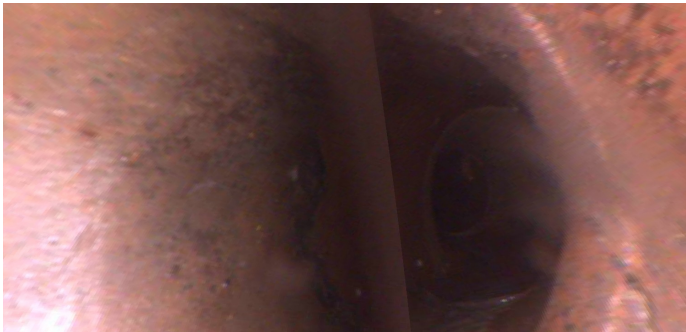
Code: **TF**
Description: **Tap Factory**

Distance (ft): **39.5**
Structural Grade: **0**
O&M Grade: **0**
Clock Start/From: **2**
Clock To:
1st Value: **4.000**
2nd Value:
Value Percent:
Continuous Index:
Within 8" of Joint:
Remarks:

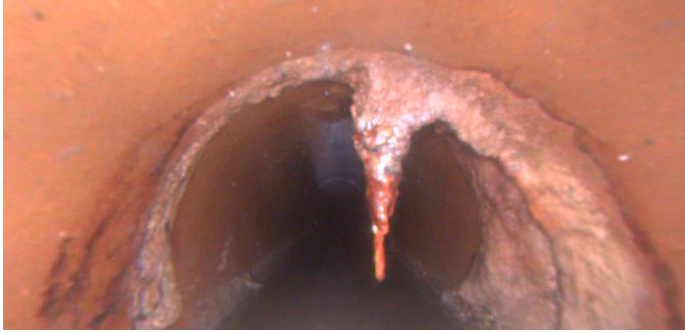
Code: ID
Description: Infil Dripper

Distance (ft): 68.2
Structural Grade: 0
O&M Grade: 3
Clock Start/From: 12
Clock To:
1st Value:
2nd Value:
Value Percent:
Continuous Index:
Within 8" of Joint: YES
Remarks:

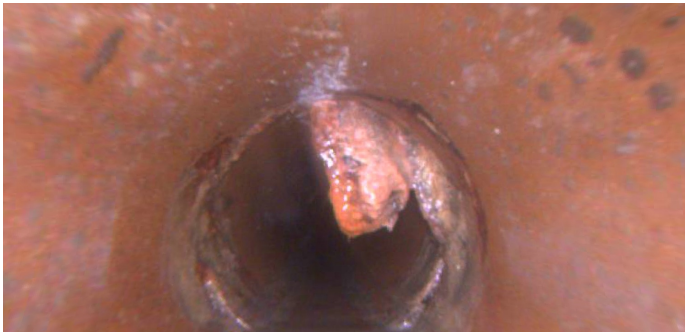
Code: ID
Description: Infil Dripper

Distance (ft): 88.6
Structural Grade: 0
O&M Grade: 3
Clock Start/From: 12
Clock To:
1st Value:
2nd Value:
Value Percent:
Continuous Index:
Within 8" of Joint:
Remarks:

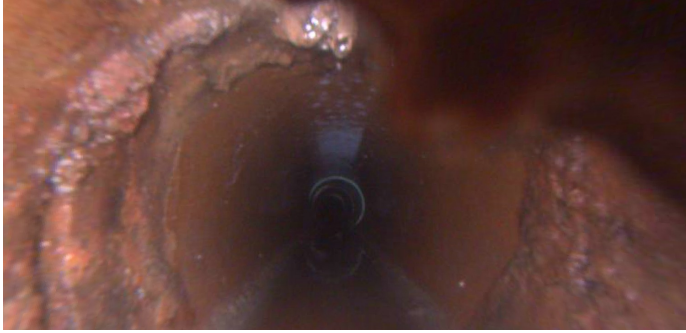
Code: ID
Description: Infil Dripper

Distance (ft): 91.9
Structural Grade: 0
O&M Grade: 3
Clock Start/From: 12
Clock To:
1st Value:
2nd Value:
Value Percent:
Continuous Index:
Within 8" of Joint: YES
Remarks:

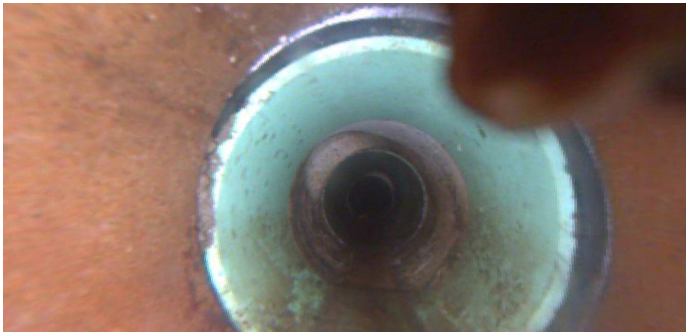
Code: MMC
Description: Material Change

Distance (ft): 94.8
Structural Grade: 0
O&M Grade: 0
Clock Start/From:
Clock To:
1st Value:
2nd Value:
Value Percent:
Continuous Index:
Within 8" of Joint: NO
Remarks: PVC

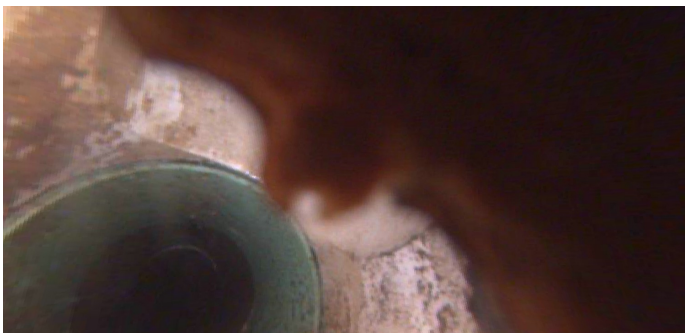
Code: **MGO**
Description: **General Observation**

Distance (ft): **98.1**
Structural Grade: **0**
O&M Grade: **0**
Clock Start/From:
Clock To:
1st Value:
2nd Value:
Value Percent:
Continuous Index:
Within 8" of Joint: **NO**
Remarks: **DAE ATTACHED TO LENS; SWITCHING TO REAR CAMERA**

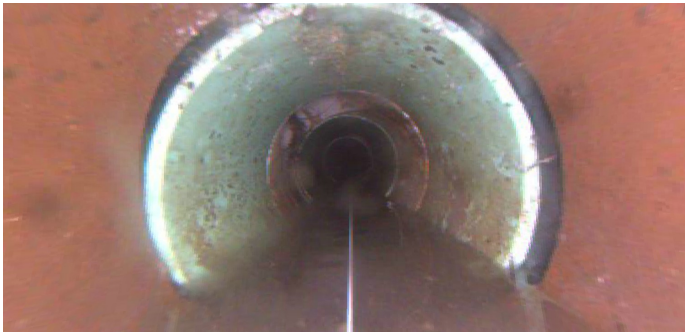
Code: **MMC**
Description: **Material Change**

Distance (ft): **100.0**
Structural Grade: **0**
O&M Grade: **0**
Clock Start/From:
Clock To:
1st Value:
2nd Value:
Value Percent:
Continuous Index:
Within 8" of Joint: **NO**
Remarks: **vcp**

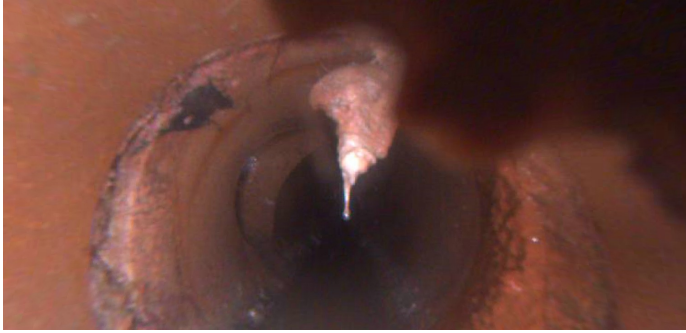
Code: **FM**
Description: **Fracture Multiple**

Distance (ft): **145.2**
Structural Grade: **4**
O&M Grade: **0**
Clock Start/From: **8**
Clock To: **12**
1st Value:
2nd Value:
Value Percent:
Continuous Index:
Within 8" of Joint: **YES**
Remarks:

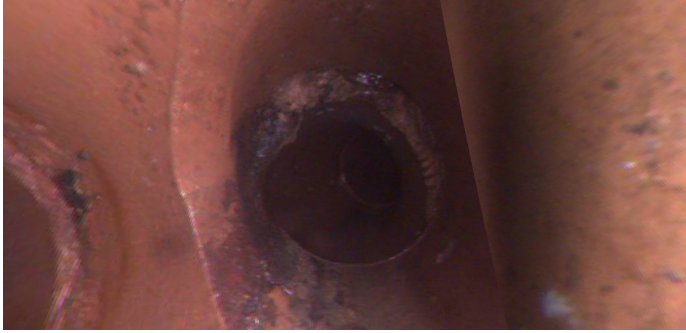
Code: **TF**
Description: **Tap Factory**

Distance (ft): **146.4**
Structural Grade: **0**
O&M Grade: **0**
Clock Start/From: **10**
Clock To:
1st Value: **4.000**
2nd Value:
Value Percent:
Continuous Index:
Within 8" of Joint:
Remarks:

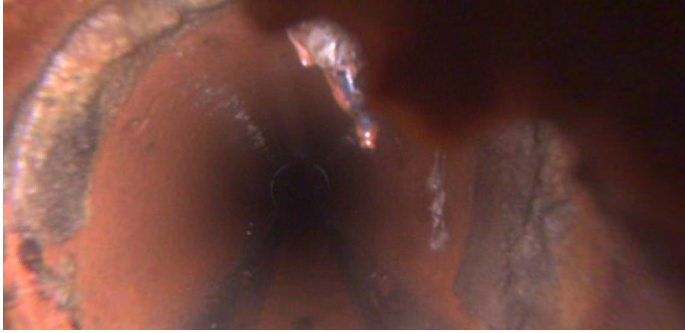
Code: ID
Description: Infil Dripper

Distance (ft): 162.9
Structural Grade: 0
O&M Grade: 3
Clock Start/From: 1
Clock To:
1st Value:
2nd Value:
Value Percent:
Continuous Index:
Within 8" of Joint: YES
Remarks:

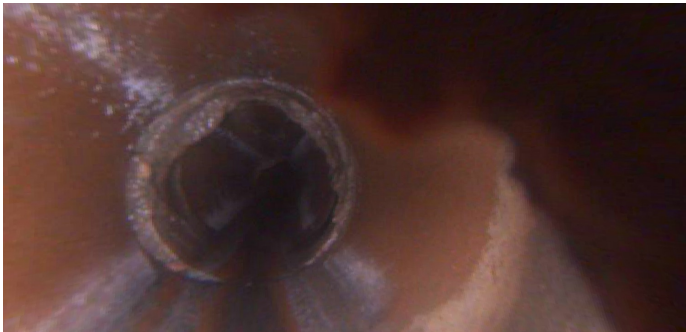
Code: **IW**
Description: **Infil Weeper**

Distance (ft): **200.9**
Structural Grade: **0**
O&M Grade: **2**
Clock Start/From: **7**
Clock To: **5**
1st Value:
2nd Value:
Value Percent:
Continuous Index: **F03**
Within 8" of Joint: **YES**
Remarks: **WANDER**
