Profile/Photo Observation Report

Street:	FOXCROFT STREET	Flow Control:	Not Controlled
City:	Hobart, IN	Year Renewed:	
Location:	Light Highway	Tape/Media #:	
Purpose:	Routine Assessment	Dia/Height:	8"
Use:	Sanitary	Material:	VCP
Drain Area:	NA	Lining:	
Category:	NA		
Comment:	Flow direction wrong

Location Details:		Direction of Survey:	Upstream
US MH:	M-208-011	DS MH:	M-208-010
		Total Length Surveyed (ft):	200.9

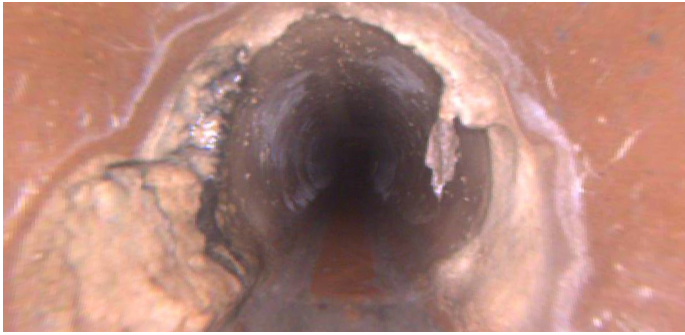
Code: **DAE**
Description: **Deposits Attached Encrustation**

Distance (ft): **3.2**
Structural Grade: **0**
O&M Grade: **2**
Clock Start/From: **7**
Clock To: **5**
1st Value:
2nd Value:
Value Percent: **10.000**
Continuous Index:
Within 8" of Joint: **YES**
Remarks:

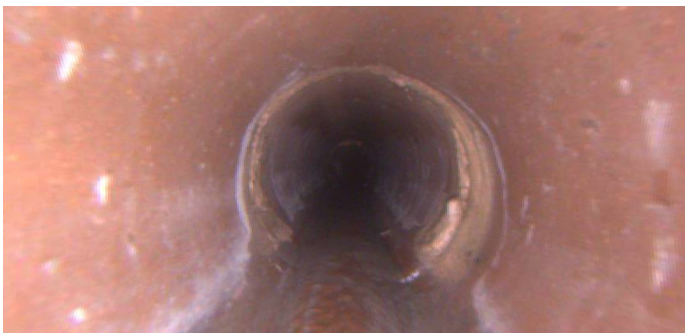
Code: **DAE**
Description: **Deposits Attached Encrustation**

Distance (ft): **5.7**
Structural Grade: **0**
O&M Grade: **2**
Clock Start/From: **7**
Clock To: **5**
1st Value:
2nd Value:
Value Percent: **5.000**
Continuous Index: **S02**
Within 8" of Joint: **YES**
Remarks: **WANDER**

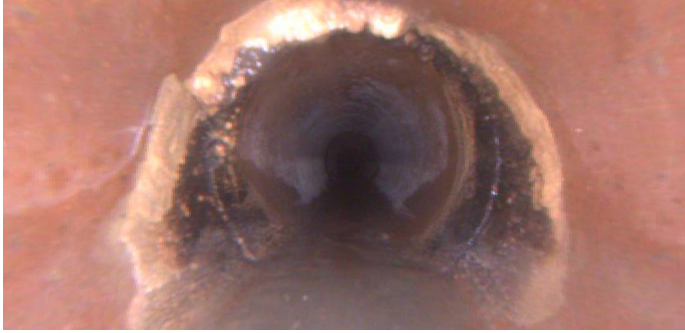
Code: ID
Description: Infil Dripper

Distance (ft): 8.9
Structural Grade: 0
O&M Grade: 3
Clock Start/From: 12
Clock To:
1st Value:
2nd Value:
Value Percent:
Continuous Index:
Within 8" of Joint: YES
Remarks:

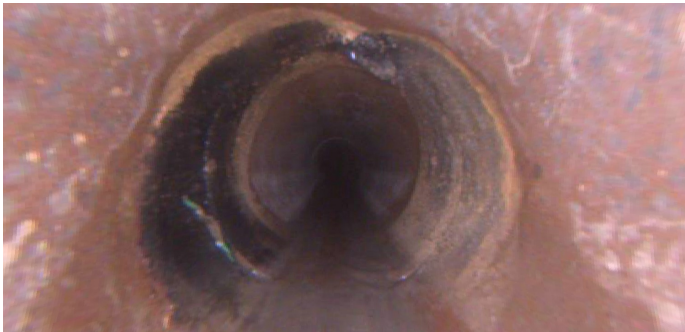
Code: ID
Description: Infil Dripper

Distance (ft): 11.7
Structural Grade: 0
O&M Grade: 3
Clock Start/From: 12
Clock To:
1st Value:
2nd Value:
Value Percent:
Continuous Index:
Within 8" of Joint: YES
Remarks:

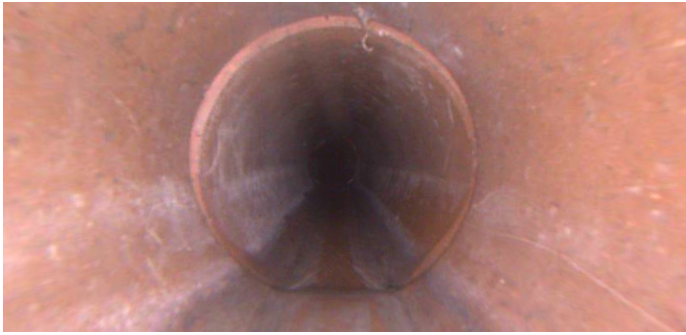
Code: **RFJ**
Description: **Roots Fine Joint**

Distance (ft): **14.6**
Structural Grade: **0**
O&M Grade: **1**
Clock Start/From: **12**
Clock To:
1st Value:
2nd Value:
Value Percent:
Continuous Index:
Within 8" of Joint: **YES**
Remarks:

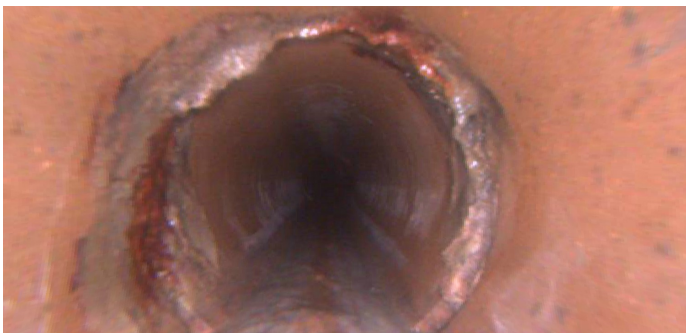
Code: **IW**
Description: **Infil Weeper**

Distance (ft): **17.7**
Structural Grade: **0**
O&M Grade: **2**
Clock Start/From: **7**
Clock To: **5**
1st Value:
2nd Value:
Value Percent:
Continuous Index: **S03**
Within 8" of Joint: **YES**
Remarks: **WANDER**

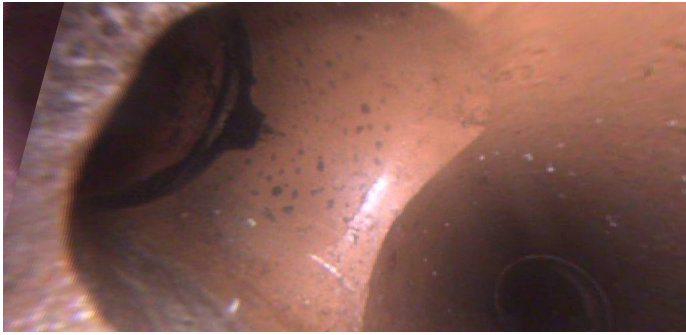
Code: **TF**
Description: **Tap Factory**

Distance (ft): **36.3**
Structural Grade: **0**
O&M Grade: **0**
Clock Start/From: **10**
Clock To:
1st Value: **4.000**
2nd Value:
Value Percent:
Continuous Index:
Within 8" of Joint:
Remarks:

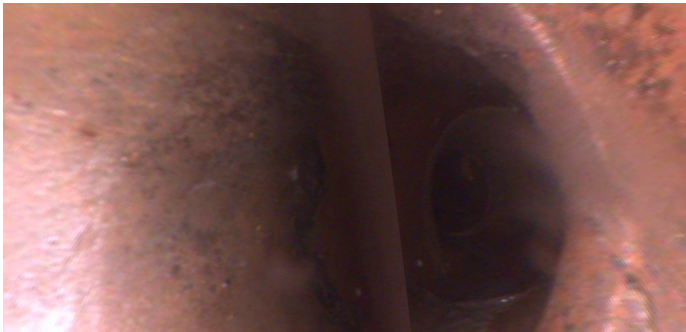
Code: **TF**
Description: **Tap Factory**

Distance (ft): **39.5**
Structural Grade: **0**
O&M Grade: **0**
Clock Start/From: **2**
Clock To:
1st Value: **4.000**
2nd Value:
Value Percent:
Continuous Index:
Within 8" of Joint:
Remarks:

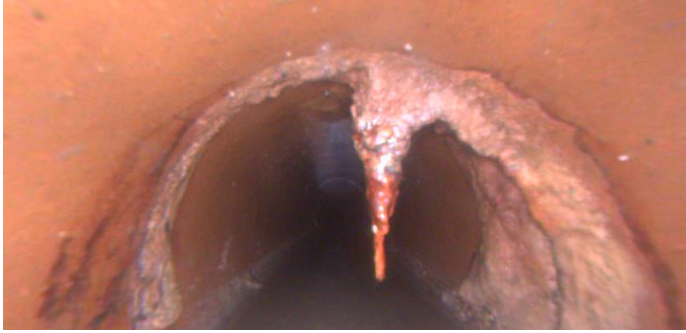
Code: ID
Description: Infil Dripper

Distance (ft): 68.2
Structural Grade: 0
O&M Grade: 3
Clock Start/From: 12
Clock To:
1st Value:
2nd Value:
Value Percent:
Continuous Index:
Within 8" of Joint: YES
Remarks:

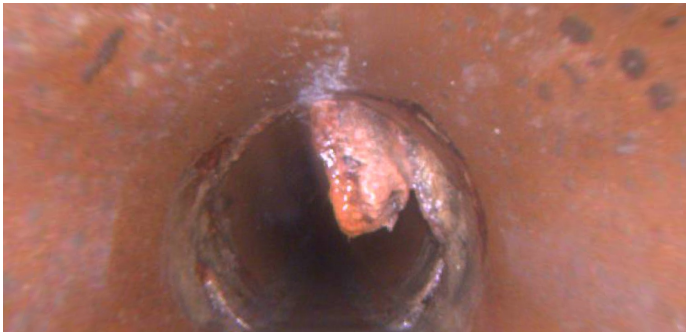
Code: ID
Description: Infil Dripper

Distance (ft): 88.6
Structural Grade: 0
O&M Grade: 3
Clock Start/From: 12
Clock To:
1st Value:
2nd Value:
Value Percent:
Continuous Index:
Within 8" of Joint:
Remarks:

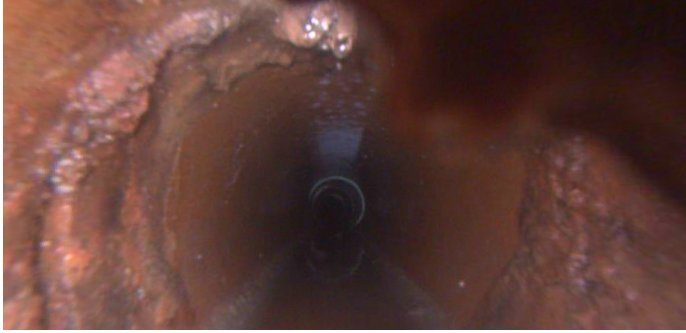
Code: ID
Description: Infil Dripper

Distance (ft): 91.9
Structural Grade: 0
O&M Grade: 3
Clock Start/From: 12
Clock To:
1st Value:
2nd Value:
Value Percent:
Continuous Index:
Within 8" of Joint: YES
Remarks:

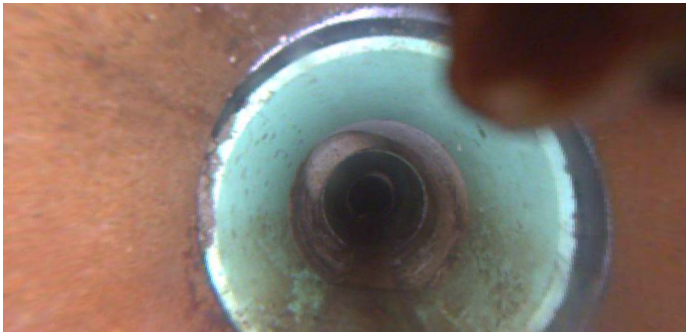
Code: MMC
Description: Material Change

Distance (ft): 94.8
Structural Grade: 0
O&M Grade: 0
Clock Start/From:
Clock To:
1st Value:
2nd Value:
Value Percent:
Continuous Index:
Within 8" of Joint: NO
Remarks: PVC

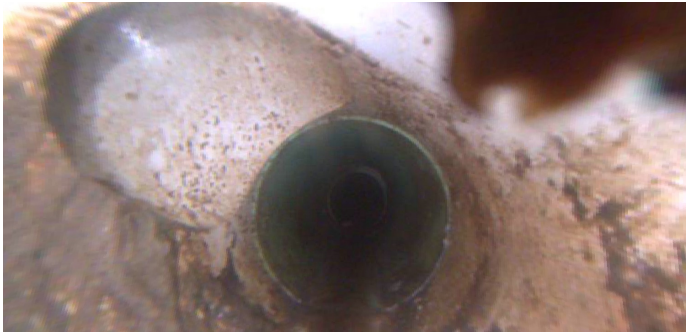
Code: **TF**
Description: **Tap Factory**

Distance (ft): **95.6**
Structural Grade: **0**
O&M Grade: **0**
Clock Start/From: **10**
Clock To:
1st Value: **4.000**
2nd Value:
Value Percent:
Continuous Index:
Within 8" of Joint:
Remarks:

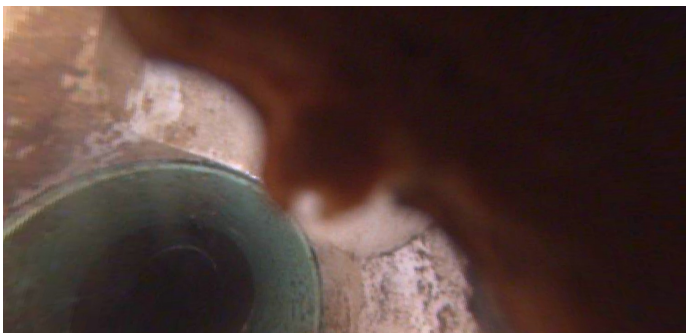
Code: **MGO**
Description: **General Observation**

Distance (ft): **98.1**
Structural Grade: **0**
O&M Grade: **0**
Clock Start/From:
Clock To:
1st Value:
2nd Value:
Value Percent:
Continuous Index:
Within 8" of Joint: **NO**
Remarks: **DAE ATTACHED TO LENS; SWITCHING TO REAR CAMERA**

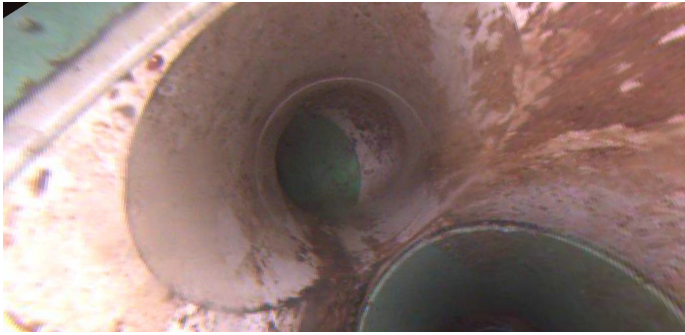
Code: **TF**
Description: **Tap Factory**

Distance (ft): **98.7**
Structural Grade: **0**
O&M Grade: **0**
Clock Start/From: **2**
Clock To:
1st Value: **4.000**
2nd Value:
Value Percent:
Continuous Index:
Within 8" of Joint:
Remarks:

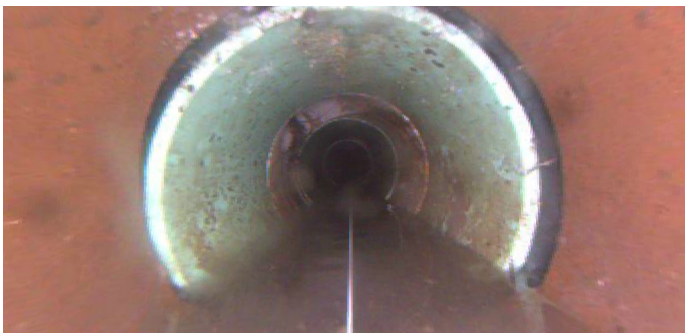
Code: **MMC**
Description: **Material Change**

Distance (ft): **100.0**
Structural Grade: **0**
O&M Grade: **0**
Clock Start/From:
Clock To:
1st Value:
2nd Value:
Value Percent:
Continuous Index:
Within 8" of Joint: **NO**
Remarks: **vcp**

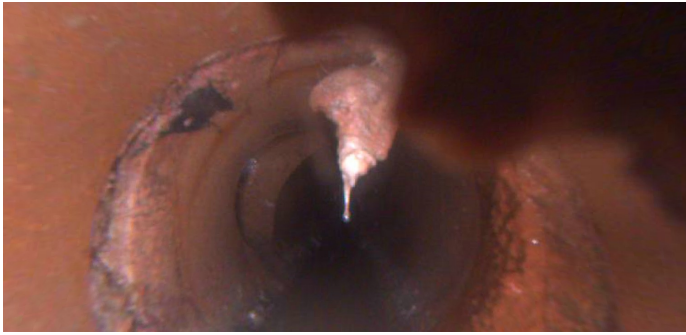
Code: **FM**
Description: **Fracture Multiple**

Distance (ft): **145.2**
Structural Grade: **4**
O&M Grade: **0**
Clock Start/From: **8**
Clock To: **12**
1st Value:
2nd Value:
Value Percent:
Continuous Index:
Within 8" of Joint: **YES**
Remarks:

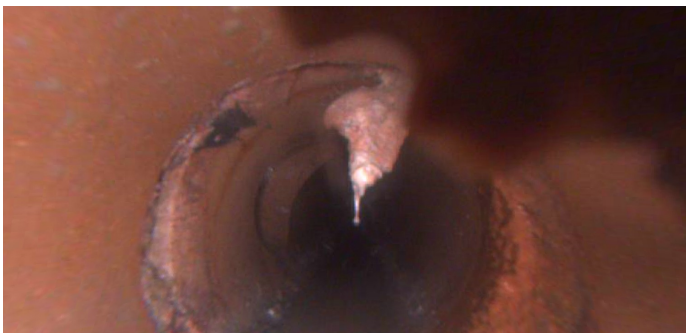
Code: **ID**
Description: **Infil Dripper**

Distance (ft): **145.2**
Structural Grade: **0**
O&M Grade: **3**
Clock Start/From: **12**
Clock To:
1st Value:
2nd Value:
Value Percent:
Continuous Index:
Within 8" of Joint: **YES**
Remarks:

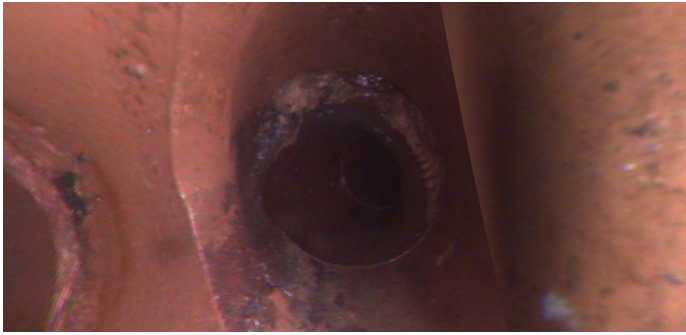
Code: **TF**
Description: **Tap Factory**

Distance (ft): **146.4**
Structural Grade: **0**
O&M Grade: **0**
Clock Start/From: **10**
Clock To:
1st Value: **4.000**
2nd Value:
Value Percent:
Continuous Index:
Within 8" of Joint:
Remarks:

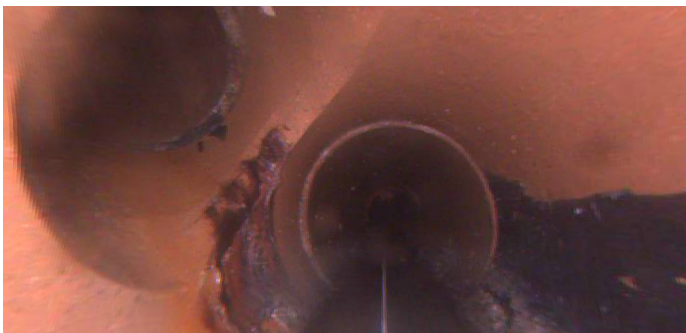
Code: **TF**
Description: **Tap Factory**

Distance (ft): **149.6**
Structural Grade: **0**
O&M Grade: **0**
Clock Start/From: **2**
Clock To:
1st Value: **4.000**
2nd Value:
Value Percent:
Continuous Index:
Within 8" of Joint:
Remarks:

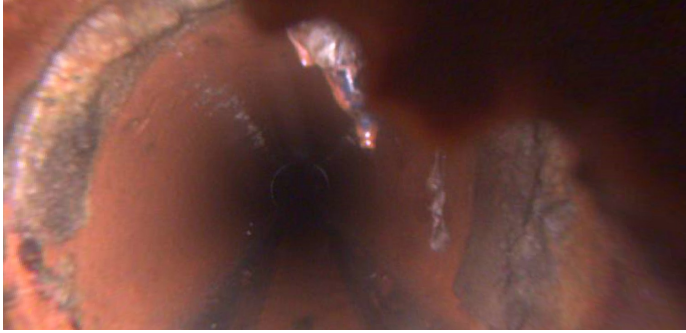
Code: ID
Description: Infil Dripper

Distance (ft): 162.9
Structural Grade: 0
O&M Grade: 3
Clock Start/From: 1
Clock To:
1st Value:
2nd Value:
Value Percent:
Continuous Index:
Within 8" of Joint: YES
Remarks:

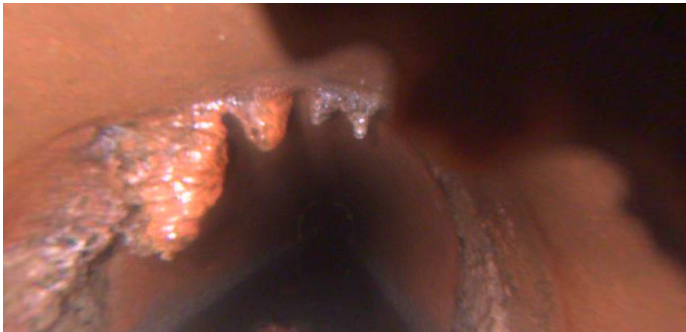
Code: ID
Description: Infil Dripper

Distance (ft): 189.5
Structural Grade: 0
O&M Grade: 3
Clock Start/From: 11
Clock To: 12
1st Value:
2nd Value:
Value Percent:
Continuous Index:
Within 8" of Joint: YES
Remarks:

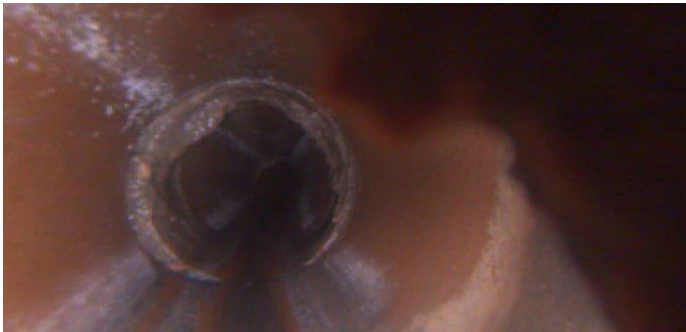
Code: **IW**
Description: **Infil Weeper**

Distance (ft): **200.9**
Structural Grade: **0**
O&M Grade: **2**
Clock Start/From: **7**
Clock To: **5**
1st Value:
2nd Value:
Value Percent:
Continuous Index: **F03**
Within 8" of Joint: **YES**
Remarks: **WANDER**

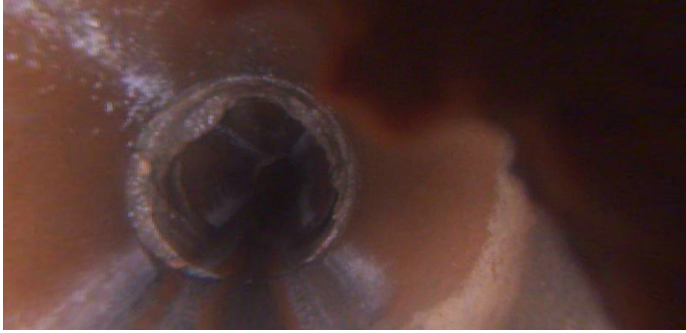
Code:	DAE
Description:	Deposits Attached Encrustation
Distance (ft):	200.9
Structural Grade:	0
O&M Grade:	2
Clock Start/From:	7
Clock To:	5
1st Value:	
2nd Value:	
Value Percent:	5.000
Continuous Index:	F02
Within 8" of Joint:	YES
Remarks:	WANDER
