## Profile/Photo Observation Report

Street:	<b>E 34TH CT</b>	Flow Control:	<b>Not Controlled</b>
City:	<b>Hobart, IN</b>	Year Renewed:	
Location:	<b>Other</b>	Tape/Media #:	
Purpose:	<b>Not Known</b>	Dia/Height:	<b>10"</b>
Use:	<b>Sanitary</b>	Material:	<b>VCP</b>
Drain Area:	<b>NA</b>	Lining:	
Category:	<b>NA</b>		
Comment:

Location Details:		Direction of Survey:	<b>Upstream</b>
US MH:	<b>M-902-017</b>	DS MH:	<b>M-902-015</b>
		Total Length Surveyed (ft):	<b>26.0</b>

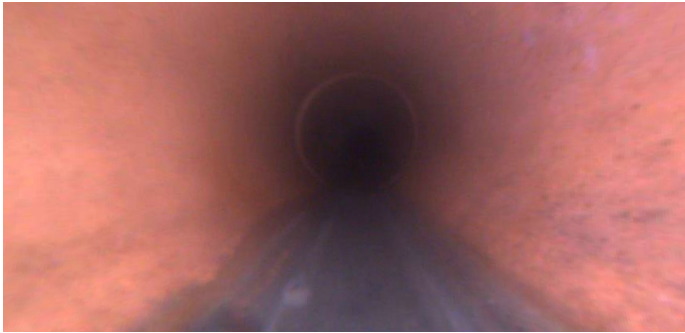
Code:	<b>MWL</b>
Description:	<b>Water Level</b>

Distance (ft):	<b>.0</b>
Structural Grade:	<b>0</b>
O&M Grade:	<b>0</b>
Clock Start/From:	
Clock To:	
1st Value:	
2nd Value:	
Value Percent:	<b>5.000</b>
Continuous Index:	
Within 8" of Joint:	<b>NO</b>
Remarks:

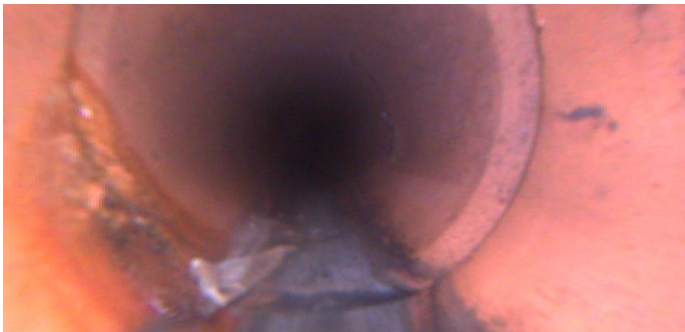
Code:	<b>DAE</b>
Description:	<b>Deposits Attached Encrustation</b>

Distance (ft):	<b>7.4</b>
Structural Grade:	<b>0</b>
O&M Grade:	<b>2</b>
Clock Start/From:	<b>7</b>
Clock To:	<b>9</b>
1st Value:	
2nd Value:	
Value Percent:	<b>5.000</b>
Continuous Index:	
Within 8" of Joint:	<b>YES</b>
Remarks:

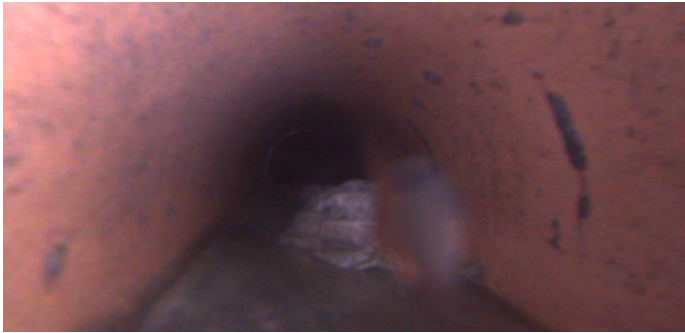
Code: **DSZ**  
Description: **Deposits Settled Other**

Distance (ft): **24.6**  
Structural Grade: **0**  
O&M Grade: **3**  
Clock Start/From: **6**  
Clock To:  
1st Value:  
2nd Value:  
Value Percent: **15.000**  
Continuous Index:  
Within 8" of Joint: **NO**  
Remarks: **wad of tissue**

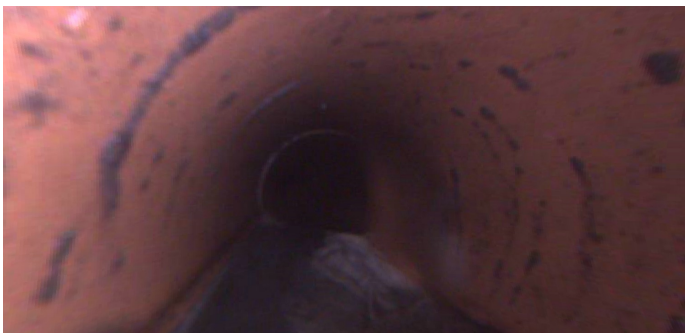
Code: **MSA**  
Description: **Abandoned Survey**

Distance (ft): **26.0**  
Structural Grade: **0**  
O&M Grade: **0**  
Clock Start/From:  
Clock To:  
1st Value:  
2nd Value:  
Value Percent:  
Continuous Index:  
Within 8" of Joint: **NO**  
Remarks: **stuck in tissue**
