Profile/Photo Observation Report

Date:	03/23/2018	Weather:		Coding:	PACP 6.0
Pipe Length (ft):	114.0	Owner:	NA	Pre Clean:	No Pre-Cleaning
P.O.#:		Surveyor:	Jen Costello	PSR:	P-208-013-014
Customer:		Clean Date:	01/01/1900	Shape:	C

Street:	FOXCROFT STREET	Flow Control:	Not Controlled
City:	Hobart, IN	Year Renewed:	
Location:	Light Highway	Tape/Media #:	
Purpose:	Routine Assessment	Dia/Height:	12"
Use:	Sanitary	Material:	VCP
Drain Area:	NA	Lining:	
Category:	NA		
Comment:	P_C at 13 ft nothing visible. Flow direction wrong		
Location Details:		Direction of Survey:	Upstream
US MH:	M-208-014	DS MH:	M-208-013
		Total Length Surveyed (ft):	13.4

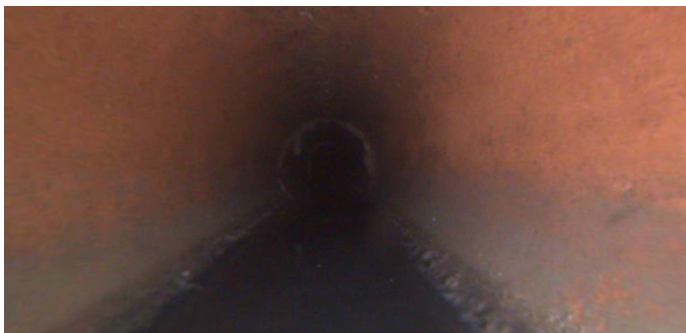
Code: **AMH**
Description: **Manhole**

Distance (ft): **.0**
Structural Grade: **0**
O&M Grade: **0**
Clock Start/From:
Clock To:
1st Value:
2nd Value:
Value Percent:
Continuous Index:
Within 8" of Joint: **NO**
Remarks: **M-208-013**

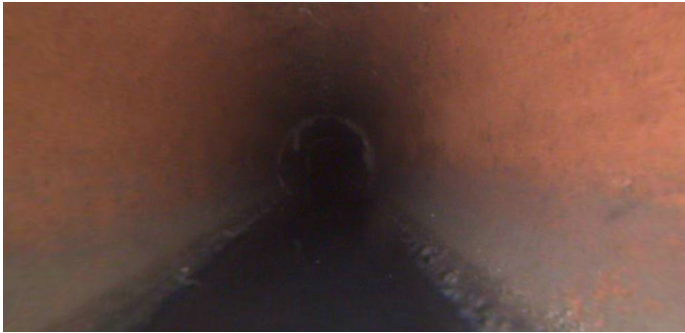
Code:	MWL
Description:	Water Level

Distance (ft):	.0
Structural Grade:	0
O&M Grade:	0
Clock Start/From:	
Clock To:	
1st Value:	
2nd Value:	
Value Percent:	10.000
Continuous Index:	
Within 8" of Joint:	NO
Remarks:

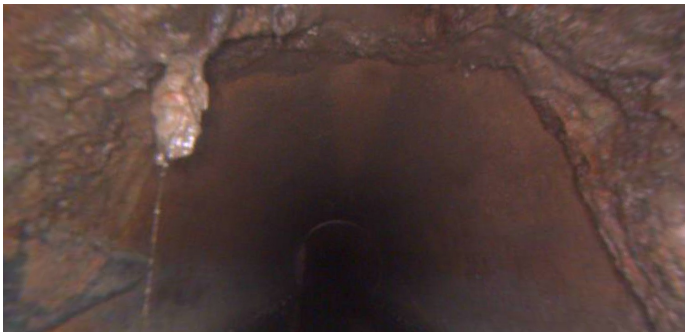
Code:	DAE
Description:	Deposits Attached Encrustation

Distance (ft):	3.7
Structural Grade:	0
O&M Grade:	2
Clock Start/From:	8
Clock To:	4
1st Value:	
2nd Value:	
Value Percent:	10.000
Continuous Index:	S01
Within 8" of Joint:	YES
Remarks:

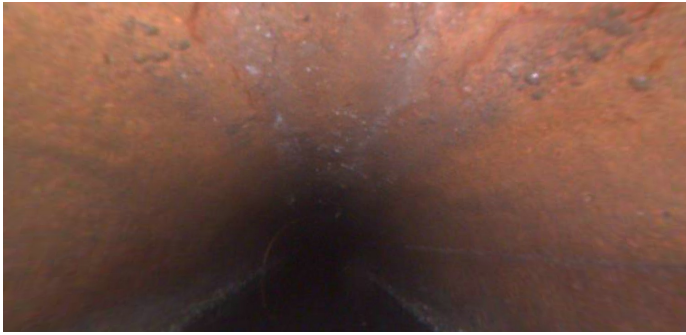
Code: **DAE**
Description: **Deposits Attached Encrustation**

Distance (ft): **13.4**
Structural Grade: **0**
O&M Grade: **2**
Clock Start/From: **8**
Clock To: **4**
1st Value:
2nd Value:
Value Percent: **5.000**
Continuous Index:
Within 8" of Joint: **YES**
Remarks:

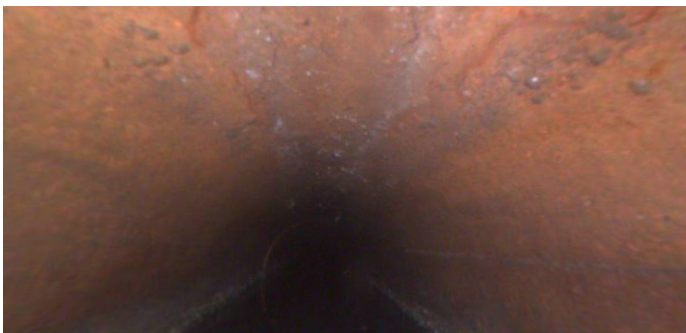
Code: **DAE**
Description: **Deposits Attached Encrustation**

Distance (ft): **13.4**
Structural Grade: **0**
O&M Grade: **2**
Clock Start/From: **8**
Clock To: **4**
1st Value:
2nd Value:
Value Percent: **10.000**
Continuous Index: **F01**
Within 8" of Joint: **YES**
Remarks:

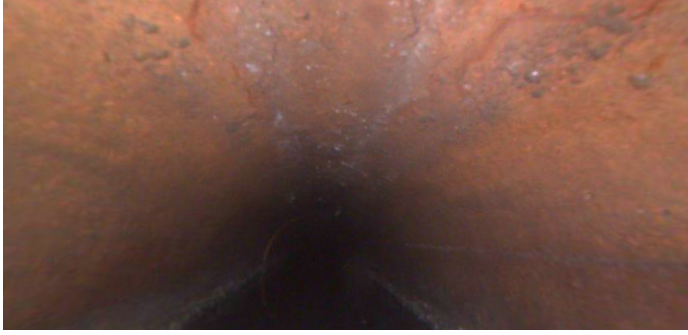
Code:	MSA
Description:	Abandoned Survey
Distance (ft):	13.4
Structural Grade:	0
O&M Grade:	0
Clock Start/From:	
Clock To:	
1st Value:	
2nd Value:	
Value Percent:	
Continuous Index:	
Within 8" of Joint:	NO
Remarks:	DAE
