## Profile/Photo Observation Report

Street:	<b>FOXCROFT STREET</b>	Flow Control:	<b>Not Controlled</b>
City:	<b>Hobart, IN</b>	Year Renewed:	
Location:	<b>Light Highway</b>	Tape/Media #:	
Purpose:	<b>Routine Assessment</b>	Dia/Height:	<b>8"</b>
Use:	<b>Sanitary</b>	Material:	<b>VCP</b>
Drain Area:	<b>NA</b>	Lining:	
Category:	<b>NA</b>		
Comment:	<b>P_C at 25 ft nothing visible . Flow direction wrong</b>		
Location Details:		Direction of Survey:	<b>Upstream</b>
US MH:	<b>M-208-016</b>	DS MH:	<b>M-208-015</b>
		Total Length Surveyed (ft):	<b>26.7</b>

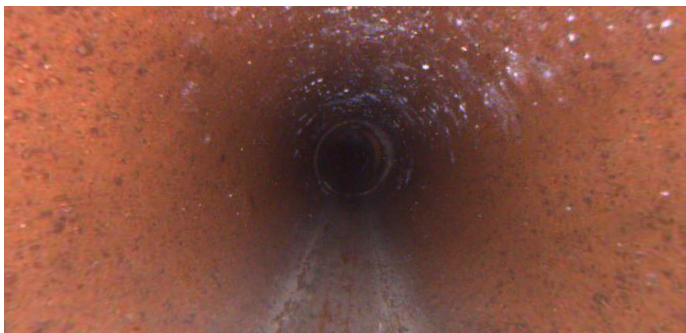
Code: **AMH**  
Description: **Manhole**

Distance (ft): **.0**  
Structural Grade: **0**  
O&M Grade: **0**  
Clock Start/From:  
Clock To:  
1st Value:  
2nd Value:  
Value Percent:  
Continuous Index:  
Within 8" of Joint: **NO**  
Remarks: **M-208-015**

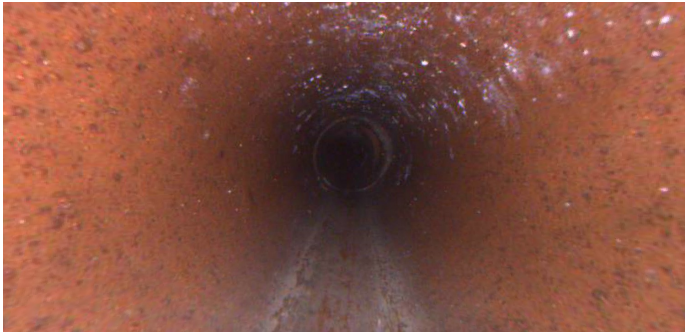
Code:	<b>MWL</b>
Description:	<b>Water Level</b>

Distance (ft):	<b>.0</b>
Structural Grade:	<b>0</b>
O&M Grade:	<b>0</b>
Clock Start/From:	
Clock To:	
1st Value:	
2nd Value:	
Value Percent:	<b>5.000</b>
Continuous Index:	
Within 8" of Joint:	<b>NO</b>
Remarks:

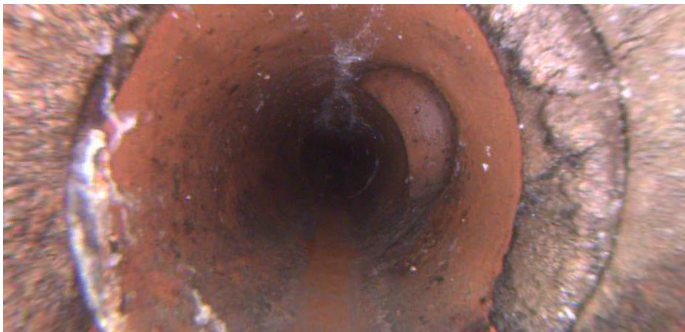
Code:	<b>DAE</b>
Description:	<b>Deposits Attached Encrustation</b>

Distance (ft):	<b>3.2</b>
Structural Grade:	<b>0</b>
O&M Grade:	<b>2</b>
Clock Start/From:	<b>8</b>
Clock To:	<b>4</b>
1st Value:	
2nd Value:	
Value Percent:	<b>5.000</b>
Continuous Index:	
Within 8" of Joint:	<b>YES</b>
Remarks:

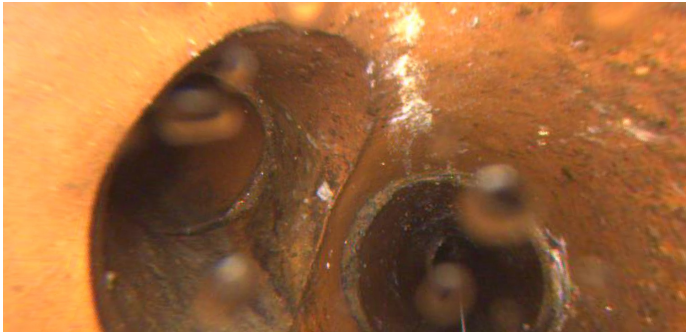
Code: **TF**  
Description: **Tap Factory**

Distance (ft): **4.3**  
Structural Grade: **0**  
O&M Grade: **0**  
Clock Start/From: **3**  
Clock To:  
1st Value: **4.000**  
2nd Value:  
Value Percent:  
Continuous Index:  
Within 8" of Joint:  
Remarks:

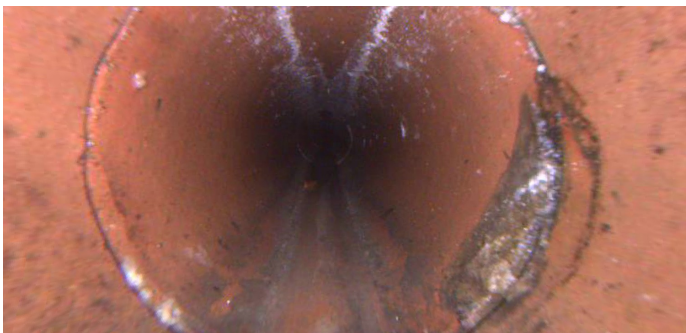
Code: **DAE**  
Description: **Deposits Attached Encrustation**

Distance (ft): **4.8**  
Structural Grade: **0**  
O&M Grade: **2**  
Clock Start/From: **2**  
Clock To: **4**  
1st Value:  
2nd Value:  
Value Percent: **5.000**  
Continuous Index:  
Within 8" of Joint: **YES**  
Remarks:

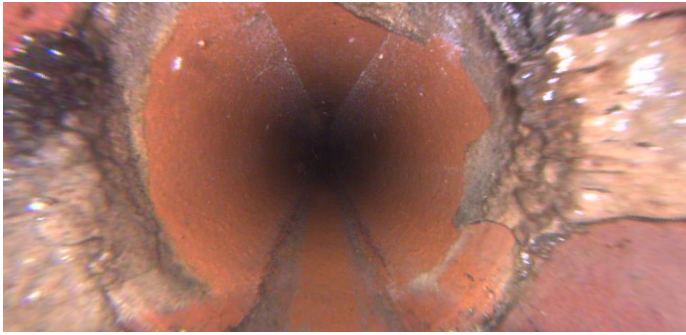
Code: **DAE**  
Description: **Deposits Attached Encrustation**

Distance (ft): **16.8**  
Structural Grade: **0**  
O&M Grade: **2**  
Clock Start/From: **8**  
Clock To: **4**  
1st Value:  
2nd Value:  
Value Percent: **5.000**  
Continuous Index:  
Within 8" of Joint: **YES**  
Remarks:

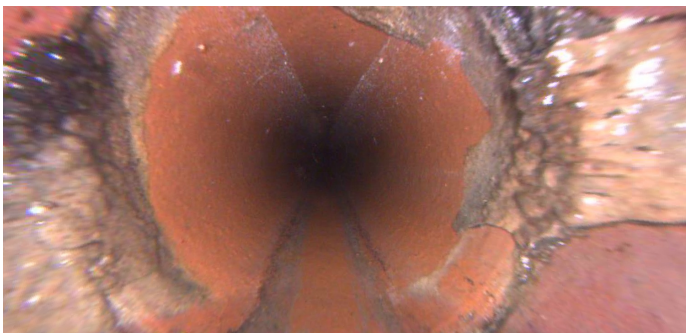
Code: **IW**  
Description: **Infil Weeper**

Distance (ft): **16.8**  
Structural Grade: **0**  
O&M Grade: **2**  
Clock Start/From: **8**  
Clock To: **4**  
1st Value:  
2nd Value:  
Value Percent:  
Continuous Index:  
Within 8" of Joint: **YES**  
Remarks:

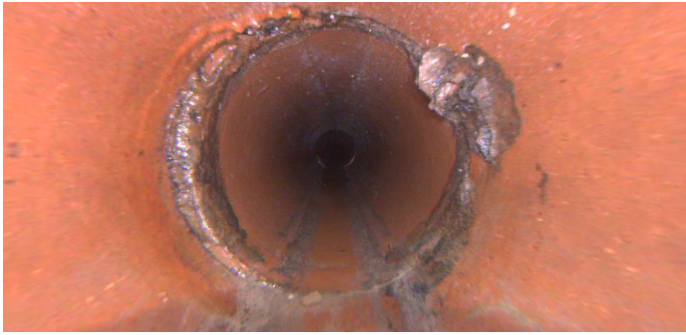
Code: **DAE**  
Description: **Deposits Attached Encrustation**

Distance (ft): **22.6**  
Structural Grade: **0**  
O&M Grade: **2**  
Clock Start/From: **8**  
Clock To: **4**  
1st Value:  
2nd Value:  
Value Percent: **10.000**  
Continuous Index:  
Within 8" of Joint: **YES**  
Remarks:

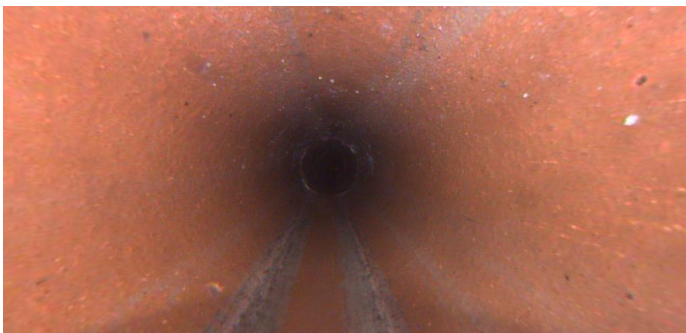
Code: **MSA**  
Description: **Abandoned Survey**

Distance (ft): **26.7**  
Structural Grade: **0**  
O&M Grade: **0**  
Clock Start/From:  
Clock To:  
1st Value:  
2nd Value:  
Value Percent:  
Continuous Index:  
Within 8" of Joint: **NO**  
Remarks: **UNKNOWN**
