Profile/Photo Observation Report

Date:	08/20/2024	Weather:		Coding:	PACP 7.0
Pipe Length (ft):		Owner:	City of Hobart	Pre Clean:	Heavy Cleaning
P.O.#:		Surveyor:	S. Bucklin	PSR:	P-208-016-017
Customer:	City of Hobart	Clean Date:	07/29/2024	Shape:	C

Street:	17th Street	Flow Control:	Not Controlled
City:	Hobart, IN	Year Renewed:	
Location:	Easement/Right of Way	Tape/Media #:	
Purpose:	Sewer System Evaluation Survey (SS)	Dia/Height:	8"
Use:	Sanitary Sewage Pipe	Material:	VCP
Drain Area:		Lining:	None
Category:	NA		
Comment:			
Location Details:	4509 17TH ST BACK YARD	Direction of Survey:	Downstream
US MH:	M-208-017	DS MH:	M-208-016
		Total Length Surveyed (ft):	276.4

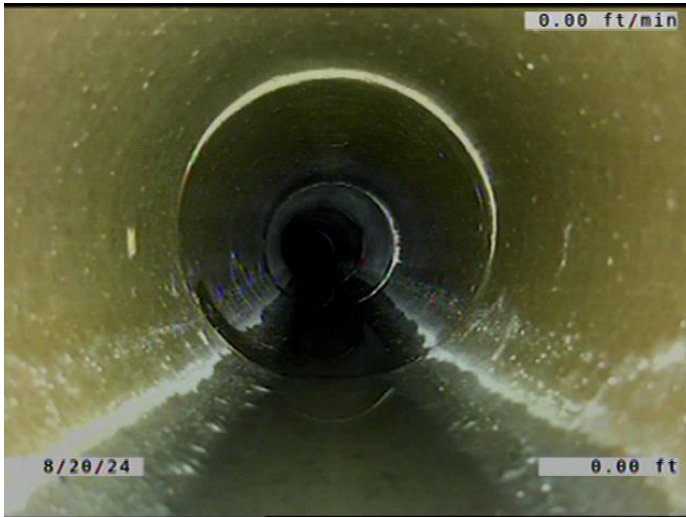
Code: **MWL**
Description: **Miscellaneous Water Level**

Distance (ft): **.0**
Structural Grade: **0**
O&M Grade: **0**
Clock Start/From:
Clock To:
1st Value:
2nd Value:
Value Percent: **5.000**
Continuous Index:
Within 8" of Joint: **NO**
Remarks:

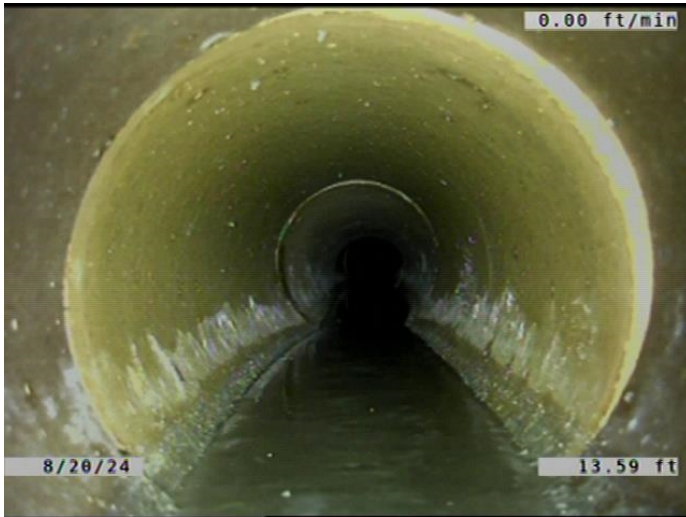
Code: **MWLS**
Description: **Miscellaneous Water Level Sag**

Distance (ft): **13.6**
Structural Grade: **2**
O&M Grade: **0**
Clock Start/From:
Clock To:
1st Value:
2nd Value:
Value Percent: **10.000**
Continuous Index: **S02**
Within 8" of Joint: **NO**
Remarks:

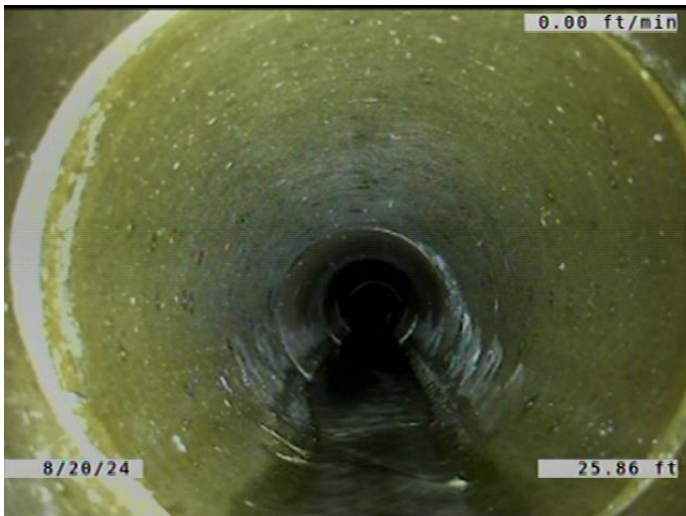
Code: **MWLS**
Description: **Miscellaneous Water Level Sag**

Distance (ft): **25.9**
Structural Grade: **2**
O&M Grade: **0**
Clock Start/From:
Clock To:
1st Value:
2nd Value:
Value Percent: **10.000**
Continuous Index: **F02**
Within 8" of Joint: **NO**
Remarks:

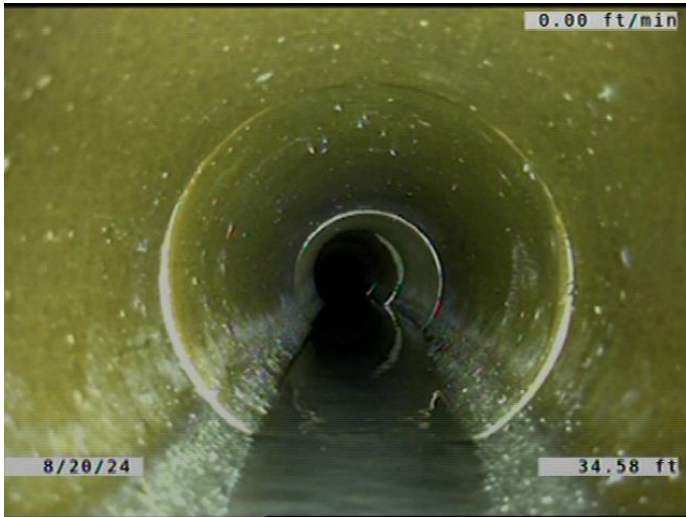
Code: **MWLS**
Description: **Miscellaneous Water Level Sag**

Distance (ft): **34.6**
Structural Grade: **2**
O&M Grade: **0**
Clock Start/From:
Clock To:
1st Value:
2nd Value:
Value Percent: **15.000**
Continuous Index: **S03**
Within 8" of Joint: **NO**
Remarks:

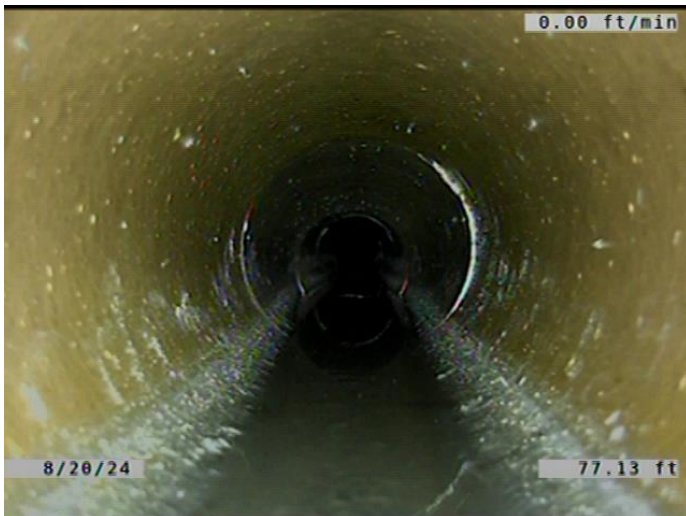
Code: **MWLS**
Description: **Miscellaneous Water Level Sag**

Distance (ft): **77.1**
Structural Grade: **2**
O&M Grade: **0**
Clock Start/From:
Clock To:
1st Value:
2nd Value:
Value Percent: **15.000**
Continuous Index: **S04**
Within 8" of Joint: **NO**
Remarks:

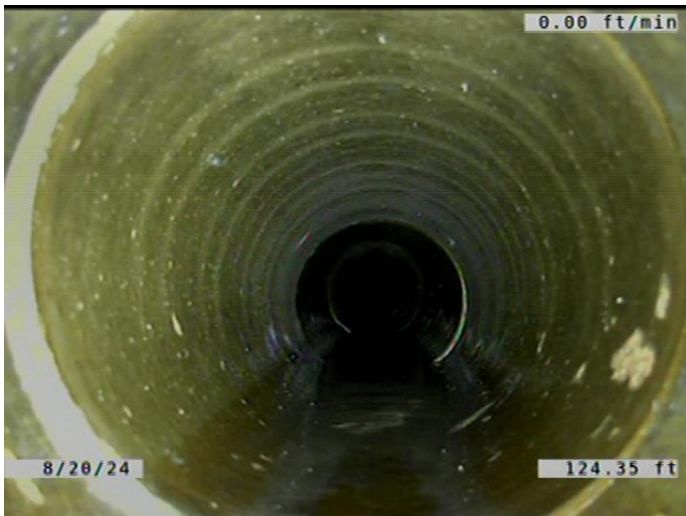
Code: **MWLS**
Description: **Miscellaneous Water Level Sag**

Distance (ft): **124.4**
Structural Grade: **2**
O&M Grade: **0**
Clock Start/From:
Clock To:
1st Value:
2nd Value:
Value Percent: **15.000**
Continuous Index: **F04**
Within 8" of Joint: **NO**
Remarks:

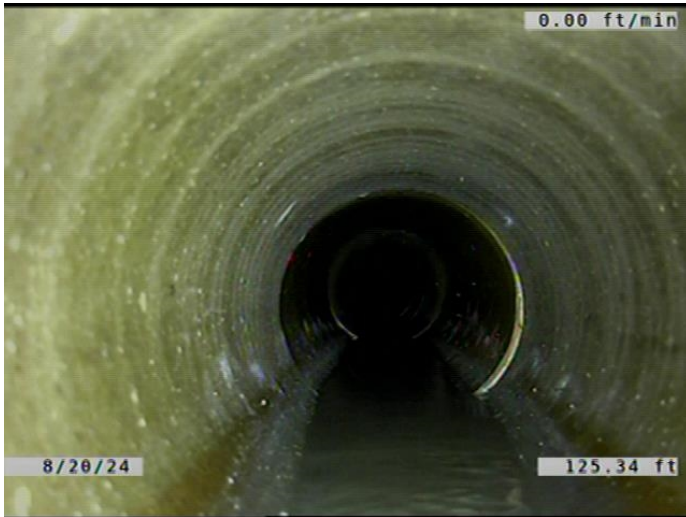
Code: **MWLS**
Description: **Miscellaneous Water Level Sag**

Distance (ft): **125.3**
Structural Grade: **2**
O&M Grade: **0**
Clock Start/From:
Clock To:
1st Value:
2nd Value:
Value Percent: **10.000**
Continuous Index: **S06**
Within 8" of Joint: **NO**
Remarks:

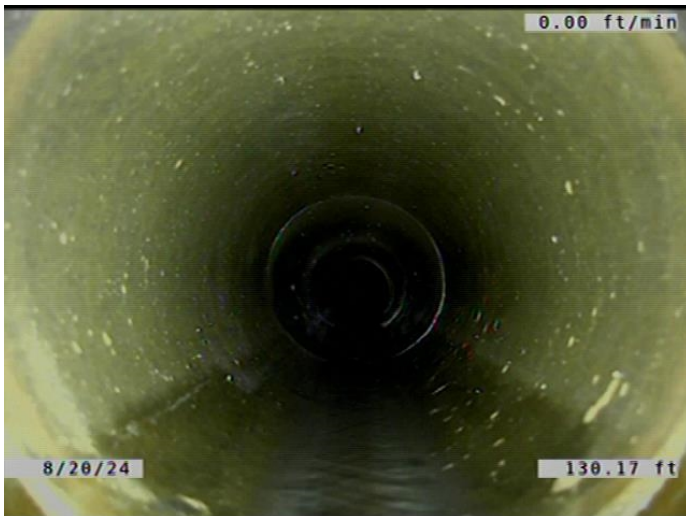
Code: **MWLS**
Description: **Miscellaneous Water Level Sag**

Distance (ft): **130.2**
Structural Grade: **2**
O&M Grade: **0**
Clock Start/From:
Clock To:
1st Value:
2nd Value:
Value Percent: **10.000**
Continuous Index: **F06**
Within 8" of Joint: **NO**
Remarks:

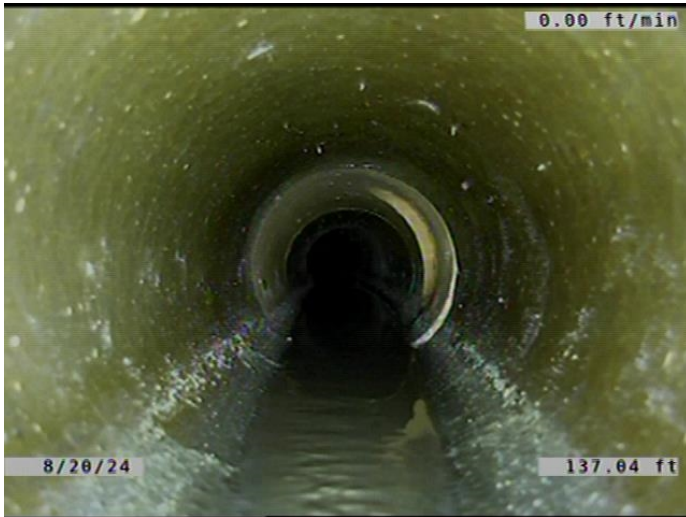
Code: **MWLS**
Description: **Miscellaneous Water Level Sag**

Distance (ft): **137.0**
Structural Grade: **2**
O&M Grade: **0**
Clock Start/From:
Clock To:
1st Value:
2nd Value:
Value Percent: **10.000**
Continuous Index: **S07**
Within 8" of Joint: **NO**
Remarks:

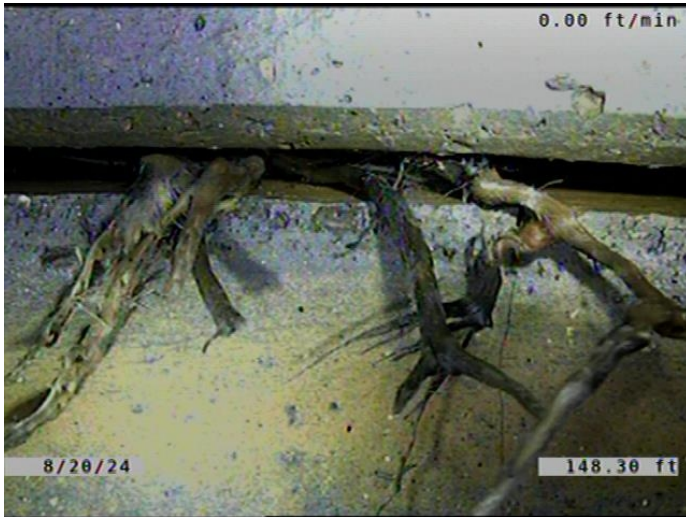
Code: **RFJ**
 Description: **Roots Fine Joint**

Distance (ft): **148.3**
 Structural Grade: **0**
 O&M Grade: **1**
 Clock Start/From: **8**
 Clock To: **4**
 1st Value:
 2nd Value:
 Value Percent:
 Continuous Index: **S08**
 Within 8" of Joint: **YES**
 Remarks:

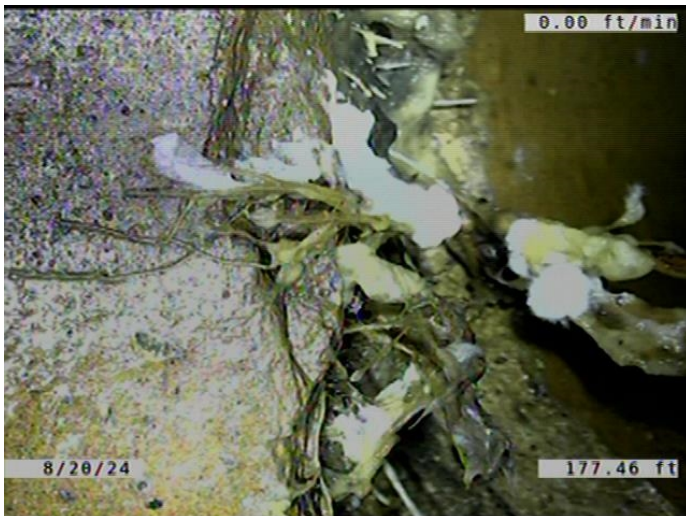
Code: **RFC**
 Description: **Roots Fine Connection**

Distance (ft): **177.5**
 Structural Grade: **0**
 O&M Grade: **1**
 Clock Start/From: **11**
 Clock To: **1**
 1st Value:
 2nd Value:
 Value Percent:
 Continuous Index:
 Within 8" of Joint: **NO**
 Remarks:

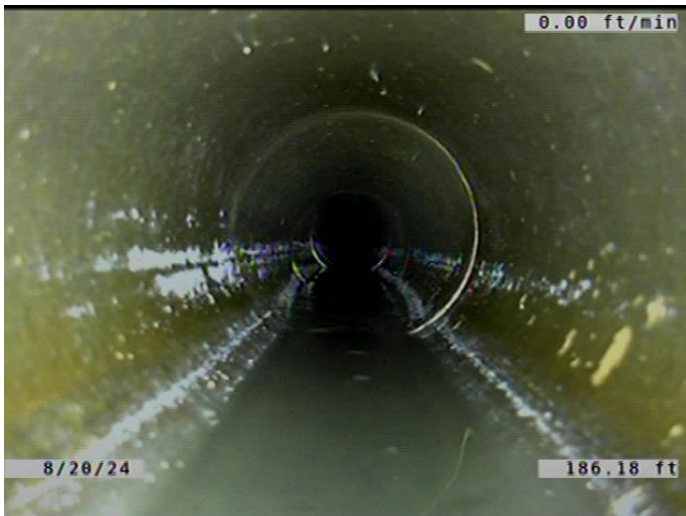
Code:	DAGS
Description:	Deposits Attached Grease
Distance (ft):	186.1
Structural Grade:	0
O&M Grade:	2
Clock Start/From:	1
Clock To:	11
1st Value:	
2nd Value:	
Value Percent:	5.000
Continuous Index:	S09
Within 8" of Joint:	YES
Remarks:

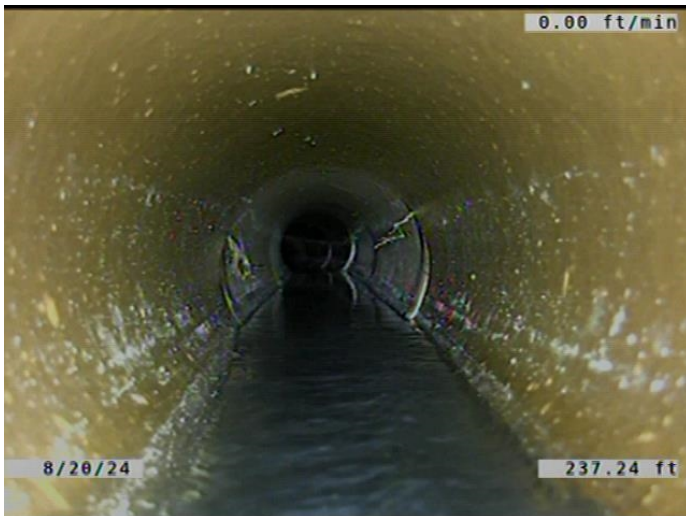
Code: **MWLS**
Description: **Miscellaneous Water Level Sag**

Distance (ft): **237.2**
Structural Grade: **2**
O&M Grade: **0**
Clock Start/From:
Clock To:
1st Value:
2nd Value:
Value Percent: **10.000**
Continuous Index: **S11**
Within 8" of Joint: **NO**
Remarks:

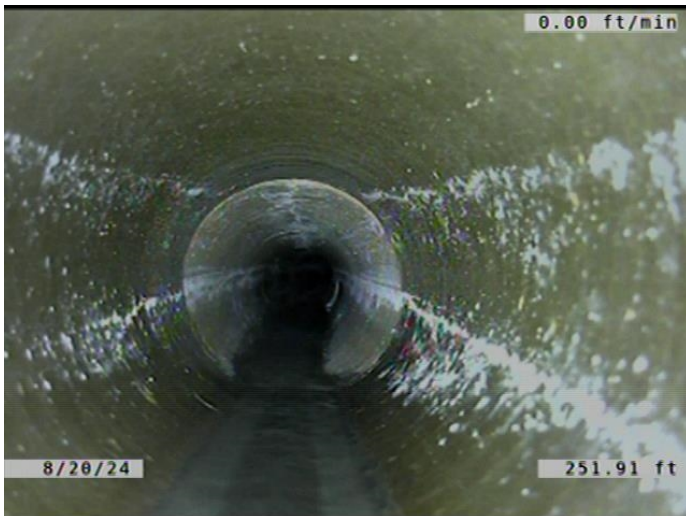
Code: **LD**
Description: **Line Down**

Distance (ft): **251.9**
Structural Grade: **0**
O&M Grade: **1**
Clock Start/From:
Clock To:
1st Value:
2nd Value:
Value Percent: **5.000**
Continuous Index:
Within 8" of Joint: **NO**
Remarks:

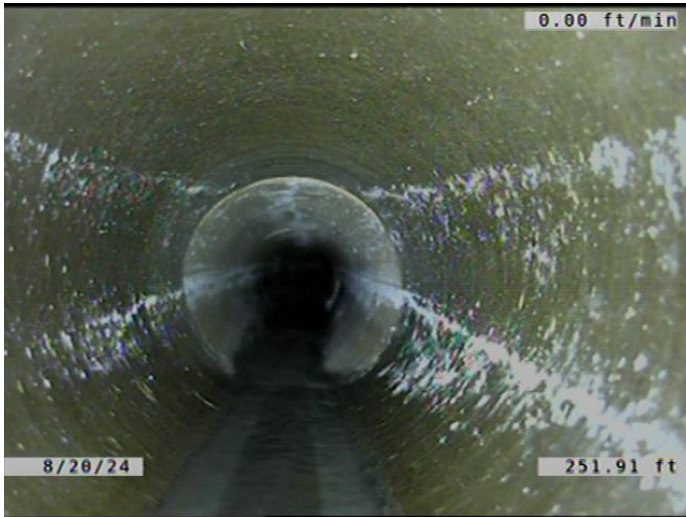
Code: **RFJ**
Description: **Roots Fine Joint**

Distance (ft): **251.9**
Structural Grade: **0**
O&M Grade: **1**
Clock Start/From: **8**
Clock To: **4**
1st Value:
2nd Value:
Value Percent:
Continuous Index: **F10**
Within 8" of Joint: **YES**
Remarks:

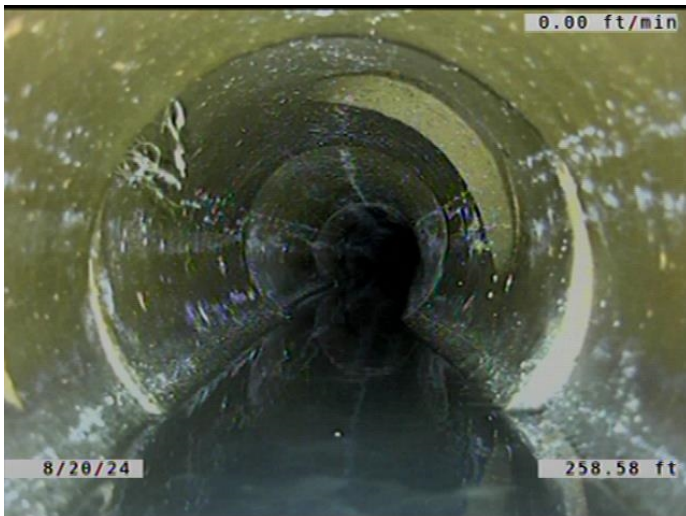
Code: **MWLS**
Description: **Miscellaneous Water Level Sag**

Distance (ft): **258.6**
Structural Grade: **2**
O&M Grade: **0**
Clock Start/From:
Clock To:
1st Value:
2nd Value:
Value Percent: **10.000**
Continuous Index: **S12**
Within 8" of Joint: **NO**
Remarks:

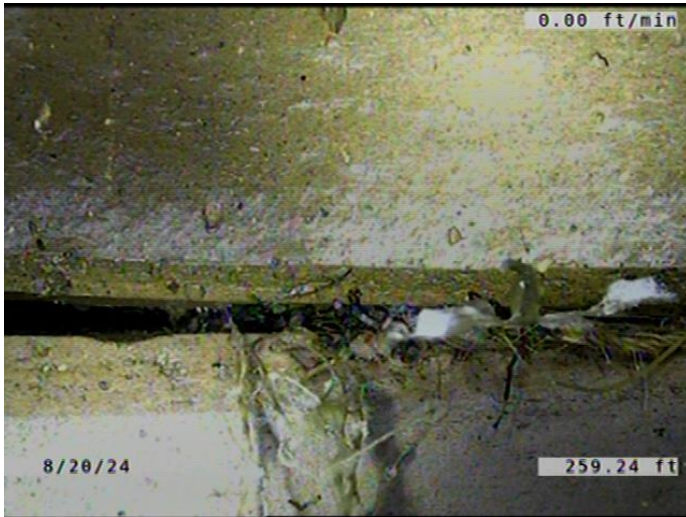
Code: **RFJ**
 Description: **Roots Fine Joint**

Distance (ft): **259.2**
 Structural Grade: **0**
 O&M Grade: **1**
 Clock Start/From: **9**
 Clock To: **3**
 1st Value:
 2nd Value:
 Value Percent:
 Continuous Index:
 Within 8" of Joint: **YES**
 Remarks:

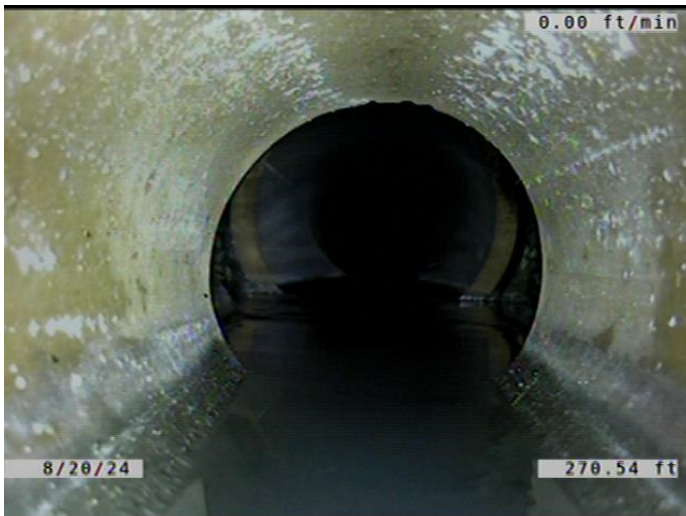
Code: **LD**
Description: **Line Down**

Distance (ft): **270.5**
Structural Grade: **0**
O&M Grade: **1**
Clock Start/From:
Clock To:
1st Value:
2nd Value:
Value Percent: **5.000**
Continuous Index:
Within 8" of Joint: **NO**
Remarks:

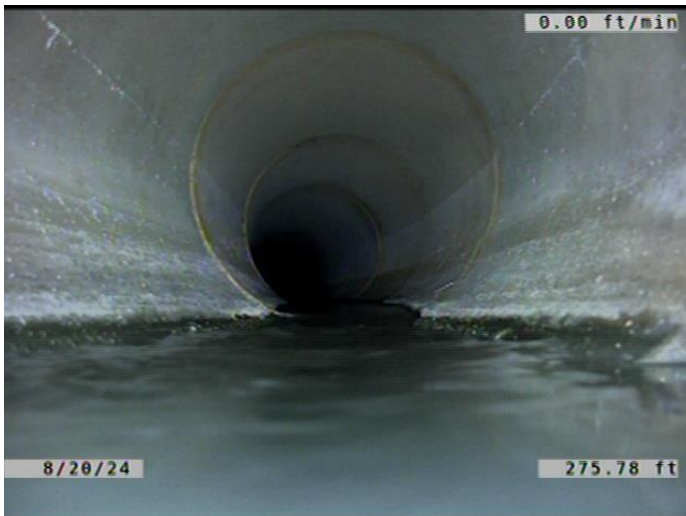
Code: **DAGS**
Description: **Deposits Attached Grease**

Distance (ft): **275.8**
Structural Grade: **0**
O&M Grade: **2**
Clock Start/From: **1**
Clock To: **11**
1st Value:
2nd Value:
Value Percent: **5.000**
Continuous Index: **F09**
Within 8" of Joint: **YES**
Remarks:

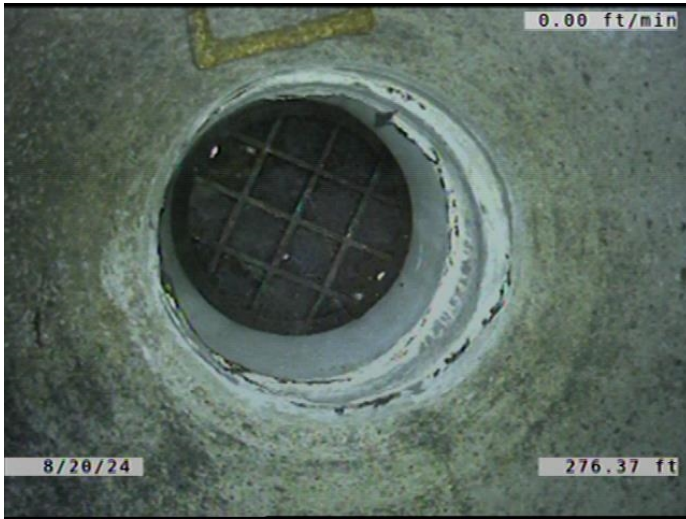
Code:	AMH
Description:	Manhole
Distance (ft):	276.4
Structural Grade:	0
O&M Grade:	0
Clock Start/From:	
Clock To:	
1st Value:	
2nd Value:	
Value Percent:	
Continuous Index:	
Within 8" of Joint:	NO
Remarks:	M-208-016
