Profile/Photo Observation Report

Street:	Brookview Court	Flow Control:	Not Controlled
City:	Hobart, IN	Year Renewed:	
Location:	Yard	Tape/Media #:	DEP236
Purpose:	Routine Assessment	Dia/Height:	15"
Use:	Sanitary	Material:	VCP
Drain Area:		Lining:	
Category:	NA		
Comment:	YES501824 Submittal 2		
Location Details:		Direction of Survey:	Downstream
US MH:	M-208-017	DS MH:	M-208-018
		Total Length Surveyed (ft):	19.6

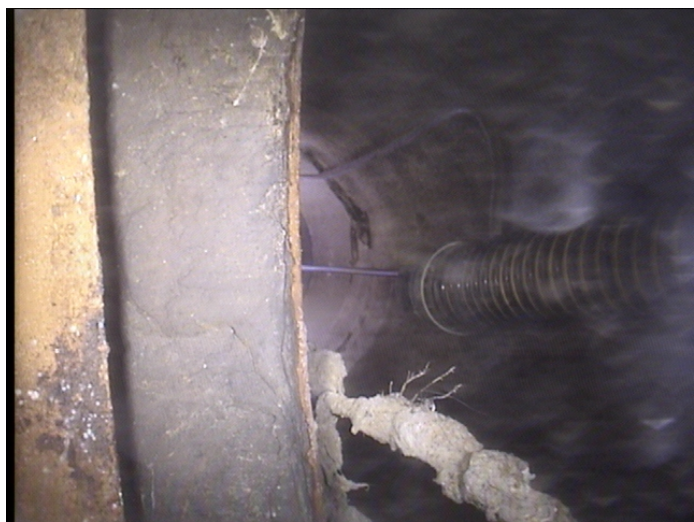
Code: **AMH**
Description: **Manhole**

Distance (ft): **.0**
Structural Grade: **0**
O&M Grade: **0**
Clock Start/From:
Clock To:
1st Value:
2nd Value:
Value Percent:
Continuous Index:
Within 8" of Joint: **NO**
Remarks: **M-208-017**

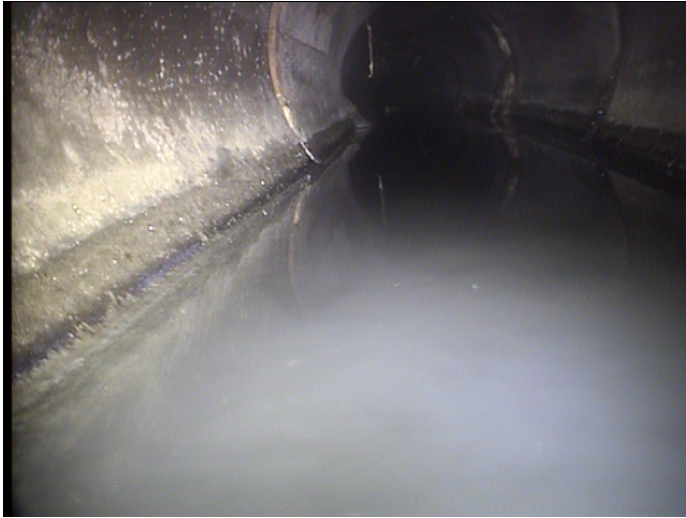
Code: **MWL**
Description: **Water Level**

Distance (ft): **.0**
Structural Grade: **0**
O&M Grade: **0**
Clock Start/From:
Clock To:
1st Value:
2nd Value:
Value Percent: **10.000**
Continuous Index:
Within 8" of Joint: **NO**
Remarks:

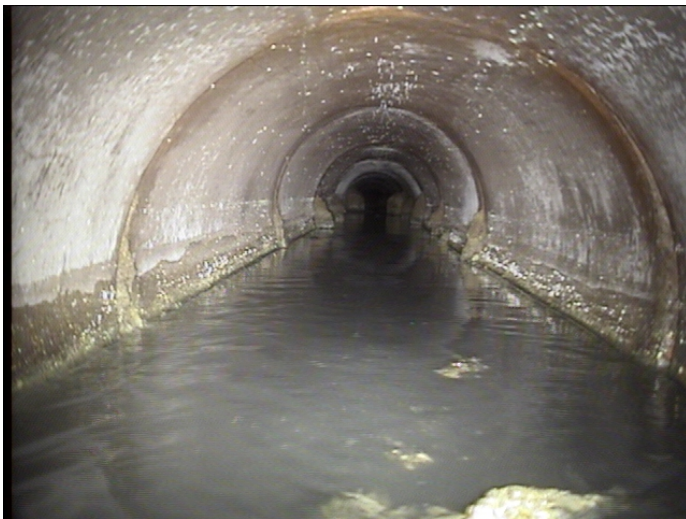
Code: **DSF**
Description: **Deposits Settled Fine**

Distance (ft): **13.9**
Structural Grade: **0**
O&M Grade: **2**
Clock Start/From: **5**
Clock To: **7**
1st Value:
2nd Value:
Value Percent: **10.000**
Continuous Index:
Within 8" of Joint: **NO**
Remarks:

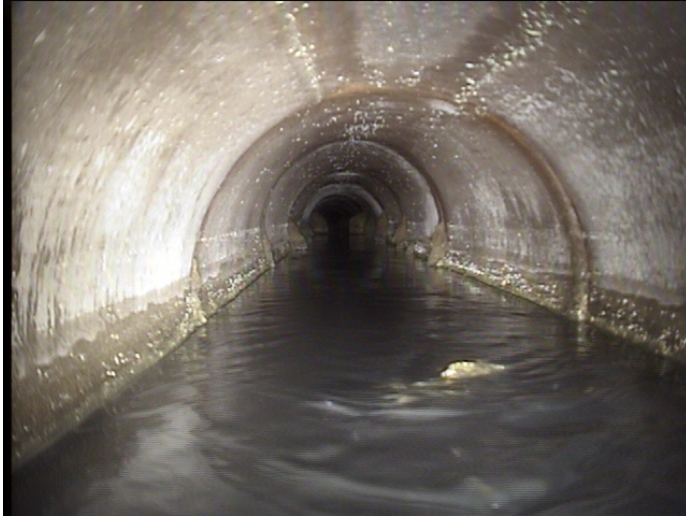
Code:	MSA
Description:	Abandoned Survey
Distance (ft):	13.9
Structural Grade:	0
O&M Grade:	0
Clock Start/From:	
Clock To:	
1st Value:	
2nd Value:	
Value Percent:	
Continuous Index:	
Within 8" of Joint:	NO
Remarks:	Heavy sediment
