## Profile/Photo Observation Report

Date:	<b>04/11/2018</b>	Weather:		Coding:	<b>PACP 6.0</b>
Pipe Length (ft):		Owner:	<b>City of Hobart</b>	Pre Clean:	<b>Not Known</b>
P.O.#:	<b>235</b>	Surveyor:	<b>B. Helbling</b>	PSR:	<b>P-208-024-017</b>
Customer:	<b>City of Hobart</b>	Clean Date:		Shape:	<b>C</b>

Street:	<b>Brookview Court</b>	Flow Control:	<b>Not Controlled</b>
City:	<b>Hobart, IN</b>	Year Renewed:	
Location:	<b>Yard</b>	Tape/Media #:	<b>DEP235</b>
Purpose:	<b>Routine Assessment</b>	Dia/Height:	<b>15"</b>
Use:	<b>Sanitary</b>	Material:	<b>VCP</b>
Drain Area:		Lining:	
Category:	<b>NA</b>		
Comment:	<b>YES501824 Submittal 2</b>		
Location Details:		Direction of Survey:	<b>Upstream</b>
US MH:	<b>M-208-017</b>	DS MH:	<b>M-208-024</b>
		Total Length Surveyed (ft):	<b>97.4</b>

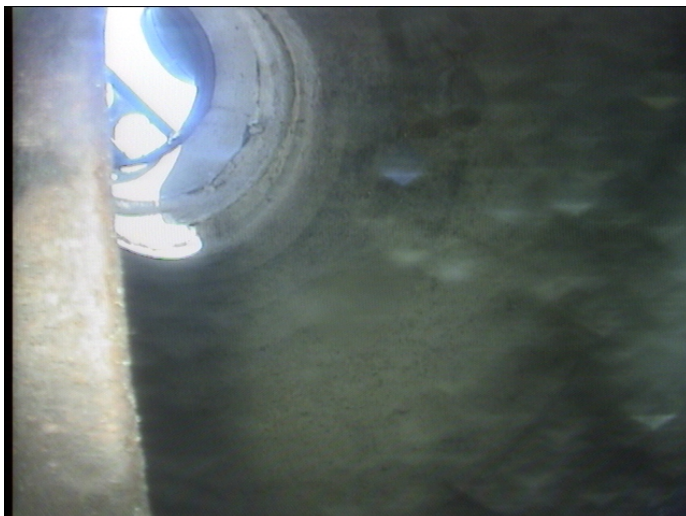
Code: **AMH**  
Description: **Manhole**

Distance (ft): **.0**  
Structural Grade: **0**  
O&M Grade: **0**  
Clock Start/From:  
Clock To:  
1st Value:  
2nd Value:  
Value Percent:  
Continuous Index:  
Within 8" of Joint: **NO**  
Remarks: **M-208-017**

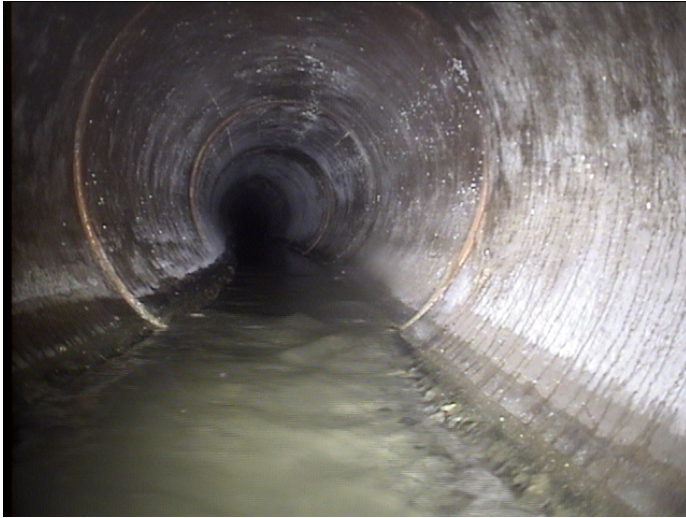
Code: **MWL**  
Description: **Water Level**

Distance (ft): **.0**  
Structural Grade: **0**  
O&M Grade: **0**  
Clock Start/From:  
Clock To:  
1st Value:  
2nd Value:  
Value Percent: **5.000**  
Continuous Index:  
Within 8" of Joint: **NO**  
Remarks:

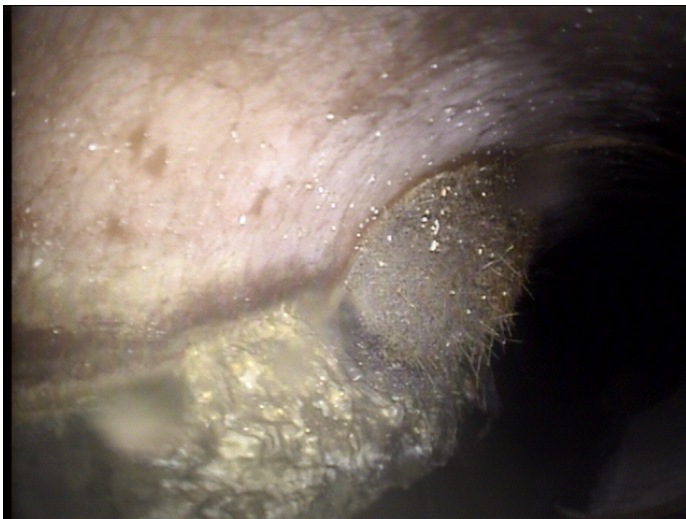
Code: **RMJ**  
Description: **Roots Medium Joint**

Distance (ft): **68.8**  
Structural Grade: **0**  
O&M Grade: **3**  
Clock Start/From: **8**  
Clock To: **11**  
1st Value:  
2nd Value:  
Value Percent: **10.000**  
Continuous Index:  
Within 8" of Joint: **YES**  
Remarks:

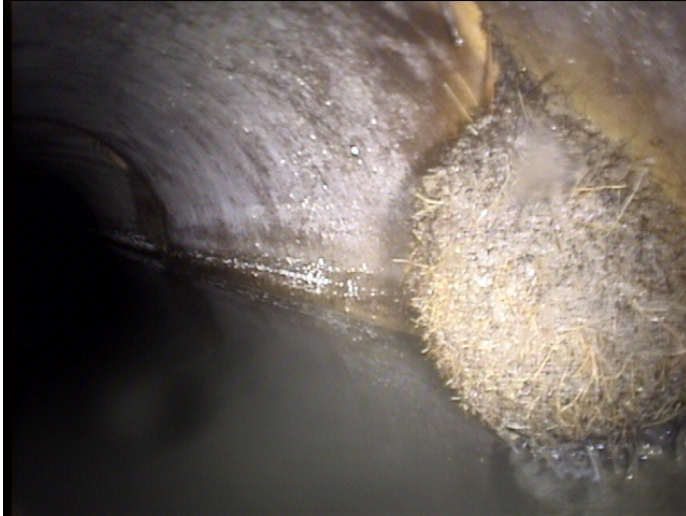
Code:	<b>RMJ</b>
Description:	<b>Roots Medium Joint</b>
Distance (ft):	<b>73.3</b>
Structural Grade:	<b>0</b>
O&M Grade:	<b>3</b>
Clock Start/From:	<b>2</b>
Clock To:	<b>4</b>
1st Value:	
2nd Value:	
Value Percent:	<b>5.000</b>
Continuous Index:	
Within 8" of Joint:	<b>YES</b>
Remarks:

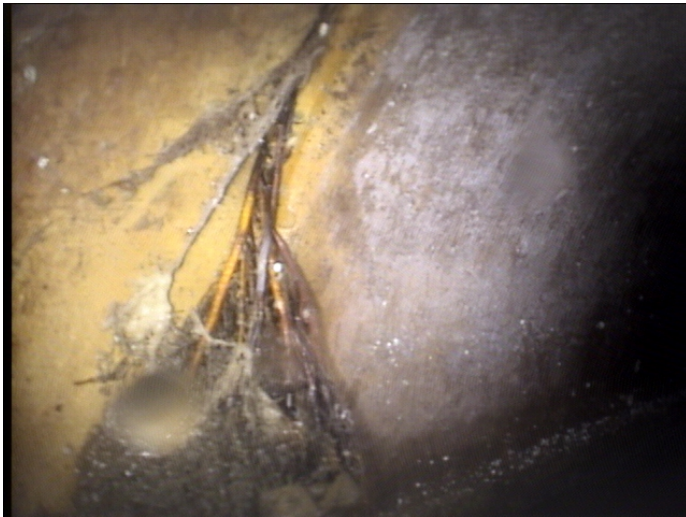
Code:	<b>RFJ</b>
Description:	<b>Roots Fine Joint</b>
Distance (ft):	<b>75.5</b>
Structural Grade:	<b>0</b>
O&M Grade:	<b>1</b>
Clock Start/From:	<b>8</b>
Clock To:	<b>9</b>
1st Value:	
2nd Value:	
Value Percent:	
Continuous Index:	
Within 8" of Joint:	<b>YES</b>
Remarks:

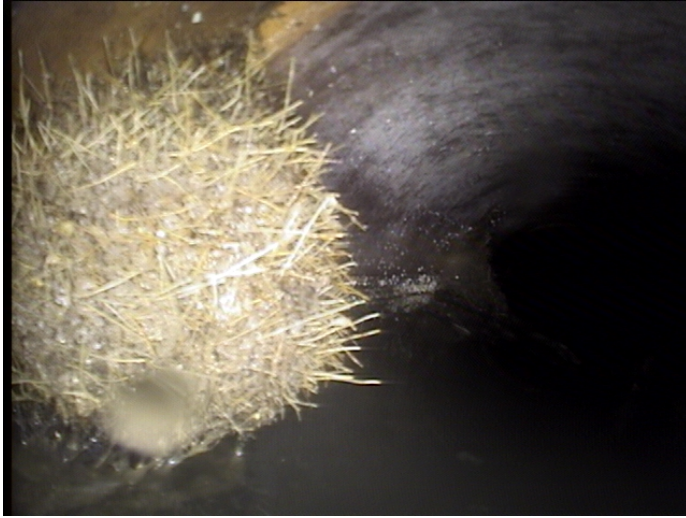
Code:	<b>RFJ</b>
Description:	<b>Roots Fine Joint</b>
Distance (ft):	<b>81.1</b>
Structural Grade:	<b>0</b>
O&M Grade:	<b>1</b>
Clock Start/From:	<b>8</b>
Clock To:	<b>10</b>
1st Value:	
2nd Value:	
Value Percent:	
Continuous Index:	
Within 8" of Joint:	<b>YES</b>
Remarks:

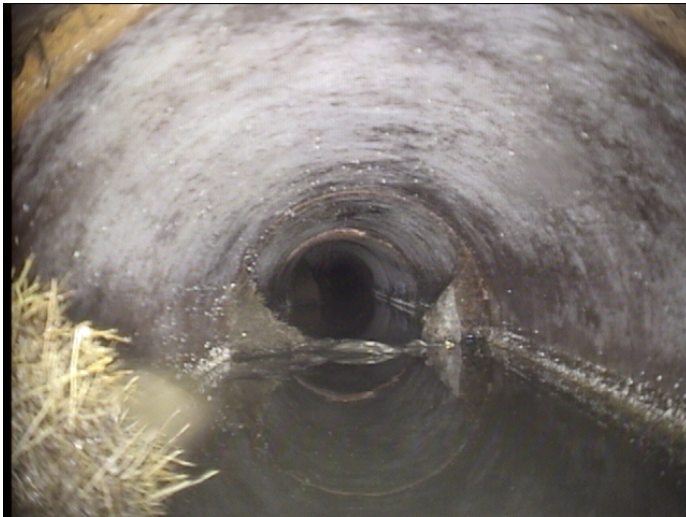
Code:	<b>MWL</b>
Description:	<b>Water Level</b>
Distance (ft):	<b>81.1</b>
Structural Grade:	<b>0</b>
O&M Grade:	<b>0</b>
Clock Start/From:	
Clock To:	
1st Value:	
2nd Value:	
Value Percent:	<b>30.000</b>
Continuous Index:	
Within 8" of Joint:	<b>NO</b>
Remarks:

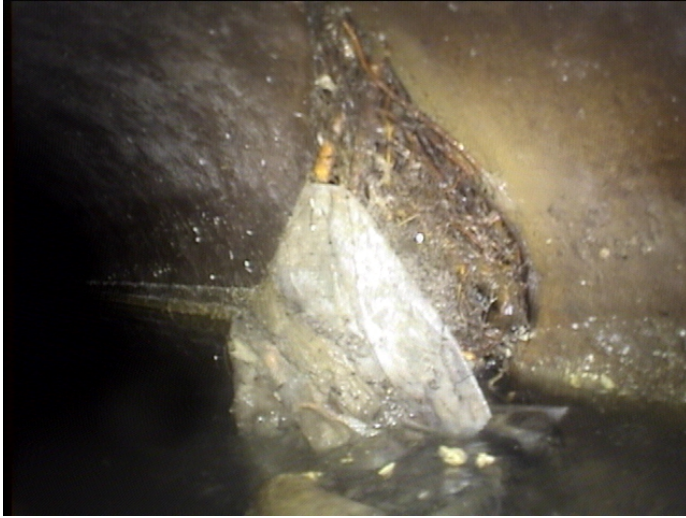
Code: **RFJ**  
Description: **Roots Fine Joint**

Distance (ft): **84.5**  
Structural Grade: **0**  
O&M Grade: **1**  
Clock Start/From: **8**  
Clock To: **4**  
1st Value:  
2nd Value:  
Value Percent:  
Continuous Index:  
Within 8" of Joint: **YES**  
Remarks:

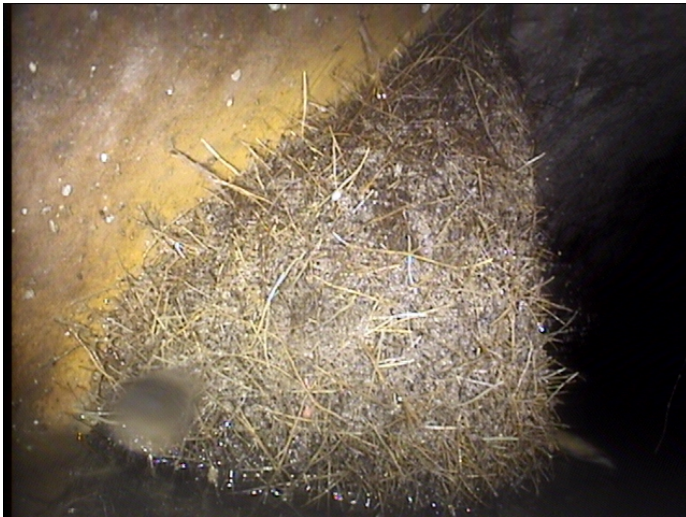
Code: **RFJ**  
Description: **Roots Fine Joint**

Distance (ft): **91.2**  
Structural Grade: **0**  
O&M Grade: **1**  
Clock Start/From: **8**  
Clock To: **10**  
1st Value:  
2nd Value:  
Value Percent:  
Continuous Index:  
Within 8" of Joint: **YES**  
Remarks:

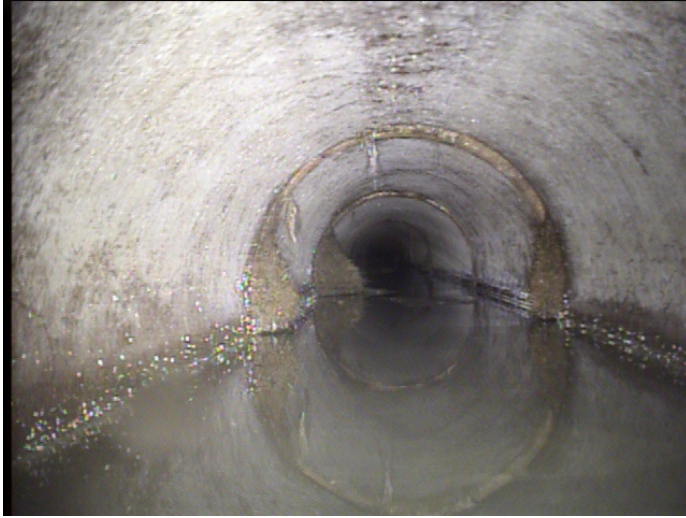
Code: **DSF**  
Description: **Deposits Settled Fine**

Distance (ft): **94.3**  
Structural Grade: **0**  
O&M Grade: **2**  
Clock Start/From: **4**  
Clock To: **8**  
1st Value:  
2nd Value:  
Value Percent: **10.000**  
Continuous Index: **S01**  
Within 8" of Joint: **NO**  
Remarks:

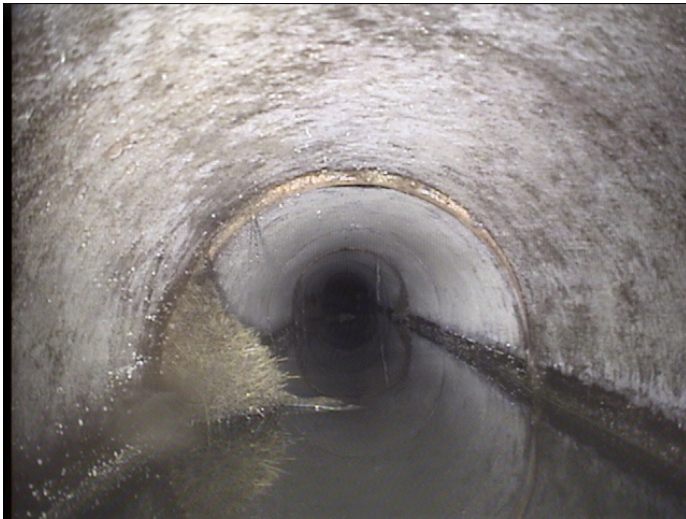
Code: **DSF**  
Description: **Deposits Settled Fine**

Distance (ft): **97.4**  
Structural Grade: **0**  
O&M Grade: **2**  
Clock Start/From: **4**  
Clock To: **8**  
1st Value:  
2nd Value:  
Value Percent: **10.000**  
Continuous Index: **F01**  
Within 8" of Joint: **NO**  
Remarks:

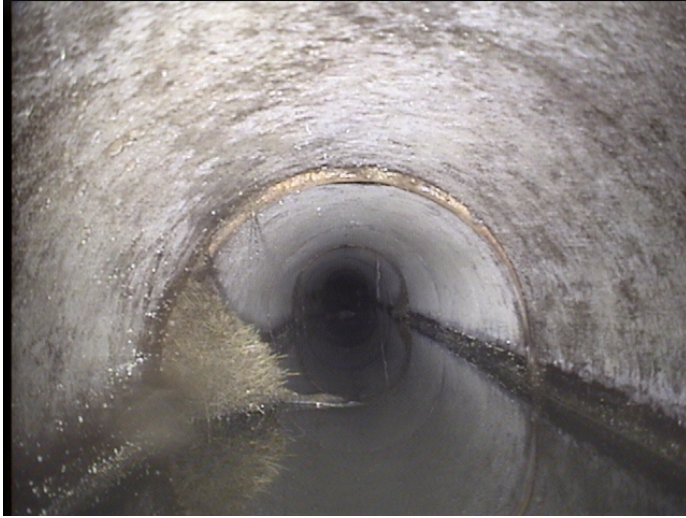
Code:	<b>MSA</b>
Description:	<b>Abandoned Survey</b>
Distance (ft):	<b>97.4</b>
Structural Grade:	<b>0</b>
O&M Grade:	<b>0</b>
Clock Start/From:	
Clock To:	
1st Value:	
2nd Value:	
Value Percent:	
Continuous Index:	
Within 8" of Joint:	<b>NO</b>
Remarks:	<b>Sediment</b>
