Profile/Photo Observation Report

O&M Index:	1.89	O&M Quick:	342E	O&M Rating:	87.00
Structural Index:	3.76	Structural Quick:	4139	Structural Rating:	233.00
Overall Index:	2.96	Overall Quick:	413A	Overall Rating:	320.00

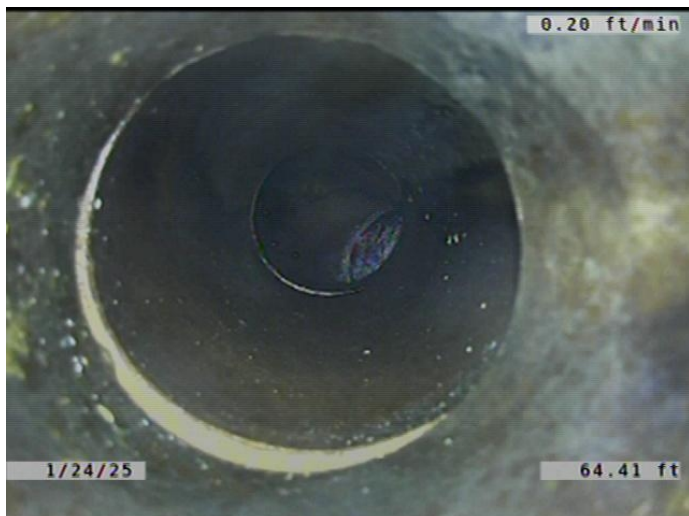
Code:	TF
Description:	Tap Factory
Distance (ft):	64.4
Structural Grade:	0
O&M Grade:	0
Clock Start/From:	1
Clock To:	
1st Value:	6.000
2nd Value:	
Value Percent:	
Continuous Index:	
Within 8" of Joint:	YES
Remarks:

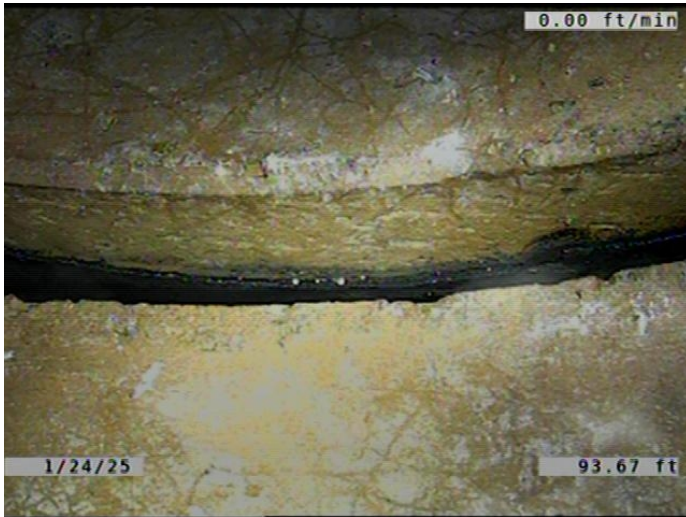
Code: **JOMD**
Description: **Joint Offset Medium Defective**

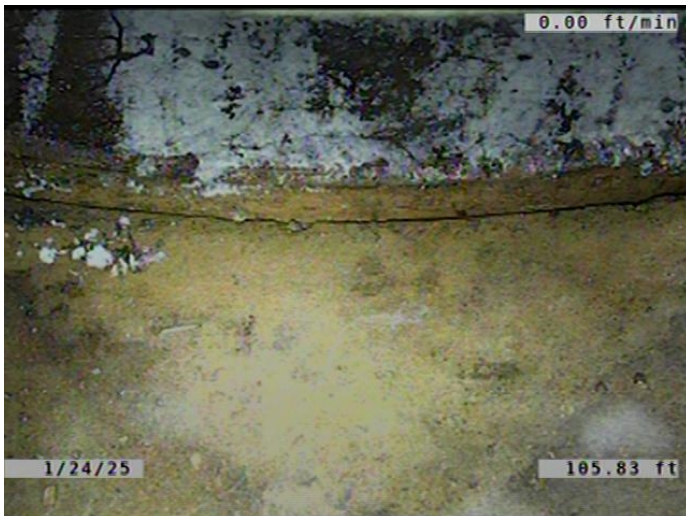
Code: **JOMD**
Description: **Joint Offset Medium Defective**

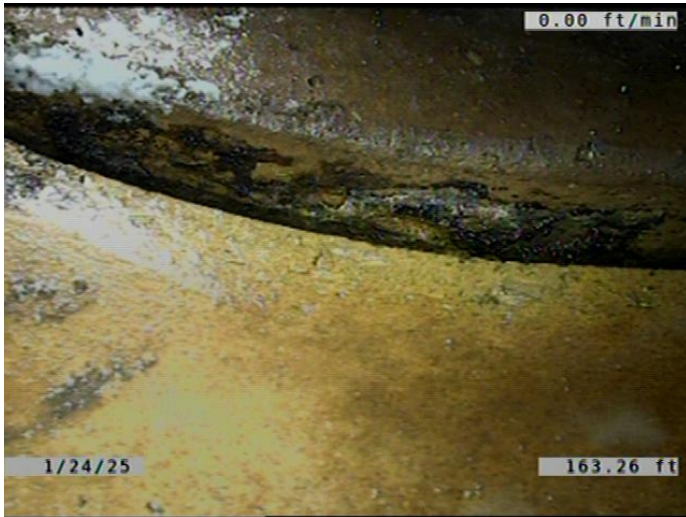
Code: **JOMD**
Description: **Joint Offset Medium Defective**

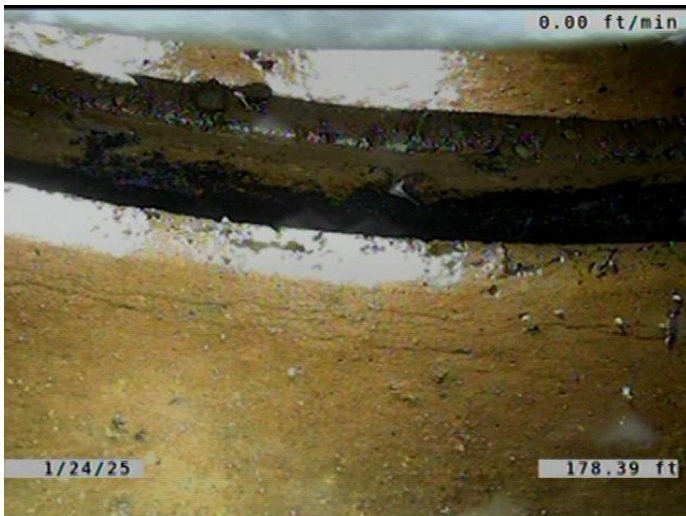
Code: **JOMD**
Description: **Joint Offset Medium Defective**

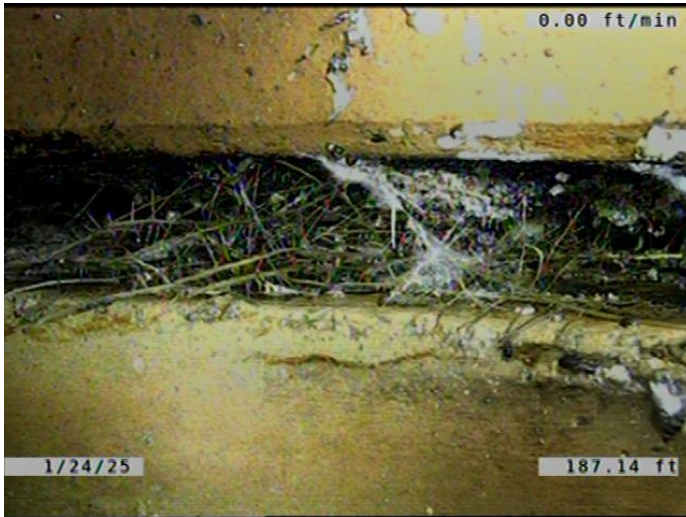
Code: **RFJ**
Description: **Roots Fine Joint**

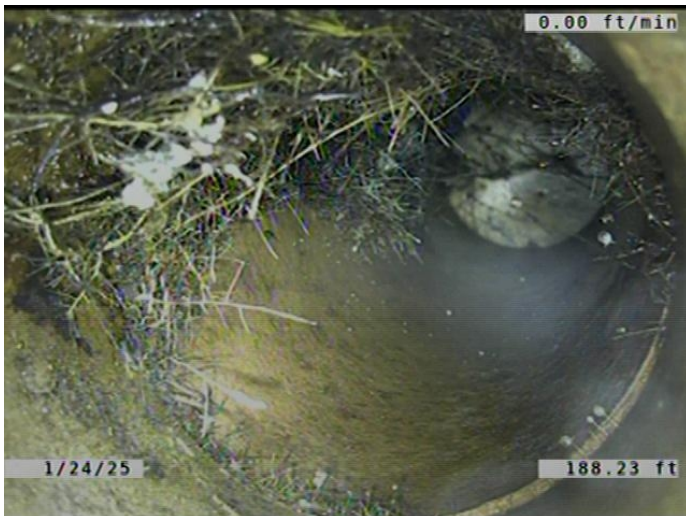
Code: **TFD**
Description: **Tap Factory Defective**

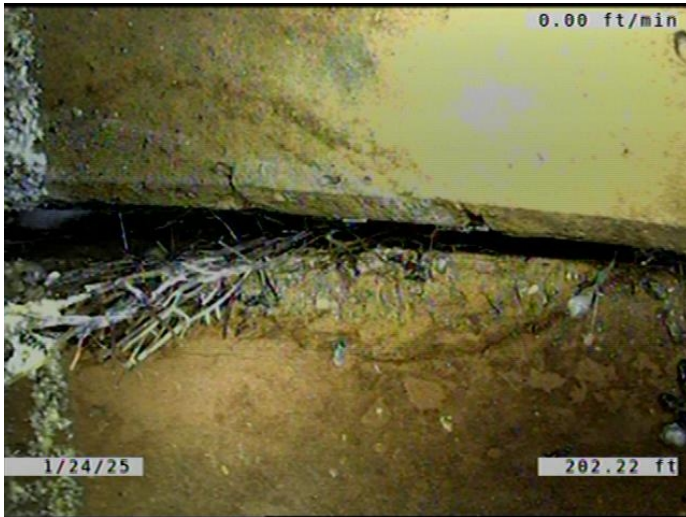
Code: **RFJ**
Description: **Roots Fine Joint**

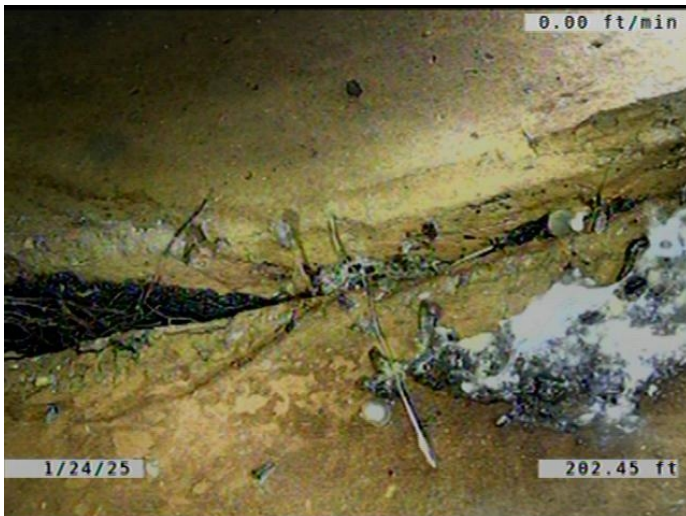
Code: **JOMD**
Description: **Joint Offset Medium Defective**

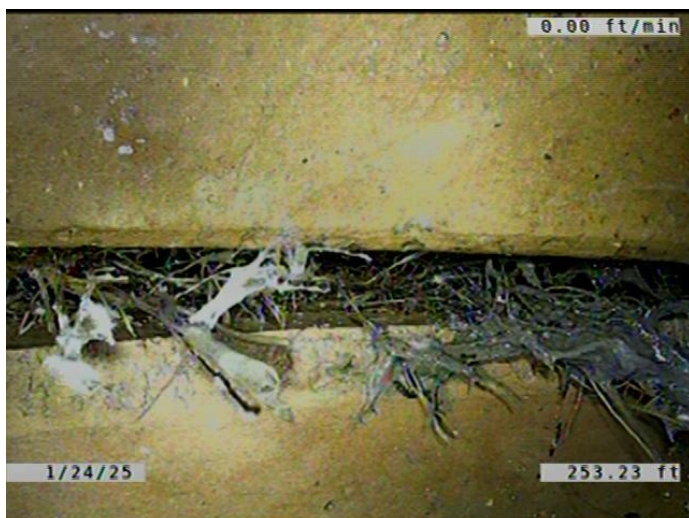
Code: **RFJ**
 Description: **Roots Fine Joint**
