Profile/Photo Observation Report

Date:	04/11/2018	Weather:		Coding:	PACP 6.0
Pipe Length (ft):		Owner:	City of Hobart	Pre Clean:	Not Known
P.O.#:	229	Surveyor:	B. Helbling	PSR:	P-208-019-014
Customer:	City of Hobart	Clean Date:		Shape:	C

Street:	Brookview Court	Flow Control:	Not Controlled
City:	Hobart, IN	Year Renewed:	
Location:	Easement/Right of Way	Tape/Media #:	DEP229
Purpose:	Routine Assessment	Dia/Height:	15"
Use:	Sanitary	Material:	VCP
Drain Area:		Lining:	
Category:	NA		
Comment:	YES501824 Submittal 2		
Location Details:		Direction of Survey:	Upstream
US MH:	M-208-019	DS MH:	M-208-014
		Total Length Surveyed (ft):	280.6

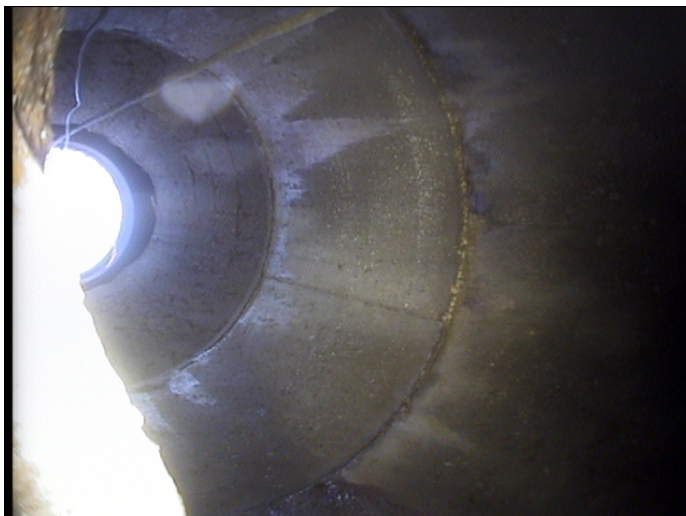
Code: **AMH**
 Description: **Manhole**

Distance (ft): **.0**
 Structural Grade: **0**
 O&M Grade: **0**
 Clock Start/From:
 Clock To:
 1st Value:
 2nd Value:
 Value Percent:
 Continuous Index:
 Within 8" of Joint: **NO**
 Remarks: **M-208-014**

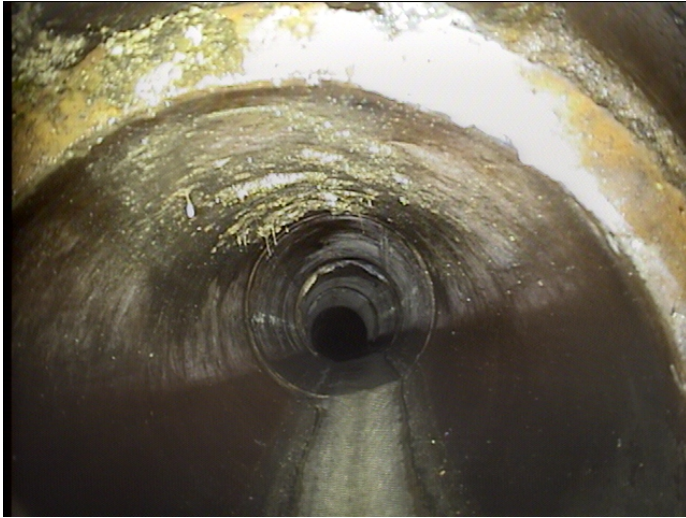
Code: **MWL**
Description: **Water Level**

Distance (ft): **.0**
Structural Grade: **0**
O&M Grade: **0**
Clock Start/From:
Clock To:
1st Value:
2nd Value:
Value Percent: **5.000**
Continuous Index:
Within 8" of Joint: **NO**
Remarks:

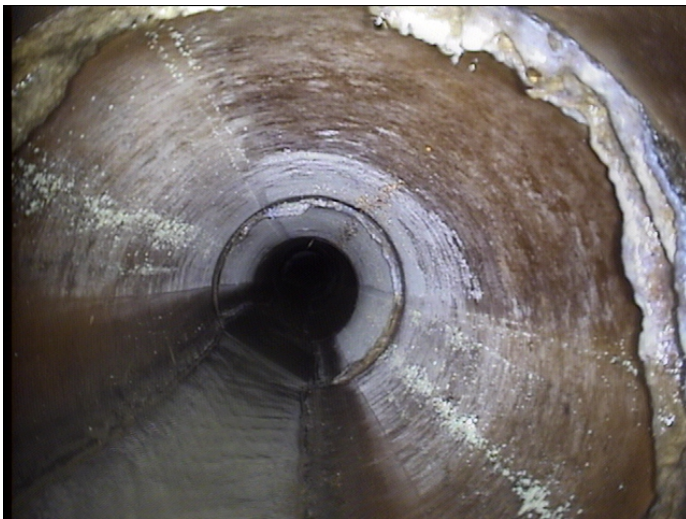
Code: **DAE**
Description: **Deposits Attached Encrustation**

Distance (ft): **6.8**
Structural Grade: **0**
O&M Grade: **2**
Clock Start/From: **7**
Clock To: **5**
1st Value:
2nd Value:
Value Percent: **5.000**
Continuous Index:
Within 8" of Joint: **YES**
Remarks:

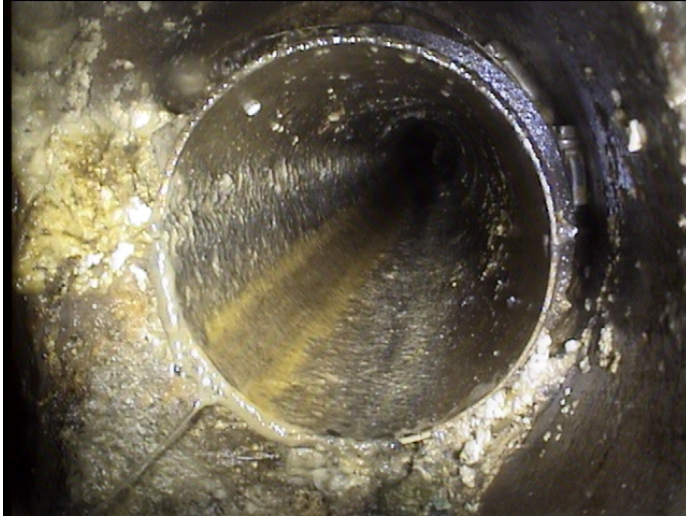
Code: **TBA**
Description: **Tap Break-in Active**

Distance (ft): **58.9**
Structural Grade: **0**
O&M Grade: **0**
Clock Start/From: **2**
Clock To:
1st Value: **4.000**
2nd Value:
Value Percent:
Continuous Index:
Within 8" of Joint: **NO**
Remarks:

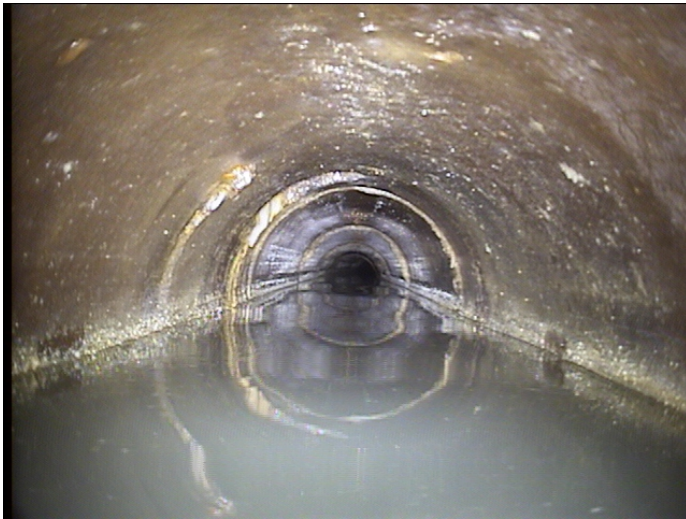
Code: **MWL**
Description: **Water Level**

Distance (ft): **59.6**
Structural Grade: **0**
O&M Grade: **0**
Clock Start/From:
Clock To:
1st Value:
2nd Value:
Value Percent: **30.000**
Continuous Index:
Within 8" of Joint: **NO**
Remarks:

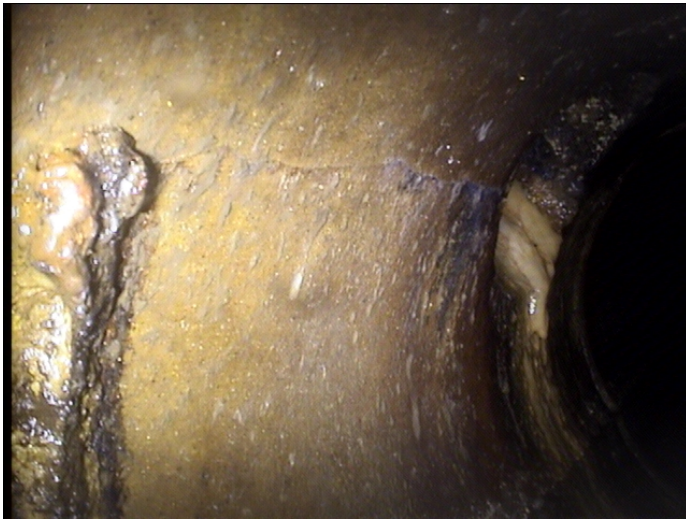
Code: **CL**
Description: **Crack Longitudinal**

Distance (ft): **61.7**
Structural Grade: **2**
O&M Grade: **0**
Clock Start/From: **10**
Clock To:
1st Value:
2nd Value:
Value Percent:
Continuous Index:
Within 8" of Joint: **NO**
Remarks:

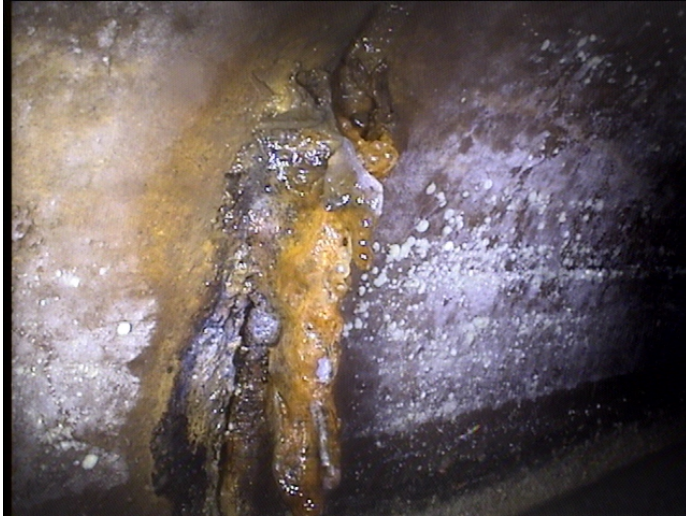
Code:	DAE
Description:	Deposits Attached Encrustation
Distance (ft):	91.9
Structural Grade:	0
O&M Grade:	2
Clock Start/From:	8
Clock To:	10
1st Value:	
2nd Value:	
Value Percent:	5.000
Continuous Index:	
Within 8" of Joint:	YES
Remarks:

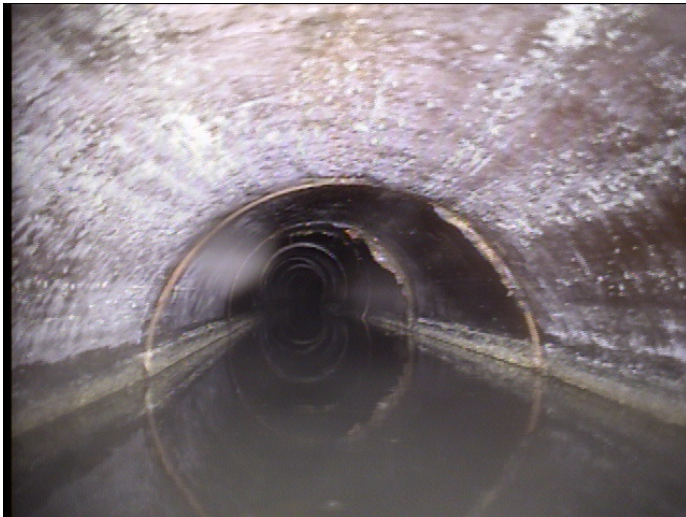
Code:	DSF
Description:	Deposits Settled Fine
Distance (ft):	99.9
Structural Grade:	0
O&M Grade:	2
Clock Start/From:	5
Clock To:	7
1st Value:	
2nd Value:	
Value Percent:	10.000
Continuous Index:	S01
Within 8" of Joint:	NO
Remarks:

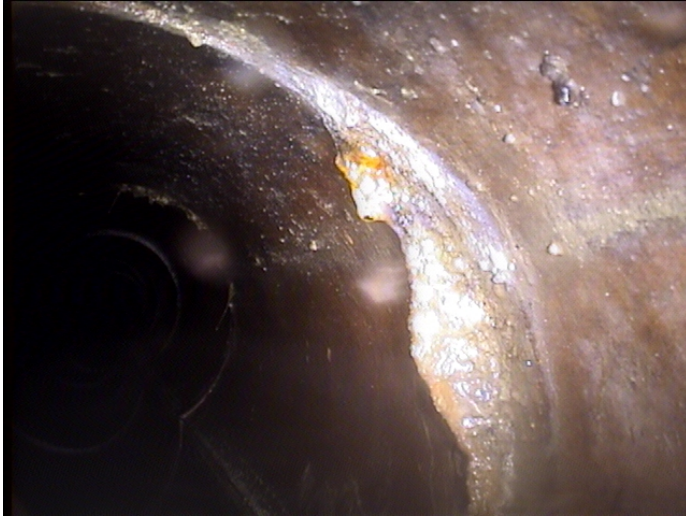
Code:	ID
Description:	Infil Dripper
Distance (ft):	104.8
Structural Grade:	0
O&M Grade:	3
Clock Start/From:	2
Clock To:	
1st Value:	
2nd Value:	
Value Percent:	
Continuous Index:	
Within 8" of Joint:	NO
Remarks:

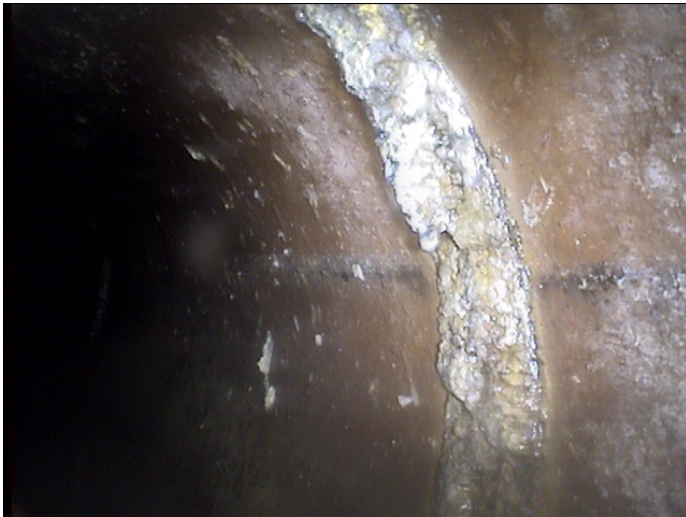
Code: **ID**
Description: **Infil Dripper**

Distance (ft): **132.1**
Structural Grade: **0**
O&M Grade: **3**
Clock Start/From: **2**
Clock To:
1st Value:
2nd Value:
Value Percent:
Continuous Index:
Within 8" of Joint: **YES**
Remarks:

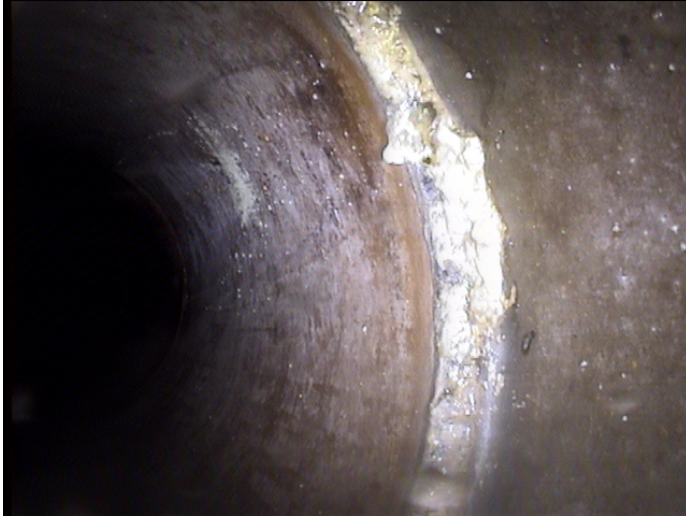
Code: **ID**
Description: **Infil Dripper**

Distance (ft): **201.2**
Structural Grade: **0**
O&M Grade: **3**
Clock Start/From: **12**
Clock To:
1st Value:
2nd Value:
Value Percent:
Continuous Index:
Within 8" of Joint: **YES**
Remarks:

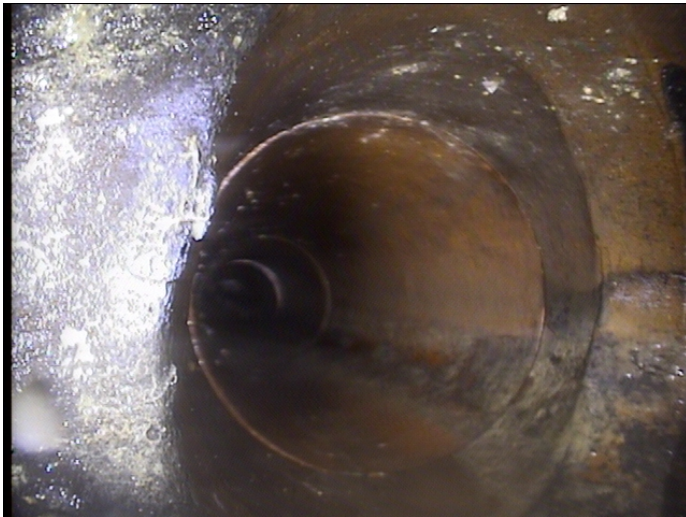
Code: **TF**
Description: **Tap Factory**

Distance (ft): **255.0**
Structural Grade: **0**
O&M Grade: **0**
Clock Start/From: **12**
Clock To:
1st Value: **4.000**
2nd Value:
Value Percent:
Continuous Index:
Within 8" of Joint: **NO**
Remarks:
